## 6 Destructive Testing and Results

### 6.1 Cutting Plan

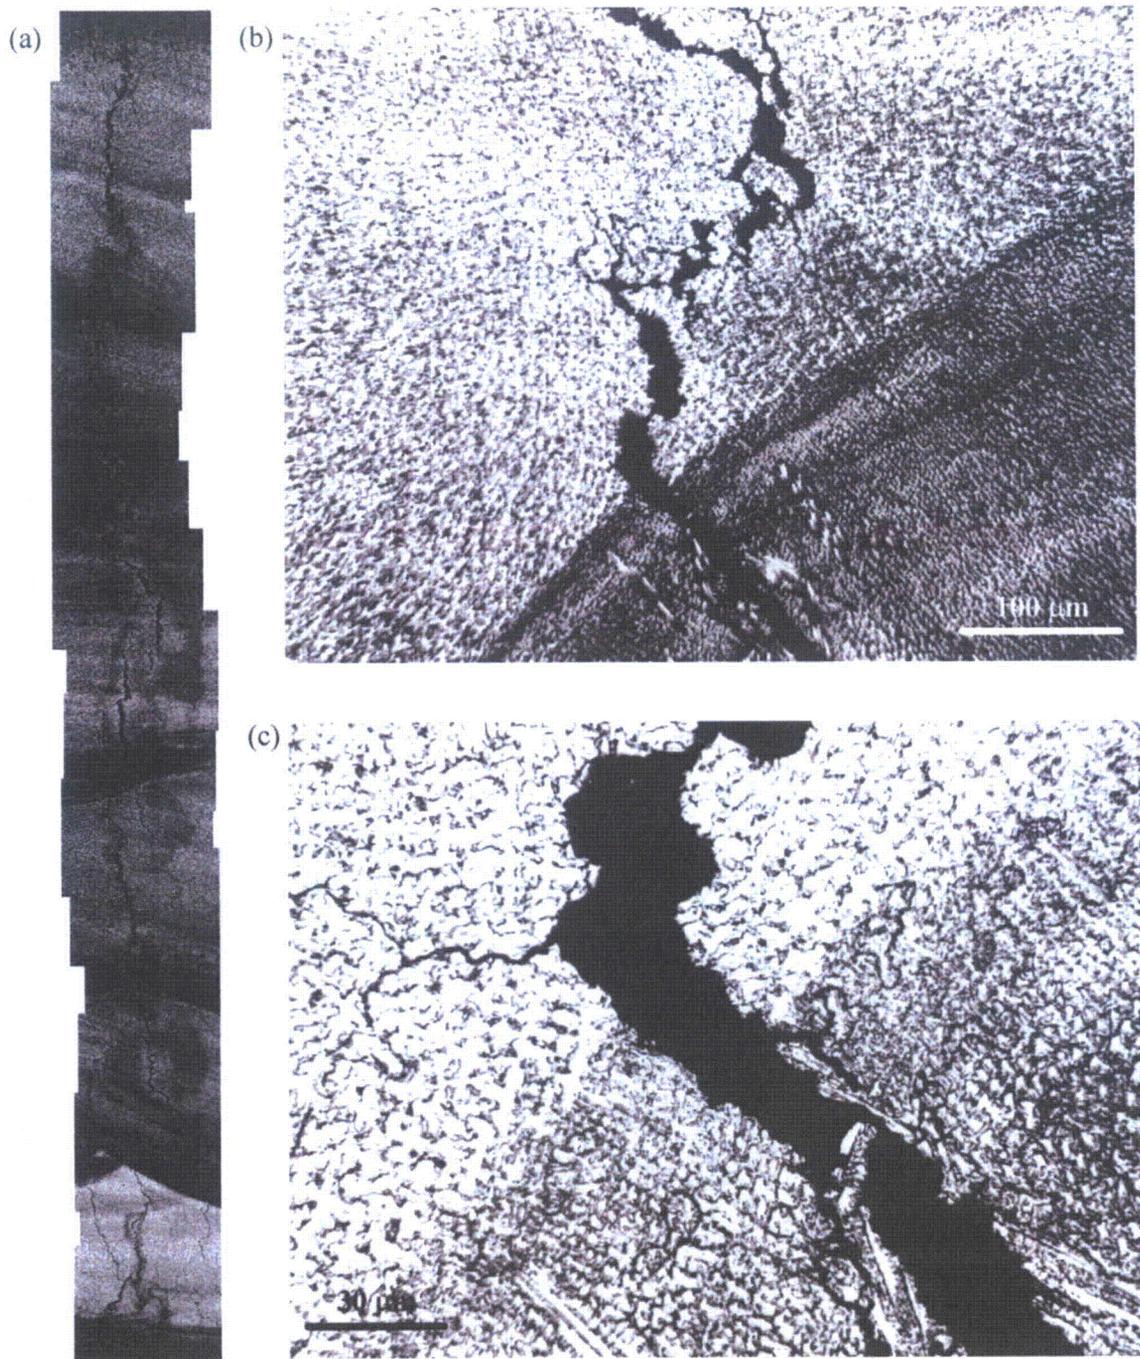
Similar to the microstructures documented for cross-section A5 (Figure 6.30), section C5 also was given an electrolytic etch using nital and orthophosphoric solutions. Although the exposure produced a heavy etch in places, the general microstructural features and the crack path could be recorded as illustrated in Figure 6.35. Once again, the SCC morphology is clearly interdendritic or intergranular following the convoluted boundaries in the Alloy 182 weld metal. Consistent with A5, wider crack openings were typically seen at the weld pass interfaces, with cracks often turning along the interface to find better-oriented boundaries for continued propagation. An example of this behavior is shown in Figures 6.35(b) and (c).

**Figure 6.35 Etched C5 Cross Section Showing Crack Propagating Through Many Alloy 182 Weld Passes**

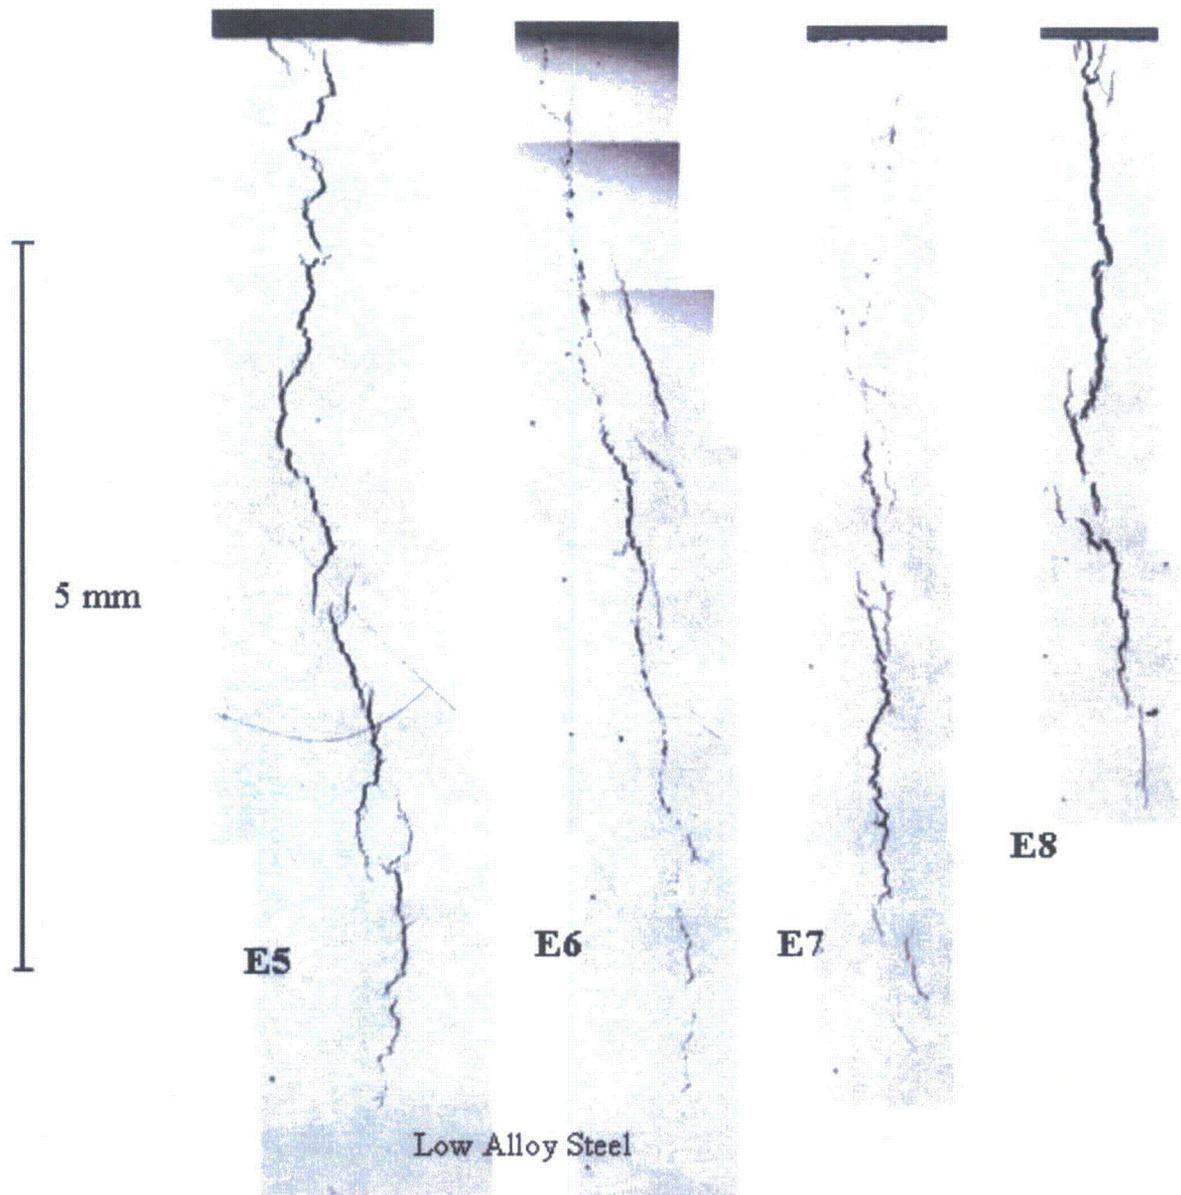
The final sequence of metallographic cross sections for piece E is given in Figure 6.36. This piece is split between the Alloy 182 butter passes and low-alloy steel plate. As a result, cracks are seen in only cross-sections E4 to E8 and propagate in only the Alloy 182 part of the way through the thickness before intersecting the low-alloy steel. Because the adjacent Alloy 600 tube was removed during initial cutting, E8 was the last slice that could be examined. The next sequential observation of the crack is from the exit surface into the interference-fit gap shown in Figure 6.23.

**Figure 6.36 E5, E6, E7, and E8 Cross-Section Samples Showing the Main Crack Running to the Low-Alloy Steel Boundary. Only a very small crack was seen in sample E4, and E8 was the closest slice to the gap surface.**

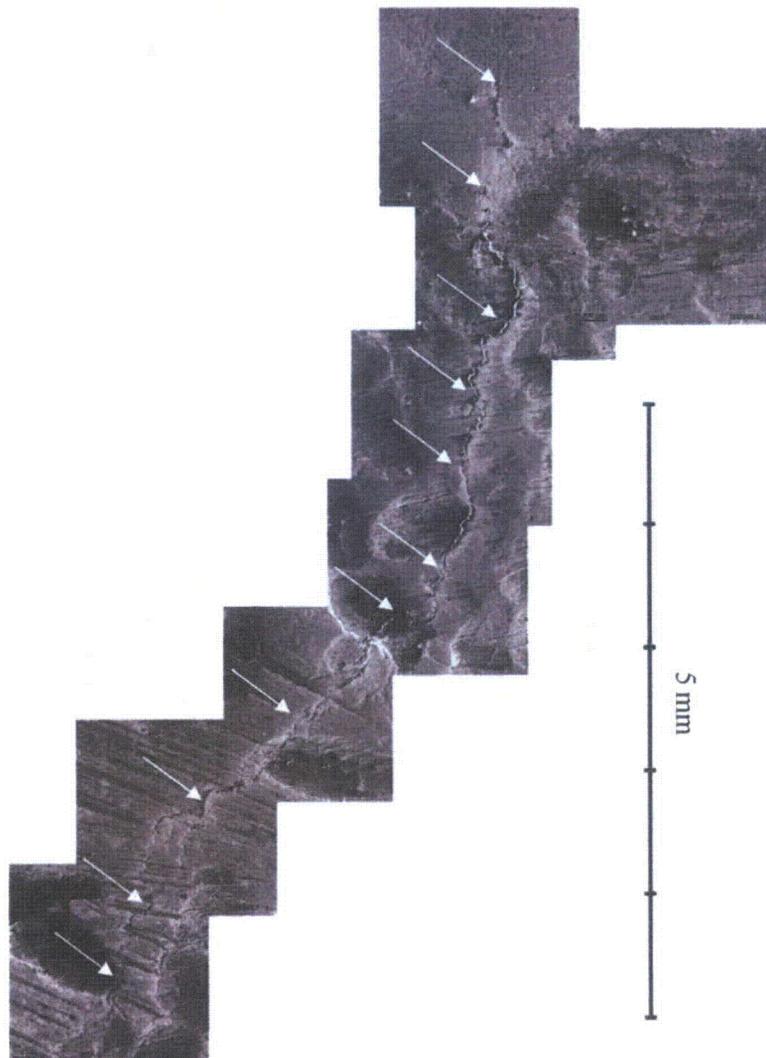
The cracks at 225, 210, and 255 were imaged using SEM to determine their length and crack opening displacement. The crack at 225 is shown in Figure 6.37. The crack at 225 was found to have a length of 8.7 mm (0.34 in.) and a maximum COD of 30  $\mu\text{m}$  (0.0012 in.). The crack at 210 was found to be less than 6 mm (0.24 in.) deep via sectioning, but as it showed up in both PT and ET it was examined with SEM. The crack at 210 degrees has a COD of between 2  $\mu\text{m}$  (0.00008 in.). The crack at 210 degrees is shown in Figure 6.38.

**Figure 6.37 SEM Image of Crack at 225 Degrees**

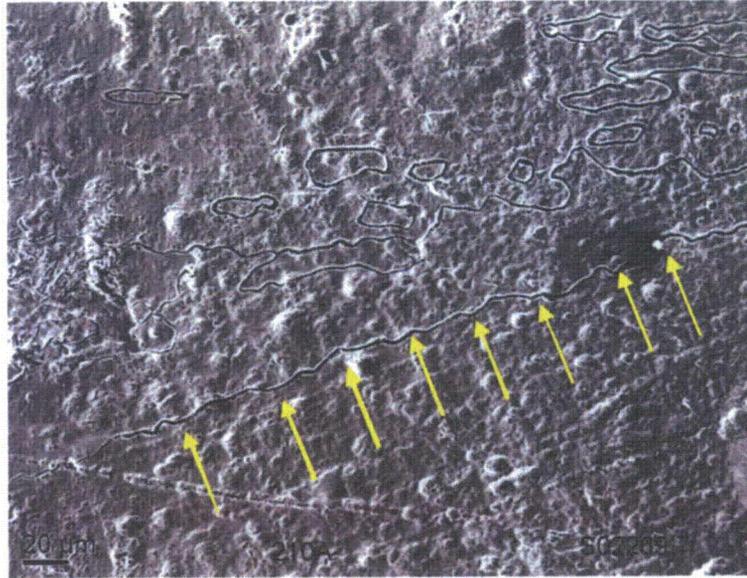
**Figure 6.38 SEM Image of Crack at 210 Degrees**

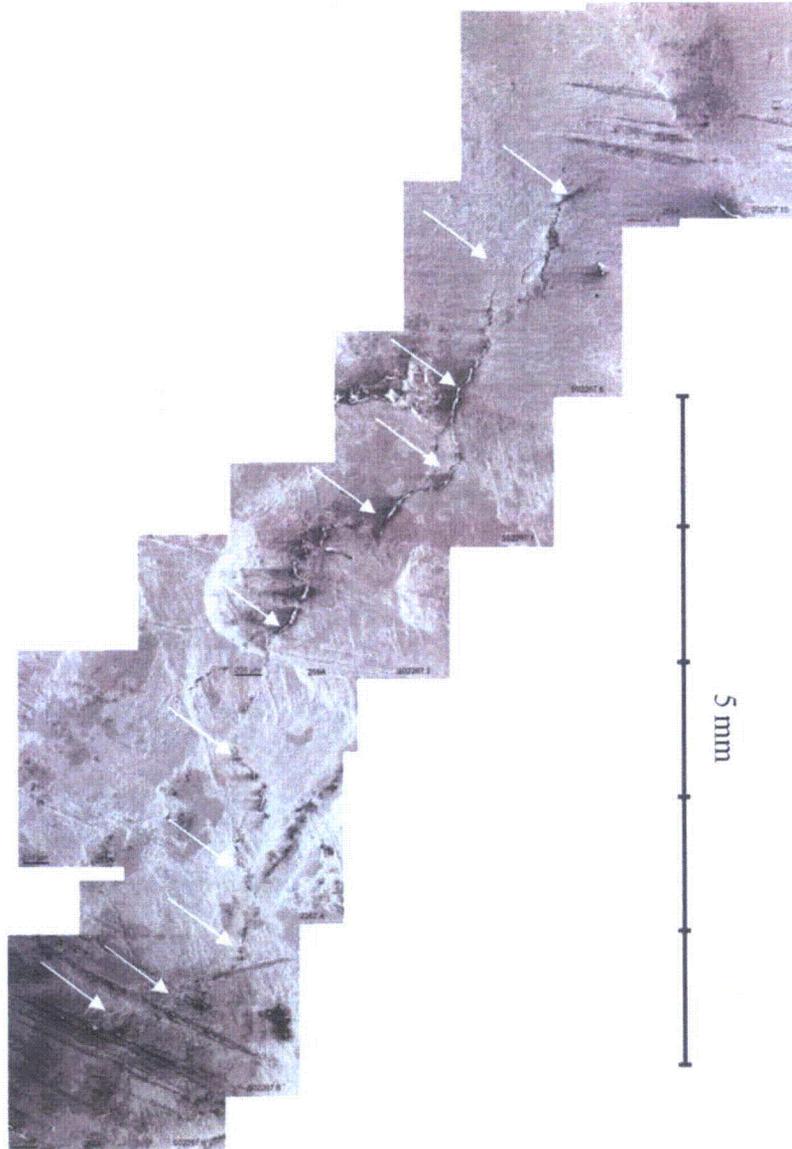
An SEM image of the 255-degree crack reveals a crack length of 7.6 mm (0.3 in.) and a COD of 40  $\mu\text{m}$  (0.0016 in.). The crack has a very broken profile, closing at several points along its length. The SEM image of the 255-degree crack is shown in Figure 6.40.

**Figure 6.40 Wetted Surface SEM Image of Crack at 255 Degrees**

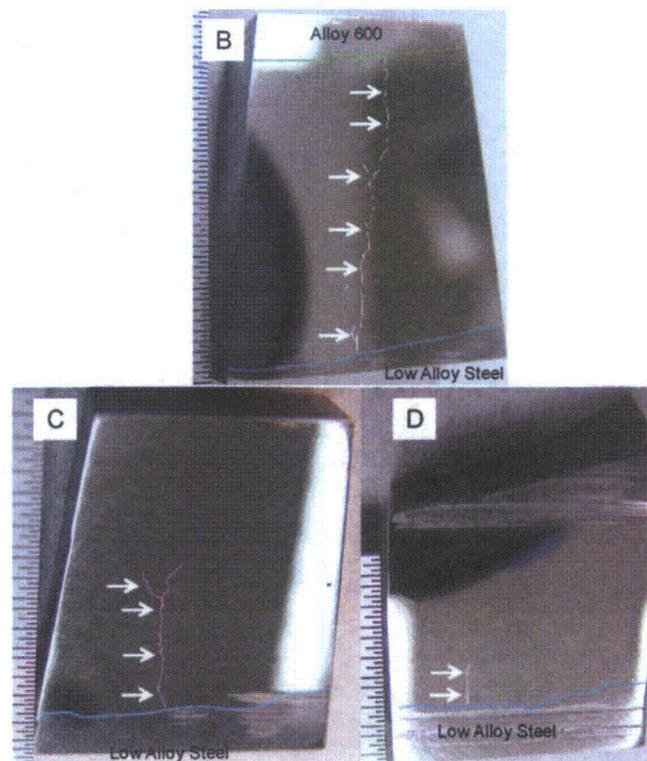
**Figure 6.42 Crack Locations at the Wetted Side Faces of Sections B, C and D of the 255-Degree Crack**

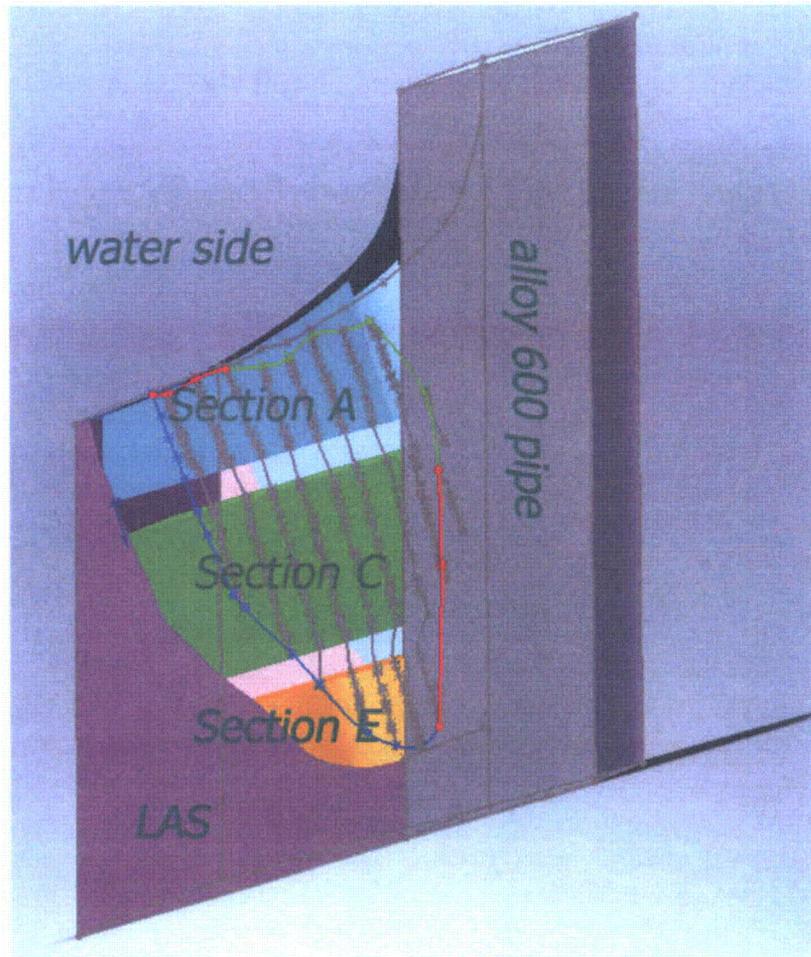
An overall image of the rendering that includes pieces A, C, and E is shown in Figure 6.43. One face of the weld section has been left out to allow viewing of the sections. As noted from the metallographic examinations, the crack rapidly expands from the initiation location on the PWR primary-water surface and spreads across the Alloy 182 weld metal reaching the low-alloy steel and Alloy 600. The green line indicates the boundary of the crack in the Alloy 182 weld metal, while the blue line indicates the crack

boundary where it arrested at the low-alloy steel interface. Red lines along the crack boundary indicate the points where the crack reaches the Alloy 600 interface and the interference gap (not shown) above the J-groove weld.

**Figure 6.43** Rendering of the Crack Within a Section of the Component Showing the Locations of Sections A, C, and E

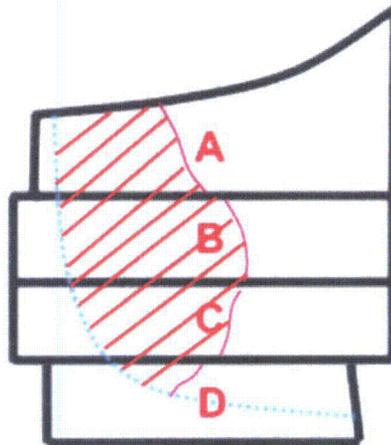
A similar but less extensive reconstruction was performed for the deep crack located at 255 degrees. This crack is interesting in that it is one that may have leaked given more time but has not yet reached the annulus. The crack appears to propagate along the buttering/carbon steel interface and grow from this interface into the weld metal. As with the crack located at 155 degrees, the crack at 255 degrees is very short at the wetted surface and grows in length under the surface. A profile of the crack at 255 degrees is shown in Figure 6.46.

- A: Crack is 11mm long on cut side
- B: Crack is 15mm on A cut side and 18mm C cut side
- C: Crack is 17mm on B cut side and 10mm on D cut side
- D: Crack is 6 mm on cut side

**Figure 6.46 Reconstruction of the Crack as It Propagates Through the Weld Metal and Buttering**

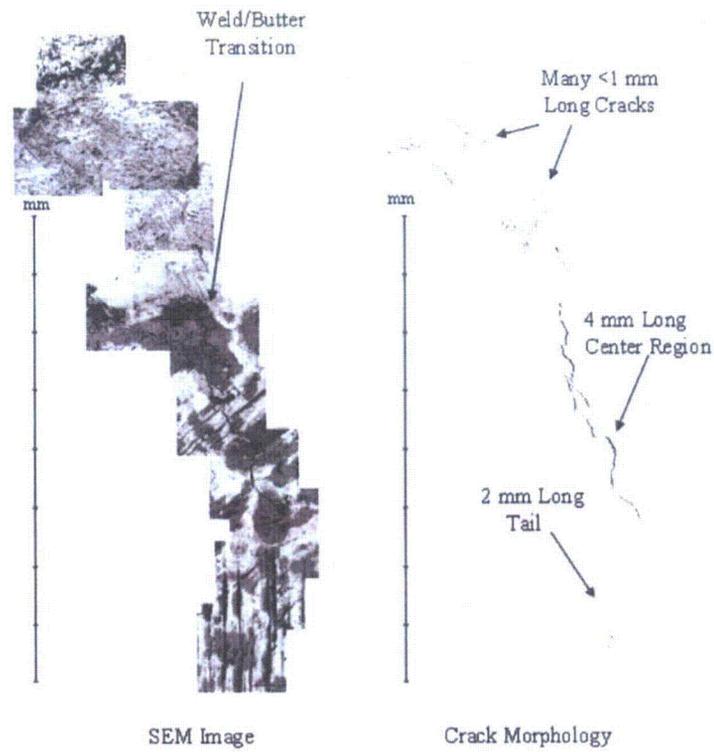
**Figure 8.1 Crack Image and Crack Morphology**

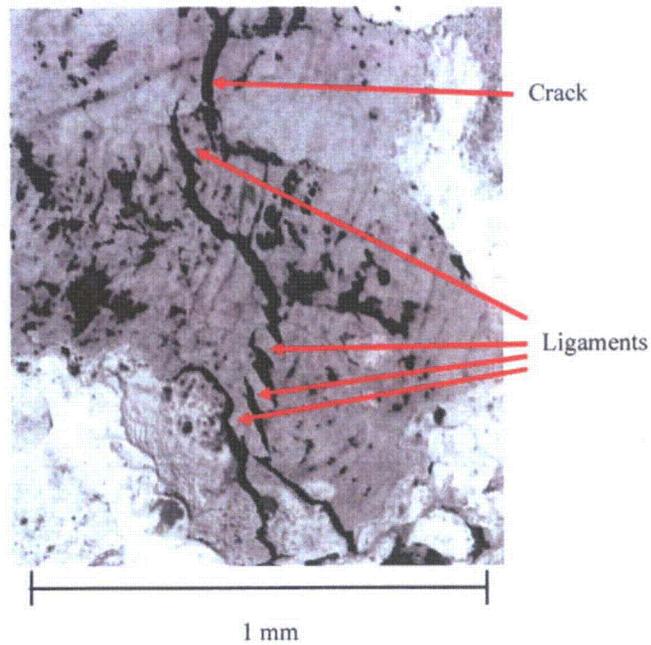
**Figure 8.2 Expanded Section of the Crack Showing Ligaments Bridging the Two Sides of the Crack**

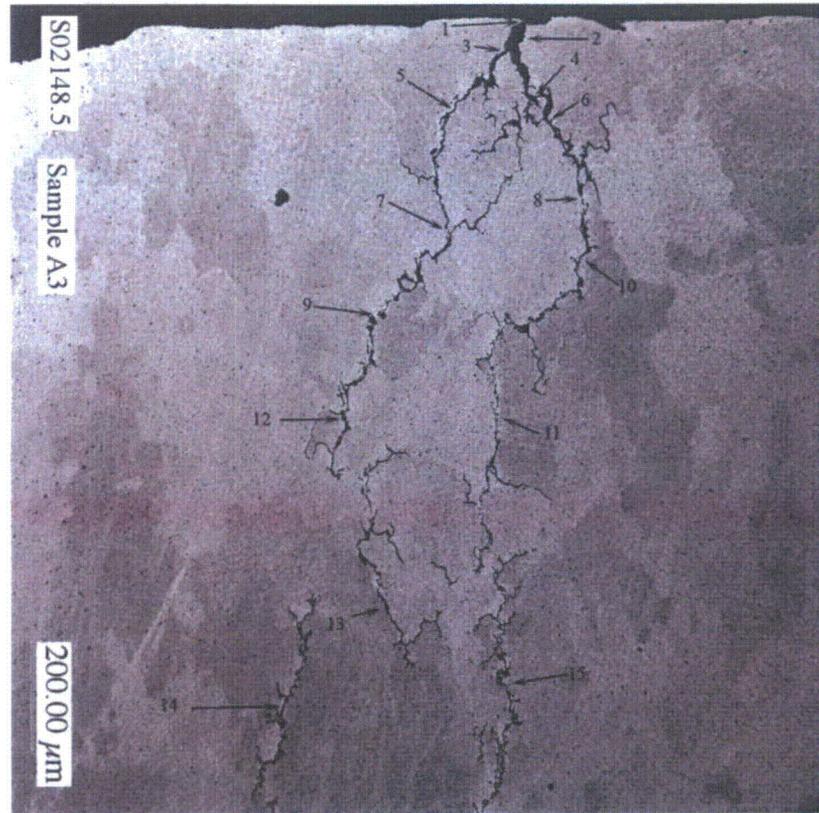
Figure 8.4 Crack CODs at Several Points Close to the Surface

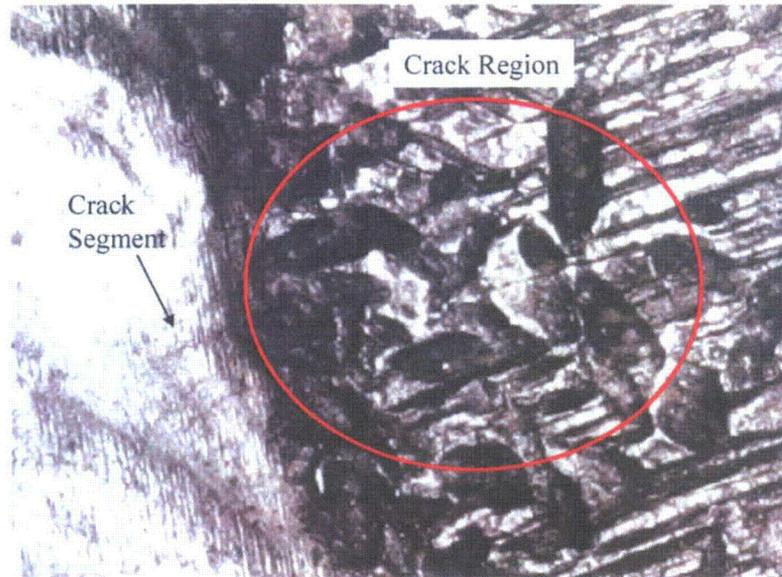
**Figure 8.7 Cracked Region with Poor Crack Detection Because of Surface Features and Oxides**

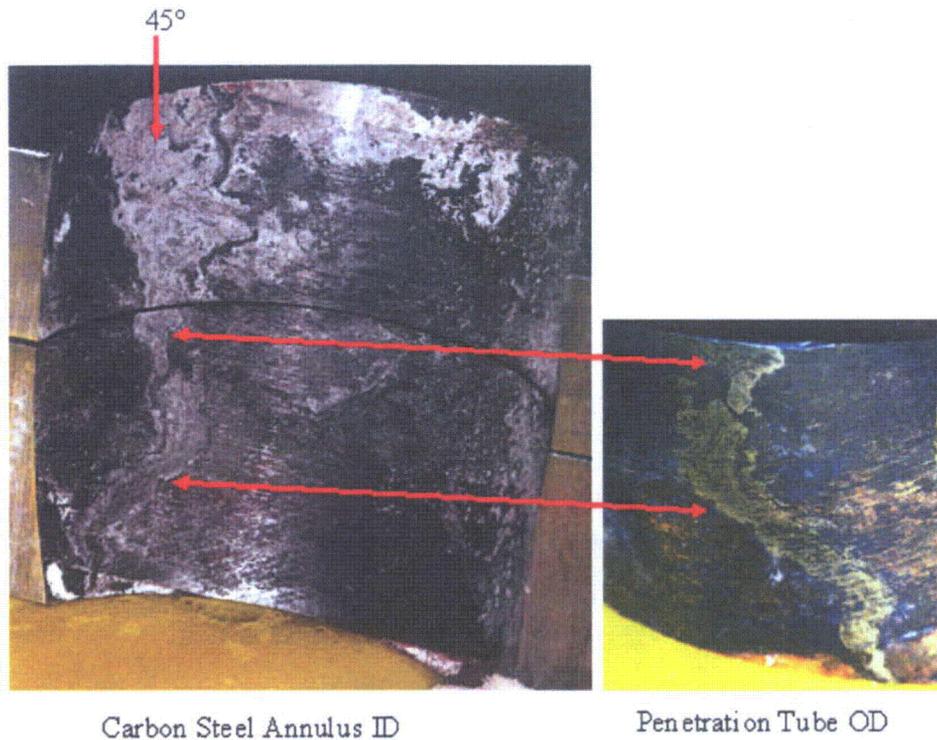
**Figure 8.8 Mirror-Image Damage to the Carbon Steel Annulus and a Section of the Alloy 600 Penetration Tube. The wetted surface is toward the top of the samples.**

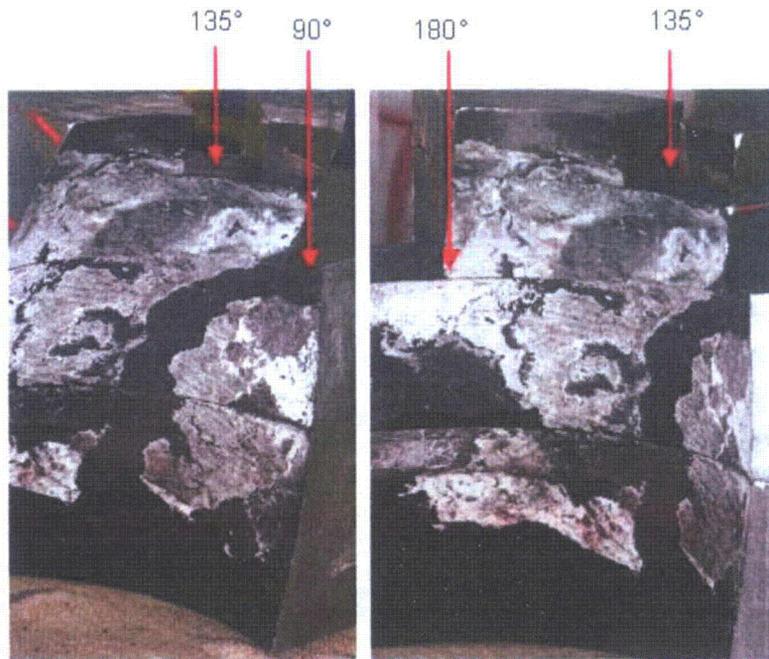
**Figure 8.9** Boric Acid Deposits on the Carbon Steel from 90–180 Degrees. The wetted surface is toward the top of the samples.

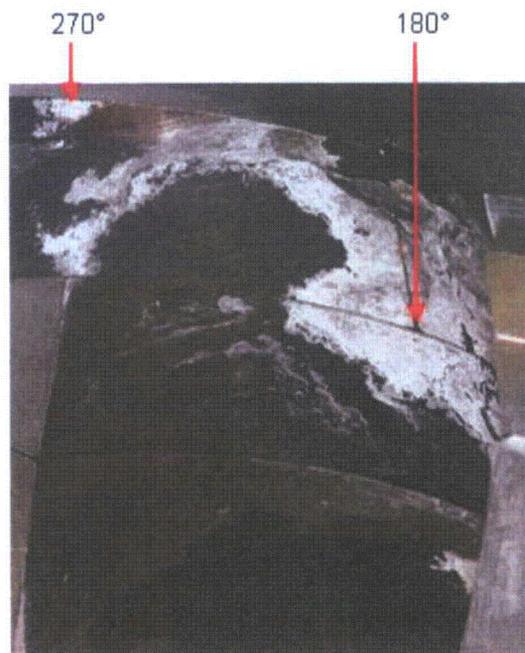
**Figure 8.10** Boric Acid Deposits on the Carbon Steel from 180–270 Degrees. The wetted surface is toward the top of the samples.

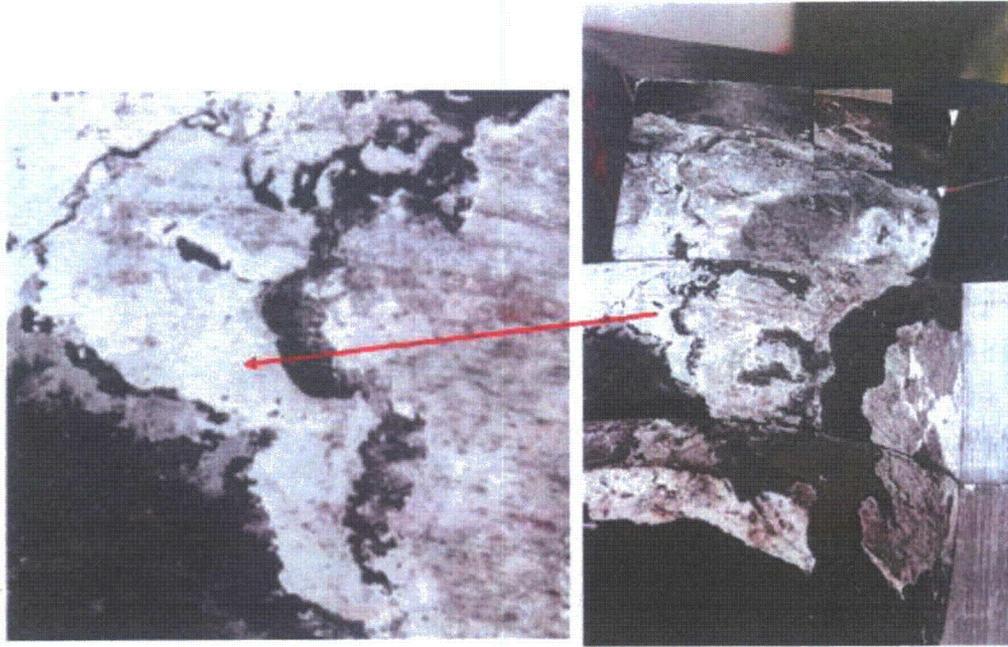
**Figure 8.11 Enlarged Region Showing Damage to the Metal in the Boric Acid-Filled Region**

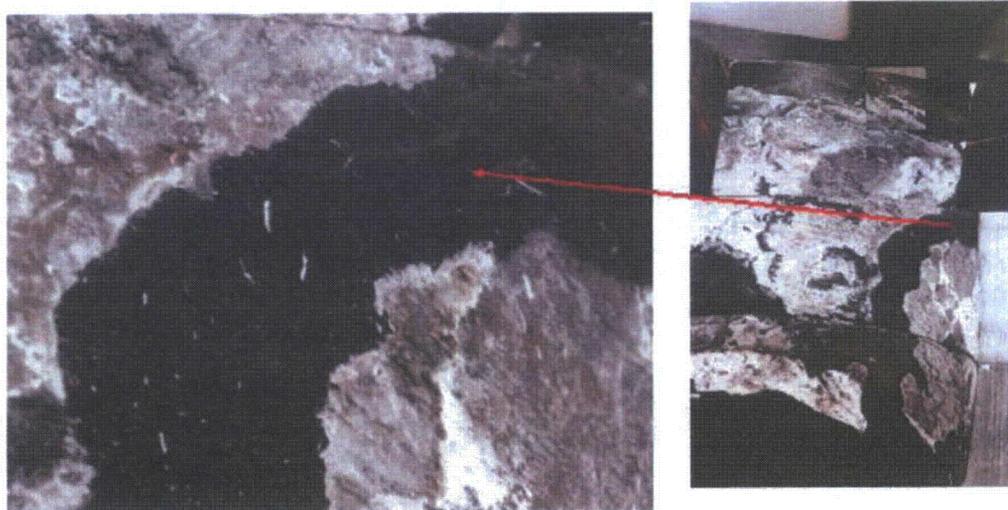
**Figure 8.12 Apparent Water Flow Damage in the "Clean" Region of the Annulus**

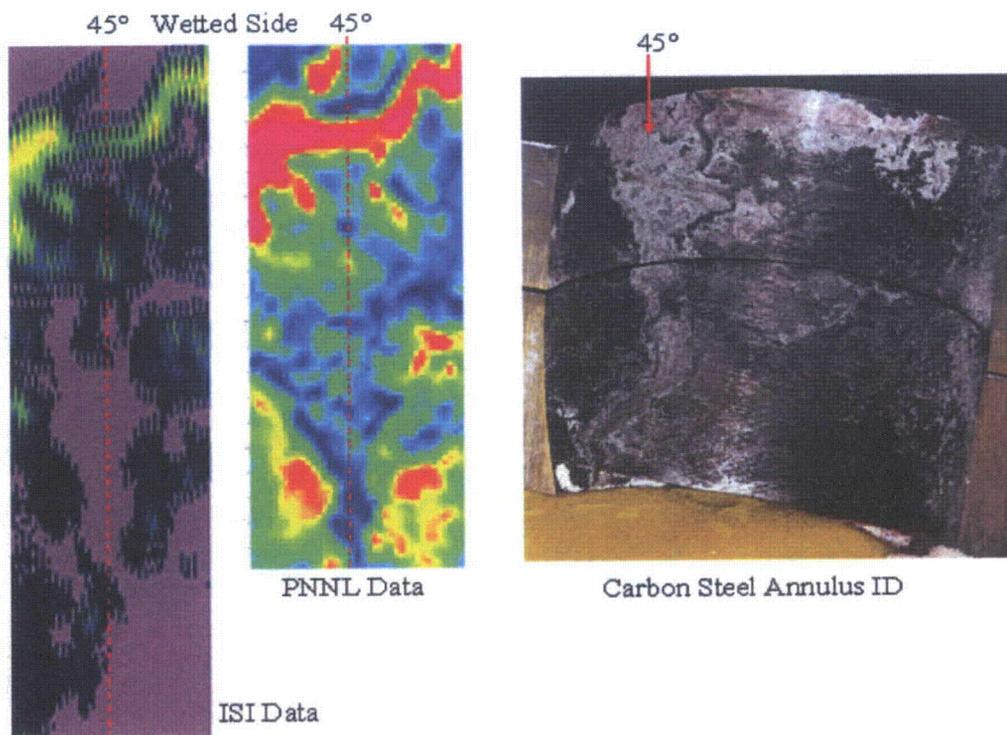
**Figure 8.15** Comparison of the UT Data and the Apparent Wastage of the Carbon Steel Near 45 Degrees
