NUREG/CR-6996
PNNL-18372

**Nondestructive and
Destructive Examination
Studies on Removed-from-Service
Control Rod Drive Mechanism
Penetrations**

In late 2002, widespread cracking in CRDM nozzles and associated Alloy 182 and 82 J-groove attachment welds was discovered at North Anna Unit 2. Accordingly, the utility decided to replace the reactor pressure vessel head. The NRC and the Electric Power Research Institute (EPRI) developed a joint program to study some of the defective North Anna Unit 2 CRDMs.

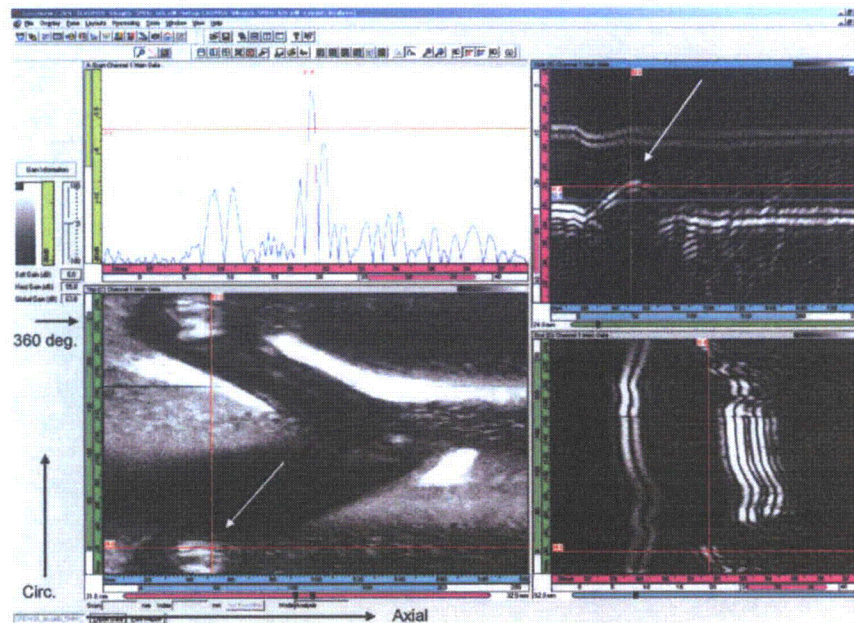
Figure 5.3 Nozzle 59 Weld Repair Intrusion Indication Detected with Time-of-Flight Diffraction at 24 mm (0.95 in.) CCW, 52 mm (2 in.) Axial, with a -5.6-dB Response. The axial and circumferential axes are also noted. One revolution (360 degrees) was represented by 224 mm (8.8 in.) circumferentially.

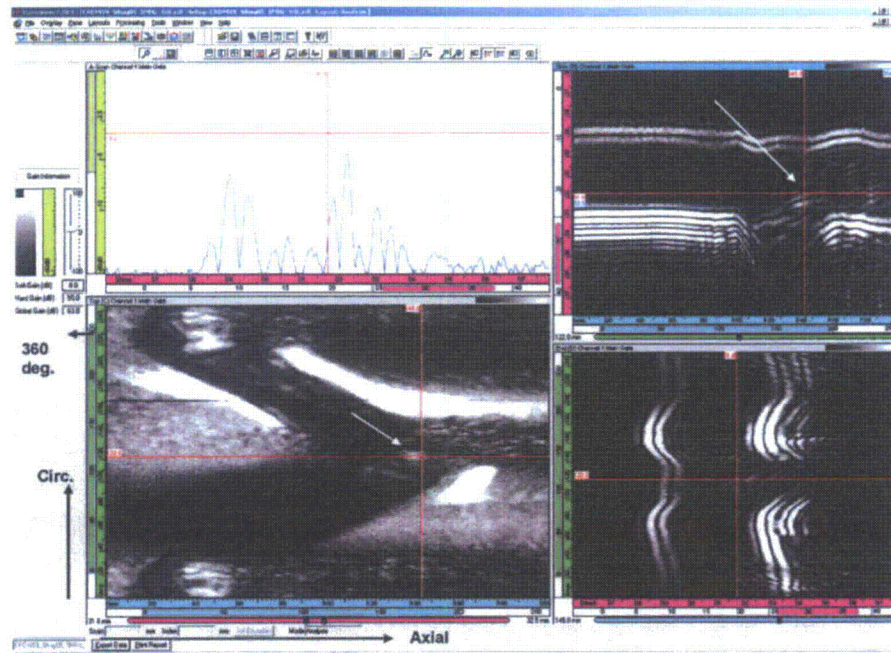
Figure 5.4 Nozzle 59 Weld Repair Intrusion Indication Detected with Time-of-Flight Diffraction at 122 mm (4.8 in.) CCW, 145 mm (5.7 in.) Axial, with a -7 -dB Response

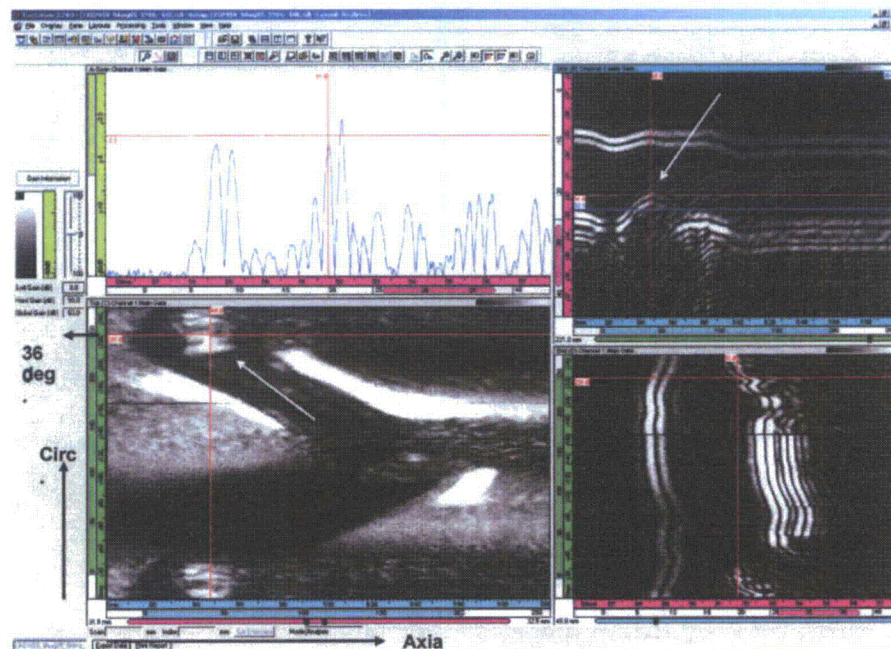
Figure 5.5 Nozzle 59 Weld Repair Intrusion Indication Detected with Time-of-Flight Diffraction at 231 mm (9.1 in.) CCW, 48 mm (1.9 in.) Axial, with a -5.7 - to -6.8 -dB Response

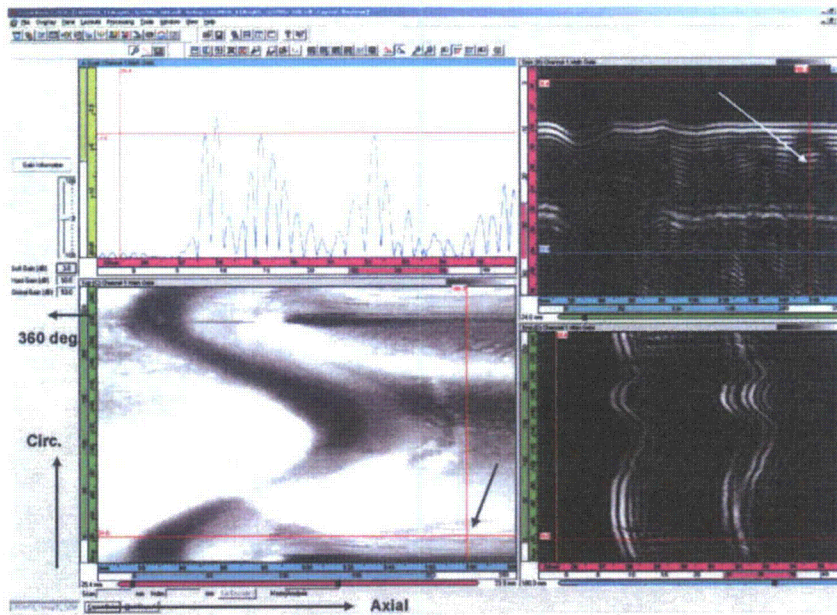
Figure 5.7 Nozzle 59, 7.5-MHz Time-of-Flight Diffraction Data Showing Interesting Indication. This indication is at 24 mm (0.95 in.) CCW and 180 mm (7.1 in.) axial position with a response of -3.8 dB in a region with many indications.

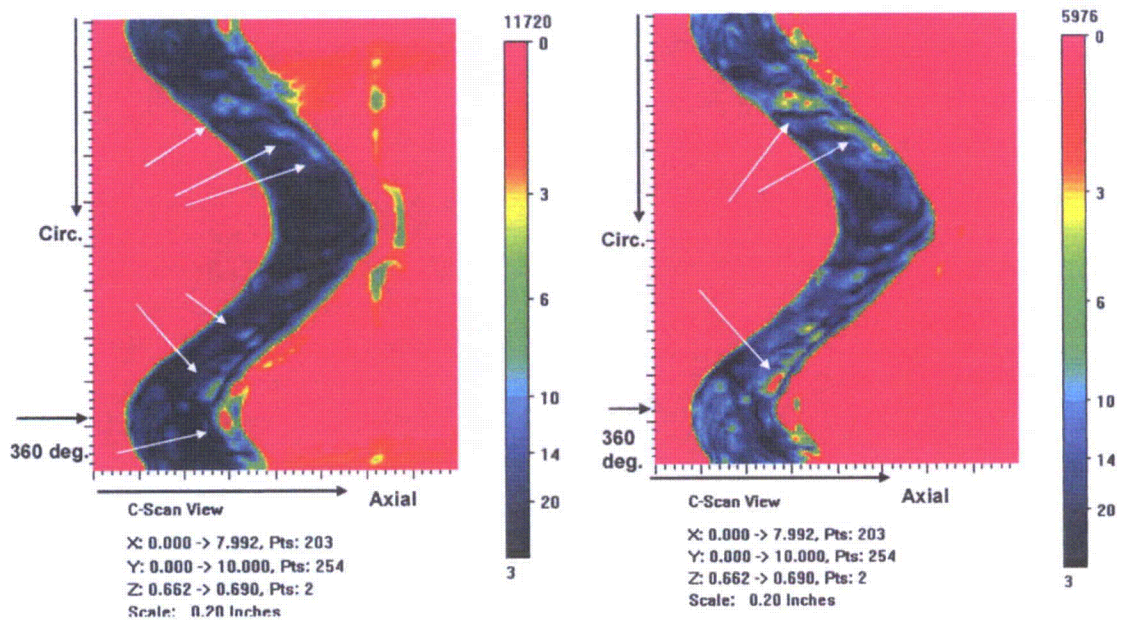
Figure 5.10 Nozzle 59, 2.25-MHz Immersion Data Showing Indications That Respond Like Lack of Fusion Starting in the J-Groove Weld Material at Two Different Displayed Amplitude Settings

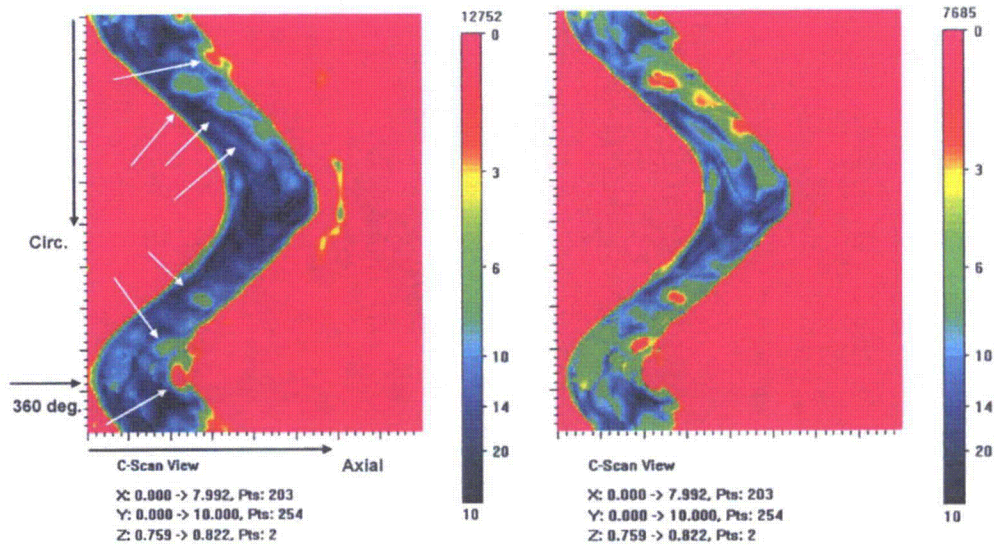
Figure 5.11 Nozzle 59, 1-MHz Immersion Data Showing Indications That Respond Like Lack of Fusion Starting in the J-Groove Weld Material at Two Different Displayed Amplitude Settings

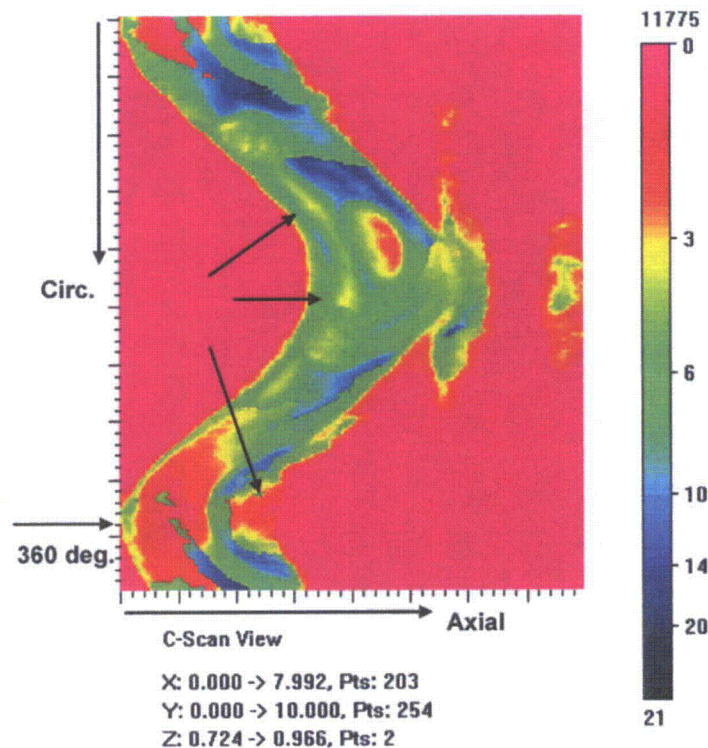
Figure 5.12 Nozzle 59, 500-kHz Immersion Data Showing Possible Lack-of-Fusion Indications Starting in the J-Groove Weld Material

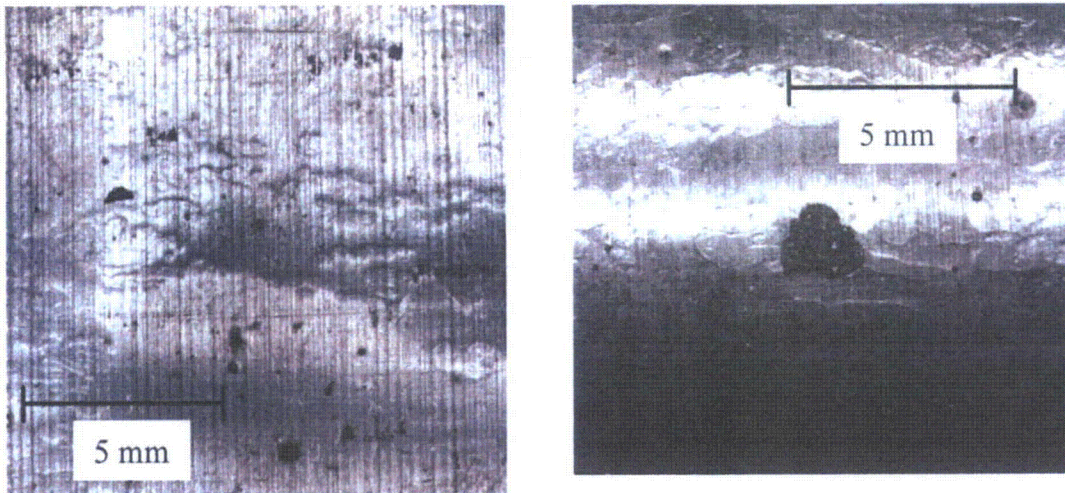
Figure 5.15 Pit-Like Indications and a Rough Patch Imaged Using High-Resolution Photographs of the Replicated Surface. The pit-like indications are located throughout the tube, while the rough patch is located at close to 180 degrees and 200 mm (7.9 in.) axially.

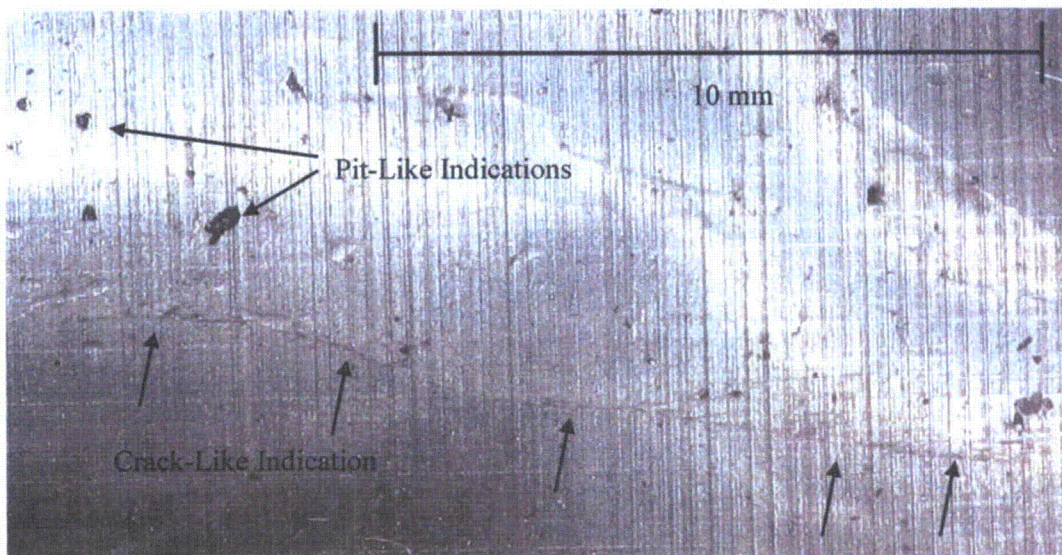
Figure 5.16 Crack-Like Indication Located at 315 Degrees Clockwise Rotation and 140 mm (5.1 in.) Axially in the Penetration Tube

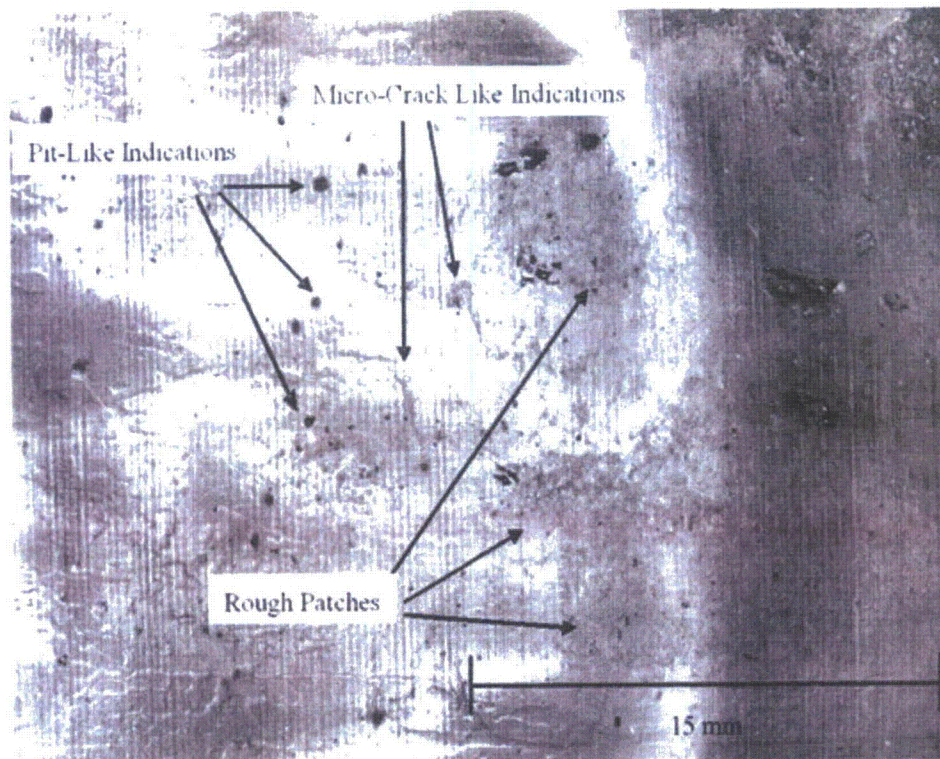
Figure 5.17 Rough Section and Possible Micro-Cracks in the Penetration Tube Interior

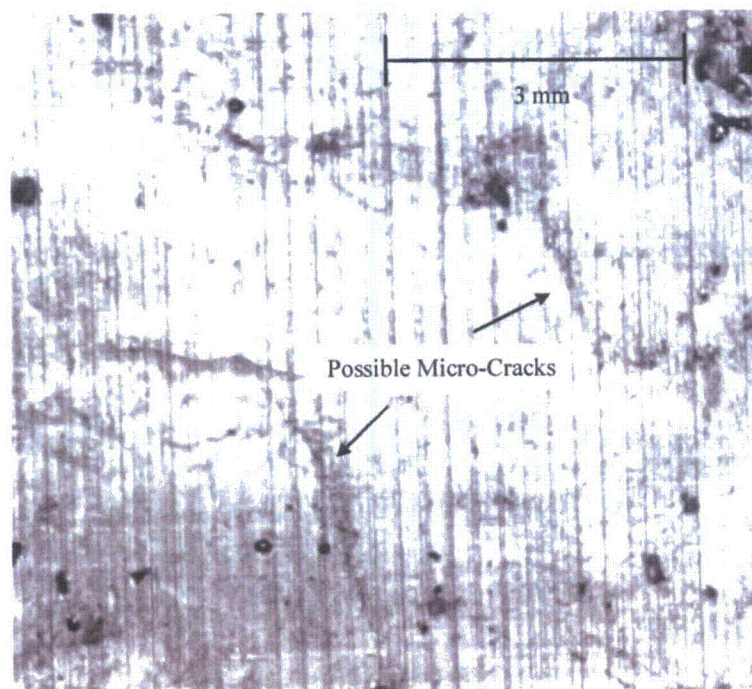
Figure 5.18 Micro-Crack-Like Indications in the Penetration Tube of Nozzle 59

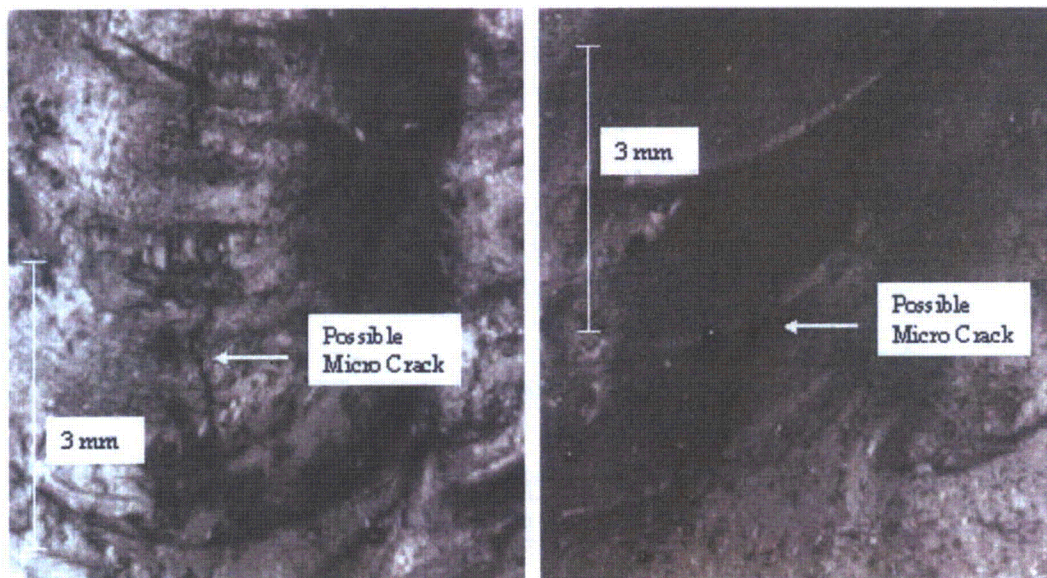
Figure 5.19 Small Crack-Like Indications near 120 Degrees in the J-Groove Weld Replica, Nozzle 59

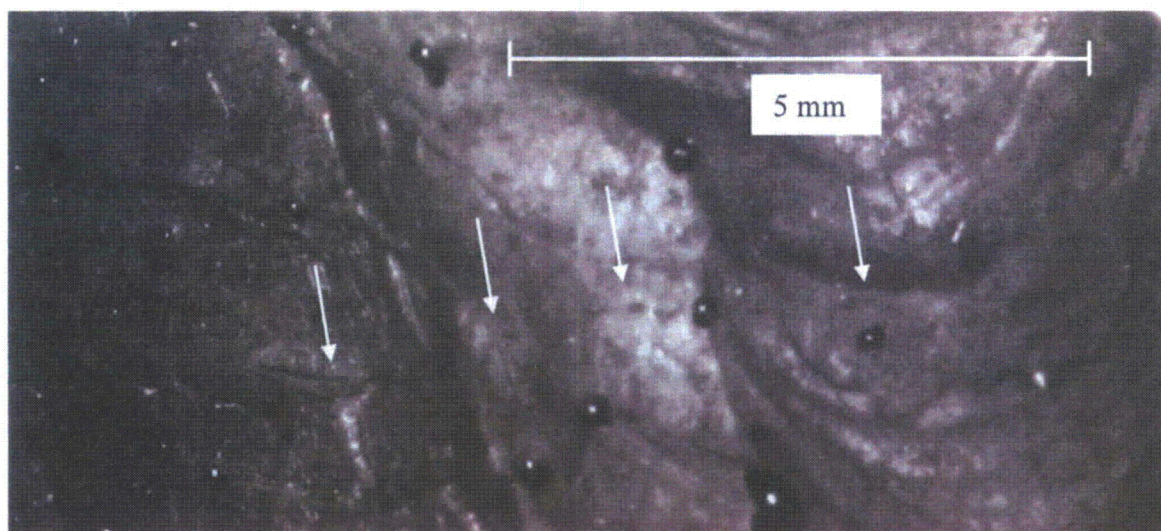
Figure 5.20 Crack-Like Indication in the J-Groove Weld Replica, of Nozzle 59 at 225 Degrees

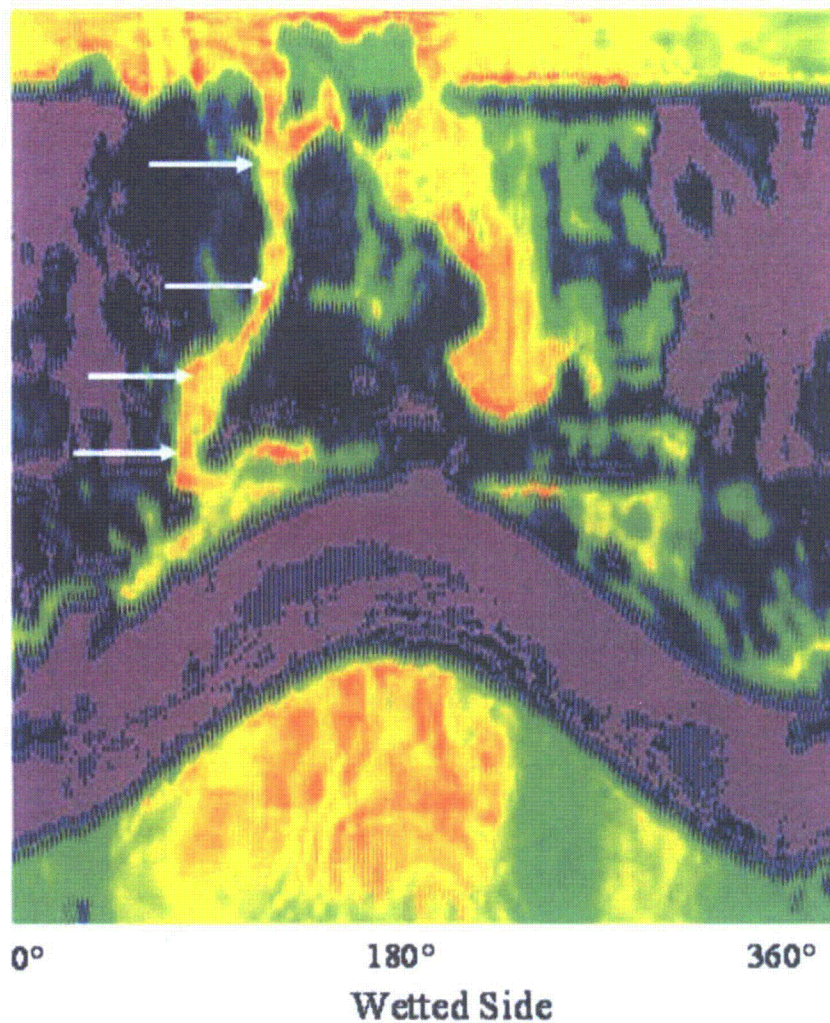
Figure 5.21 Industry-Acquired ISI Data Taken to Detect and Characterize the Presence of Any Leakage Path in Nozzle 31. The leakage path called by the ISI team is shown with the white arrows.

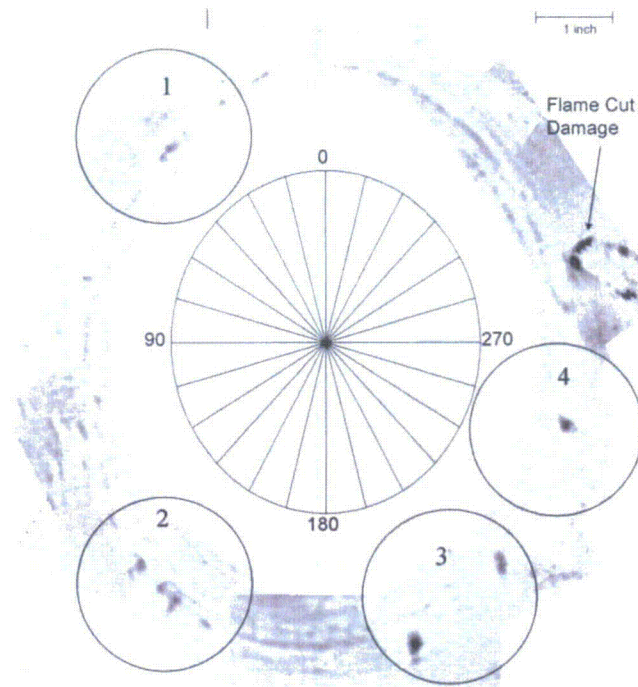
Figure 5.24 Eddy Current Results for 0-Degree Scan of the J-Groove Weld of Nozzle 31. Four areas of interest were found at close to 60, 150, 215, and 270 degrees.

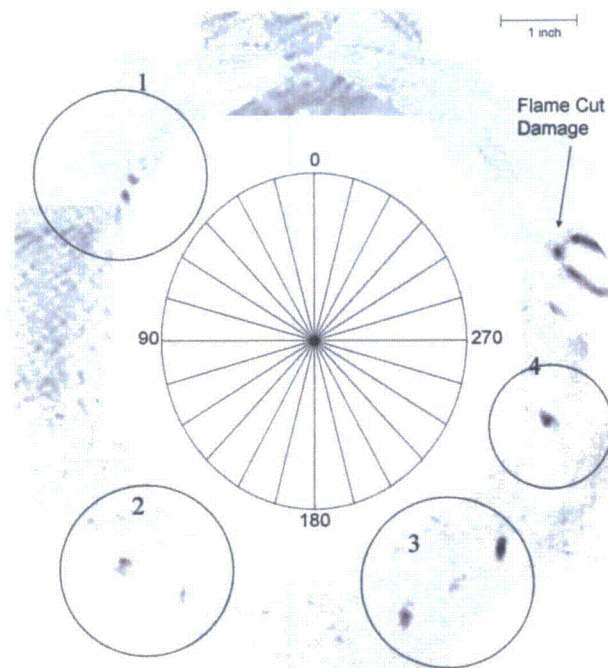
Figure 5.25 Eddy Current Results for 45-Degree Scan of the J-Groove Weld of Nozzle 31. Four areas of interest were found at close to 60, 150, 215, and 270 degrees.

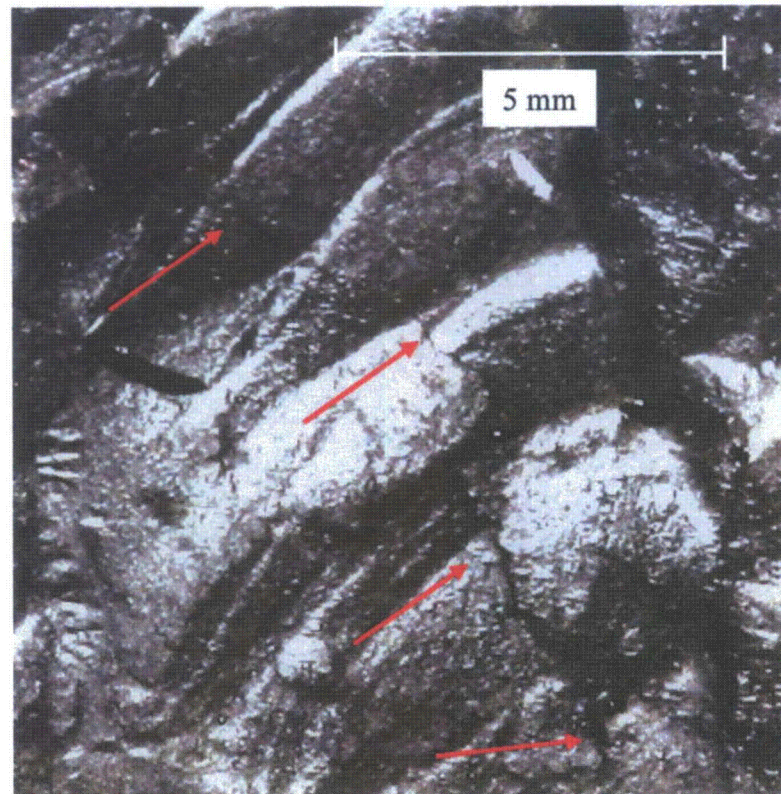
Figure 5.40 Crack-Like Indication 10 mm (0.0004 in.) Long at 145 Degrees CCW

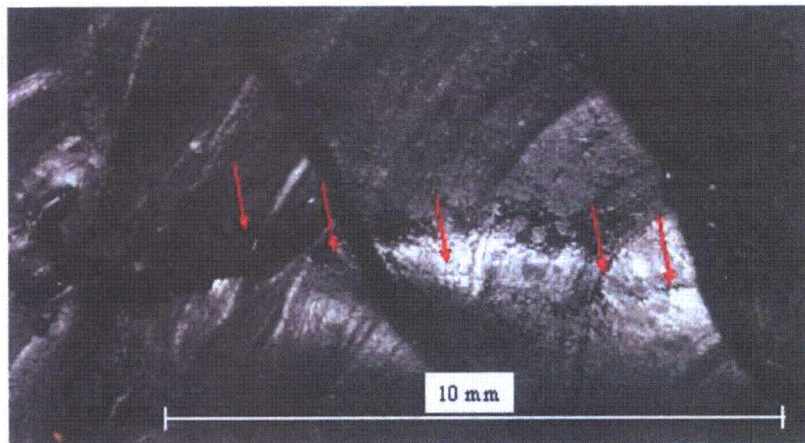
Figure 5.41 Crack-Like Indication at 135 Degrees CCW, 5 to 10 mm (0.0002 to 0.0004 in.) Long

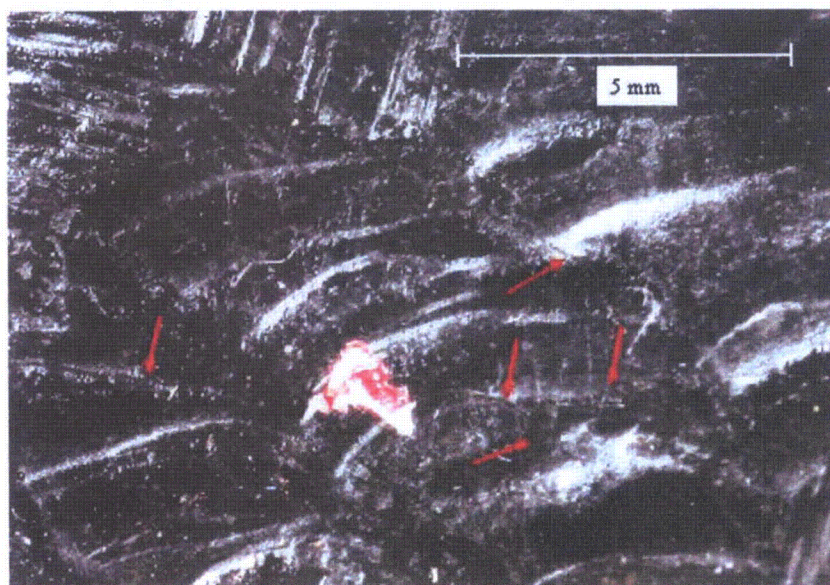
Figure 5.42 Cracked Area at 275 Degrees CCW. This branched crack-like indication traverses through the area. The cracked region is 1 cm².

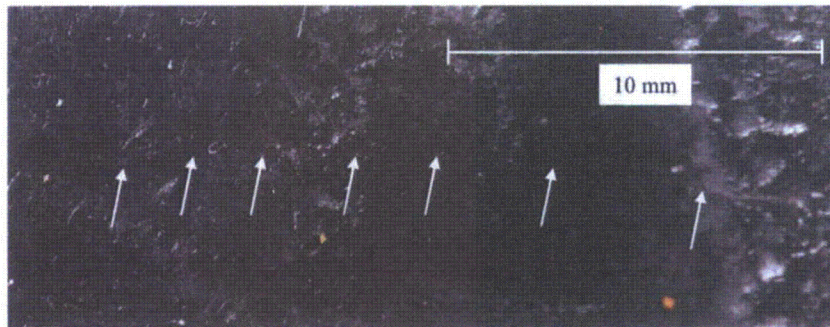
Figure 5.43 Crack-Like Indication at 270 Degrees CCW. The indication leaves the J-groove weld and propagates into the buttering. The indication is 15–20 mm (0.6–0.8 in.) long.

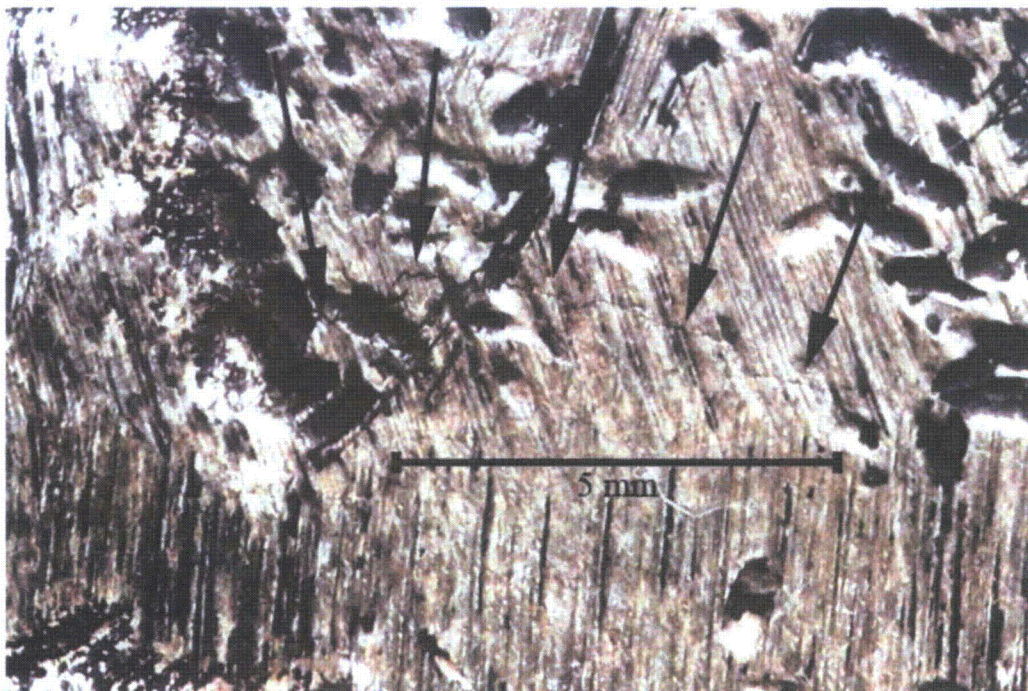
Figure 5.45 Crack-Like Indication Imaged Via Visual Testing at the Weld/Buttering Interface at 200 Degrees

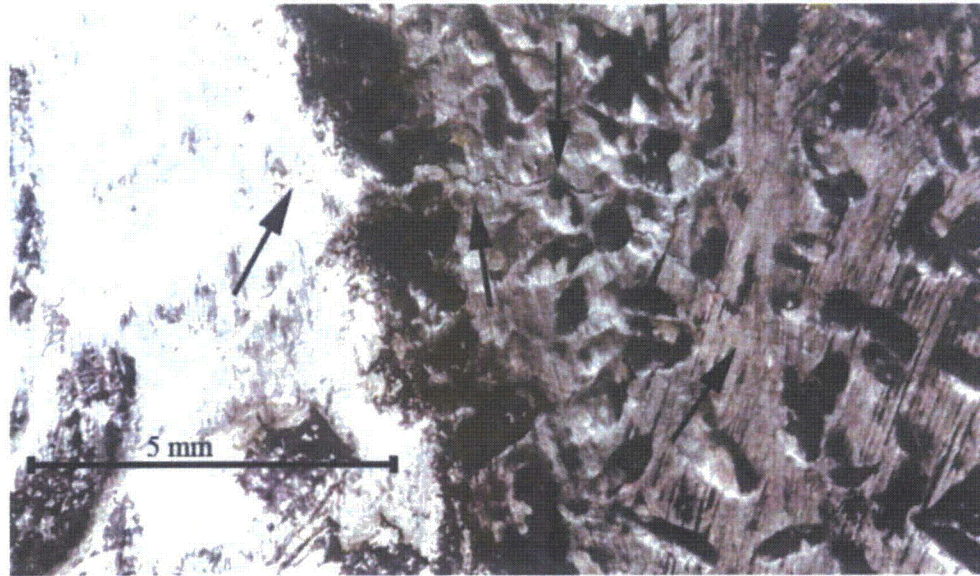
Figure 5.46 Crack-Like Indication Imaged Via Visual Testing at the Weld/Buttering Interface at 225 Degrees

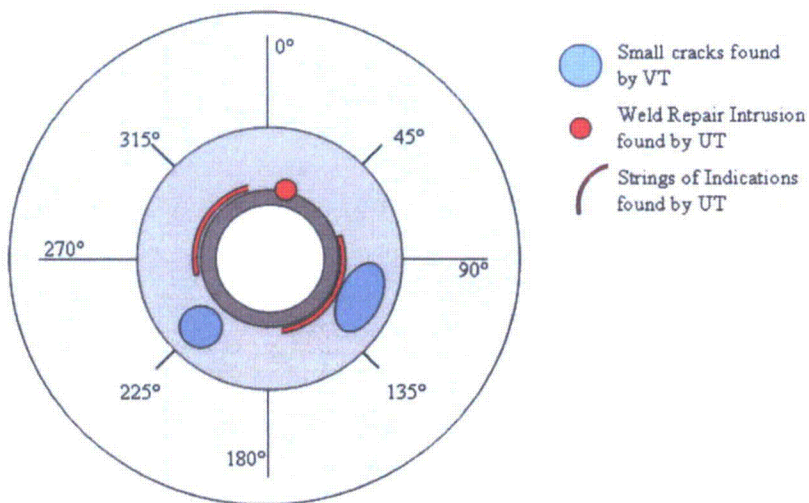
Figure 5.49 Nondestructive Examination Indications Found in Nozzle 59

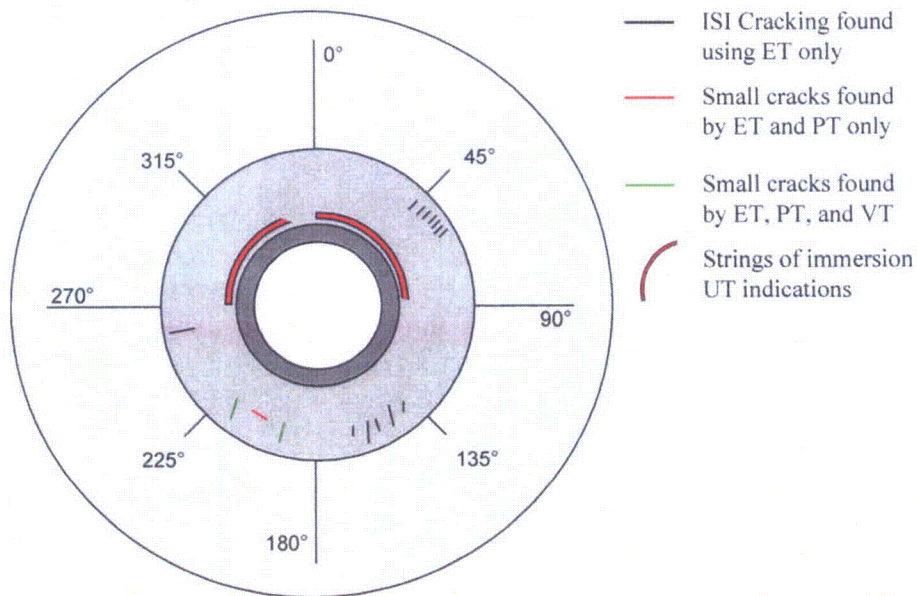
Figure 5.51 Nondestructive Examination Indications Found in Nozzle 31
