UNITED STATES
NUCLEAR REGULATORY COMMISSION
OFFICE OF NUCLEAR REACTOR REGULATION
WASHINGTON, DC 20555-0001

NRC INFORMATION NOTICE 2010-06: INADVERTENT CONTROL ROD WITHDRAWAL
EVENT WHILE SHUTDOWN

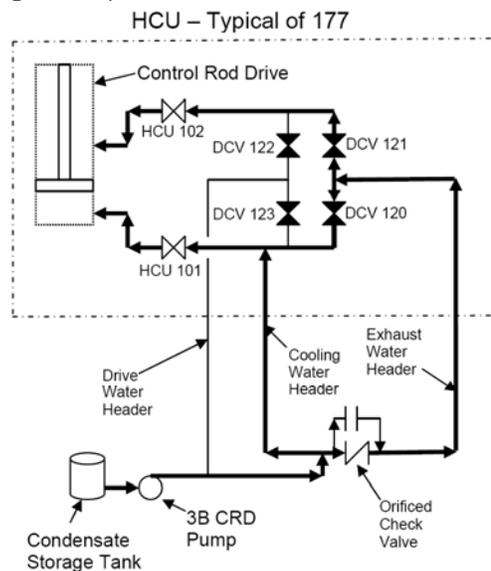
Initial Plant Conditions. All 177 CRD HCU insert valves (HCU 101) and withdraw valves (HCU 102) were open; all 177 CRD HCU directional control valves 120, 121, 122, and 123 were closed; and one CRD pump was operating applying pressure to each of the 177 unisolated HCU under-piston and over-piston areas (see Figure 1). Pressure to the under-piston area was applied through the cooling water header through the open insert valve (HCU 101). Pressure to the over-piston area was applied through the exhaust header (via the orificed check valve) through a designed reverse flow path in directional control valve 121 (which was shut), and then through the open withdraw valve (HCU 102). While the pressures to the under-piston and over-piston areas were roughly equal, a net inward force was applied because the under-piston has a larger surface area (see Figure 3a).

Figure 1 Running 3B CRD pump and flow paths available to the unisolated HCUs

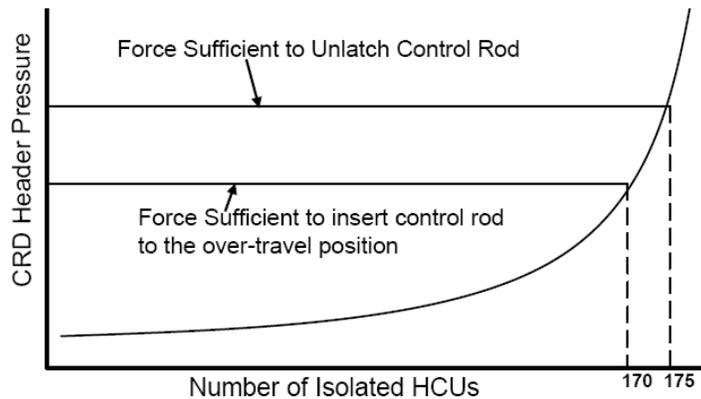
Control Rod Insertion. As shown in Figure 2, the CRD header pressure and proportional net inward rod force was initially small because the flow paths to all 177 unisolated HCUs were available. Using procedural instructions, non-licensed operators began isolating the 177 HCUs one at a time. As each successive HCU was isolated, available CRD header flow paths decreased and since CRD header flow rate remained constant, system back pressure (i.e., CRD header differential pressure) increased resulting in an exponentially increasing the net inward force on the remaining unisolated HCUs. After the 170th (NRC inspector determination) HCU was isolated, the net force to the under-piston area of the seven unisolated HCUs was sufficient to lift the CRD and insert the rod into the over-travel position (Figure 3b). [Note: NRC Inspection Report 05000249/2009009 discusses that the NRC inspector disagreed with the licensee's determination that only 5 control rods (rather than 7 control rods) inserted to an over-travel position.]

Figure 2 The number of isolated HCUs versus CRD header pressure and the net force applied to the under-piston area of unisolated HCUs

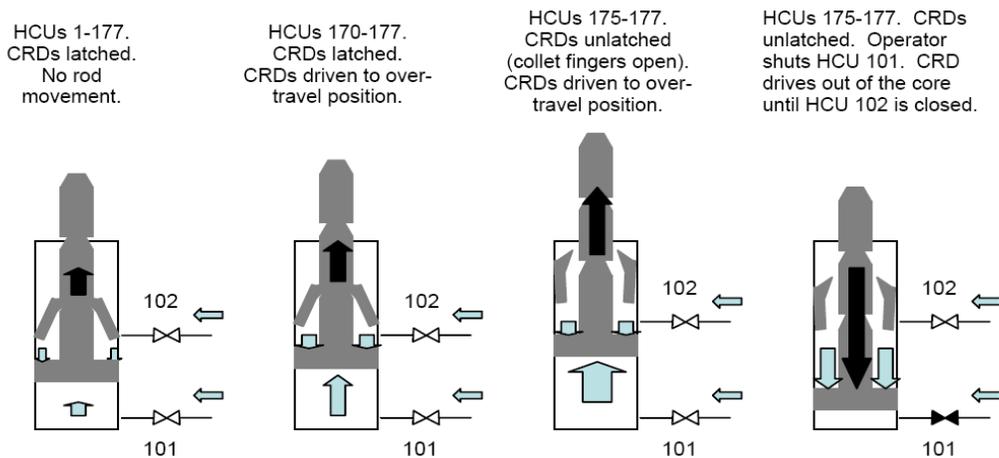
Figure 3 Status of CRDs

Control Rod Unlatching. When the 174th HCU was isolated, CRD header differential pressure increased such that the control rods associated with the last three HCUs unlatched because of the force applied to the collet piston in the over-piston area was sufficient to compress the collet spring (Figure 3c).

Control Rod Withdrawal. The withdrawal of the three unlatched control rods occurred due to the order the valves were closed to isolate the HCU. By procedure, each of the 177 HCUs was isolated by first closing its insert valve (HCU 101) and then closing its withdraw valve (HCU 102). Closing the insert valve isolated the HCU under-piston area causing this area to depressurize through designed leakage flow paths. After the 175th HCU's insert valve was shut, the associated control rod was free to move out of the core because the rod was unlatched and a net force was applied to the over-piston area (Figure 3d). Outward control rod motion also occurred for the 176th and 177th HCUs for the same reason. Control rod motion continued until the non-licensed operator shut the associated HCU withdraw valve. The three control rods withdrew to the 06, 18, and 16 positions, respectively.

Root Cause Evaluation. The licensee determined that the root cause of this event was latent procedural deficiencies. The procedure did not contain any precautions, prerequisites, selection criteria, or limitations for the quantity of HCUs to be isolated with an operating CRD pump. The licensee had previously reviewed operating experience involving control rod withdrawal events at Japanese boiling-water reactors and had implemented procedural changes to prevent this occurrence at the station. However, the licensee had not revised all of the affected procedures, including the one that was used during this event.

Specific corrective actions taken by the licensee included: identifying and updating all applicable procedures with key recommendations provided in the operating experience; specifying a minimum number of HCUs to be kept in service with a CRD pump operating while shutdown; monitoring CRD drive pressures, rod positions, and alarms during activities that could result in an inadvertent control rod movement; and ensuring that personnel who isolate HCUs are aware that they can affect control rod system drive pressure and cause inadvertent control rod movement.
