4.1.4 Analysis of Corrosion Product from Neutronit Specimen SSE2 from the LTCTF

5. CONCLUSIONS

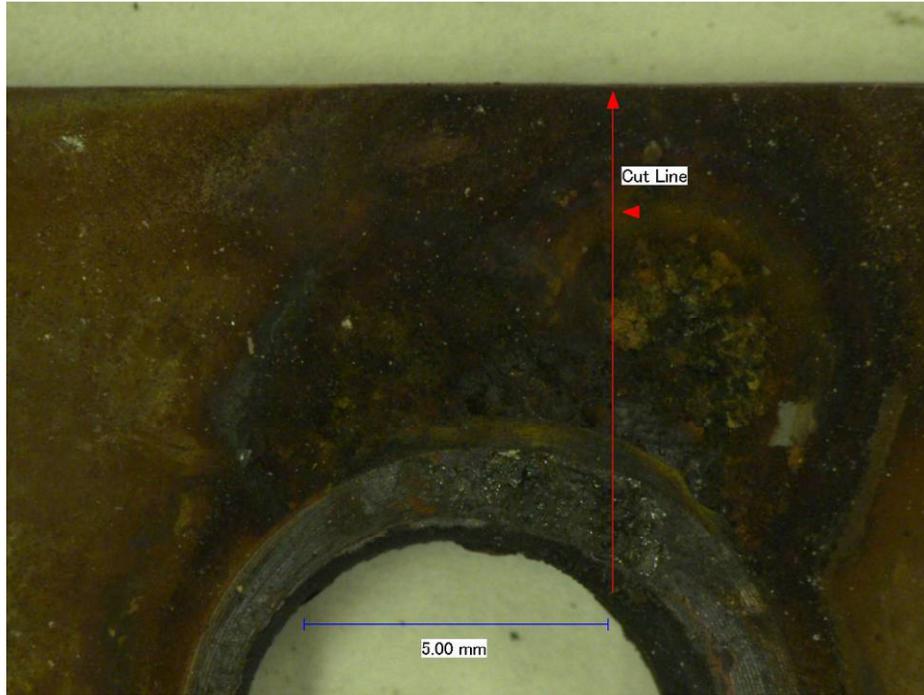
For preparation of the sample for analysis, an area with a large corrosion product cap on the surface was chosen, and the cut was made through this area, which is marked by the red line in Figure 30. This surface corrosion product was located under and adjacent to a Teflon washer as described in the experimental procedure section of the LLNL corrosion paper. Figure 30 shows the area of the test specimen that was prepared for analysis.

Figure 30. Specimen SSE 30 cut line.

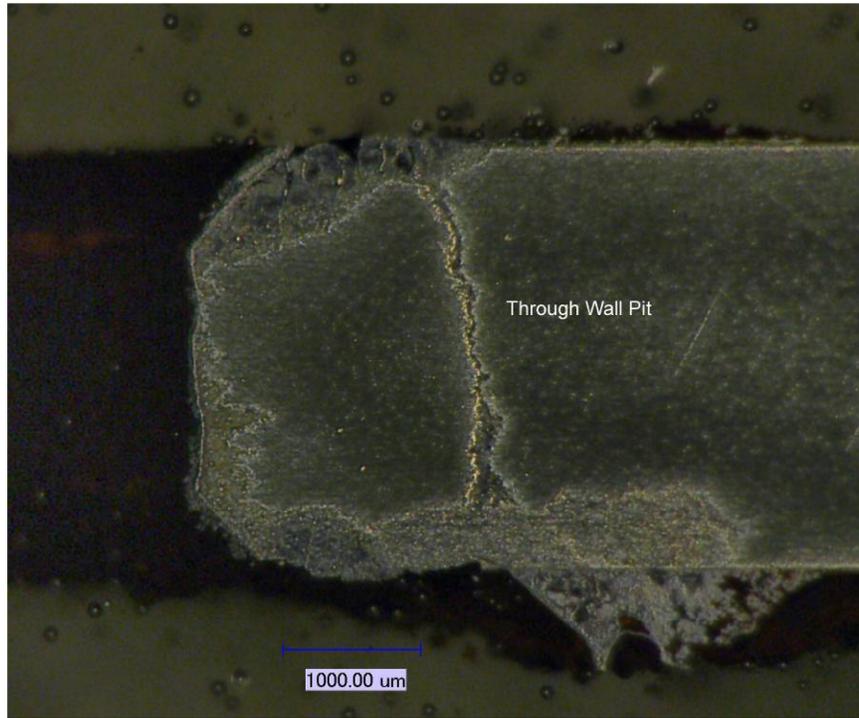
LOM images of the specimen after vacuum mounting are shown in Figures 31 and 32. The sample is totally penetrated under the Teflon attachment washer, with corrosion products evident on the surface and under the original surface.

Figure 31. Specimen SSE 30, mounted specimen, showing through-wall penetration and corrosion product.

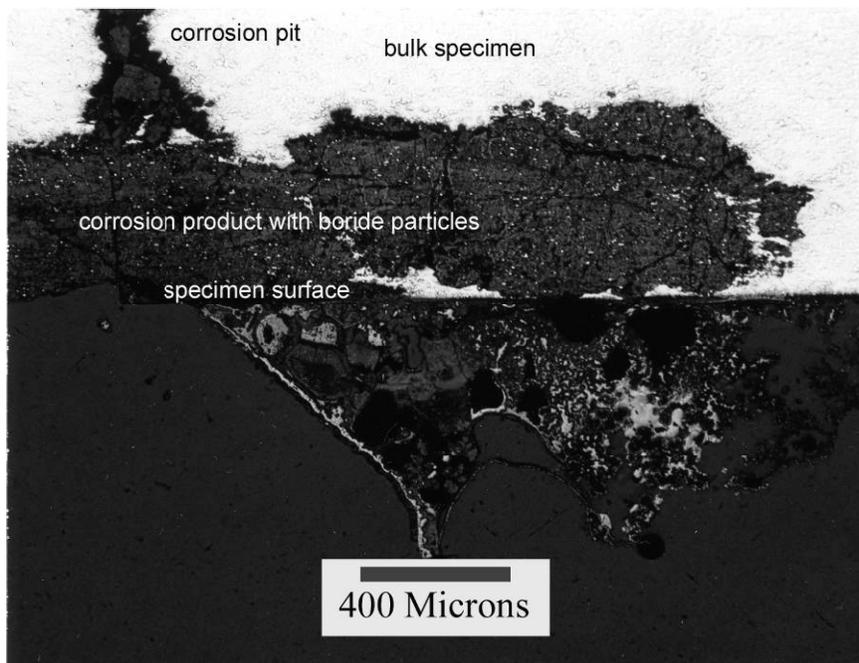
Figure 32. Specimen SSE 30 corrosion products.

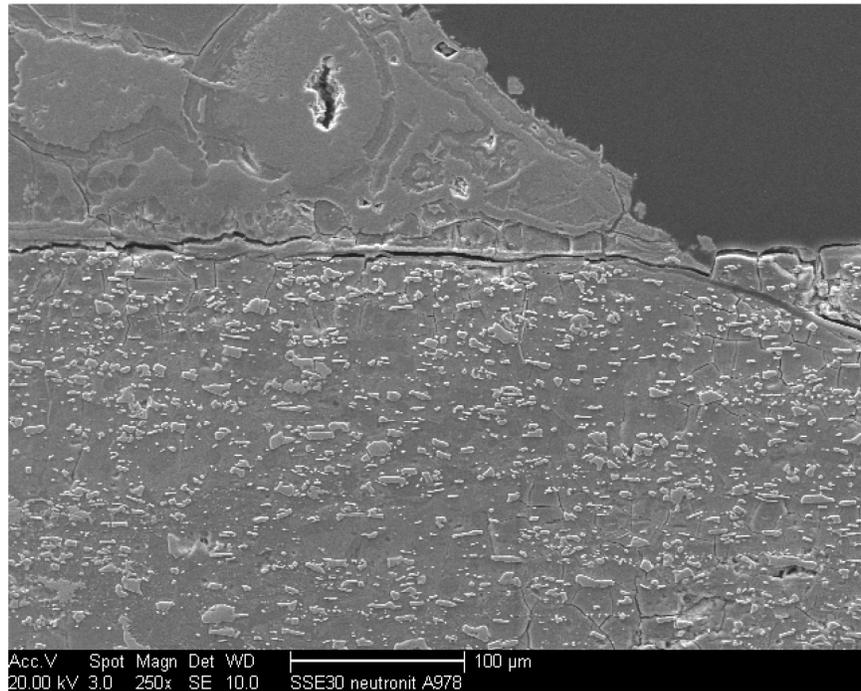
Figure 33 shows a SEM SE image of the sampling areas for the corrosion products that lie above and below the original sample surface.

Figure 33. Specimen SSE 30 SE image.

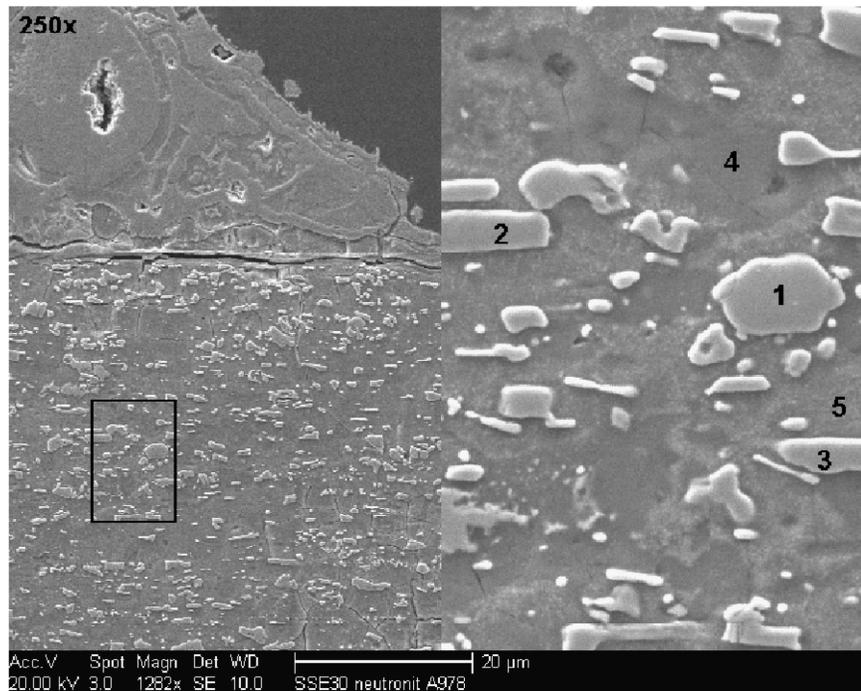
As shown in Figure 34, an area was chosen (box with black border) for sampling in the corrosion product found under the apparent original sample surface. The analytical results are in Table 11. The particles, marked as spots 1 and 2, appear to be borides. Spot 3 has the physical appearance of a boride, but no boron was detected. Spots 4 and 5 are corrosion products where some boron was detected in spot 4 and no boron was detected in spot 5.

Figure 34. Specimen SSE 30 SE image, corrosion product analysis. (The 20 µm bar corresponds to the image on the right.)

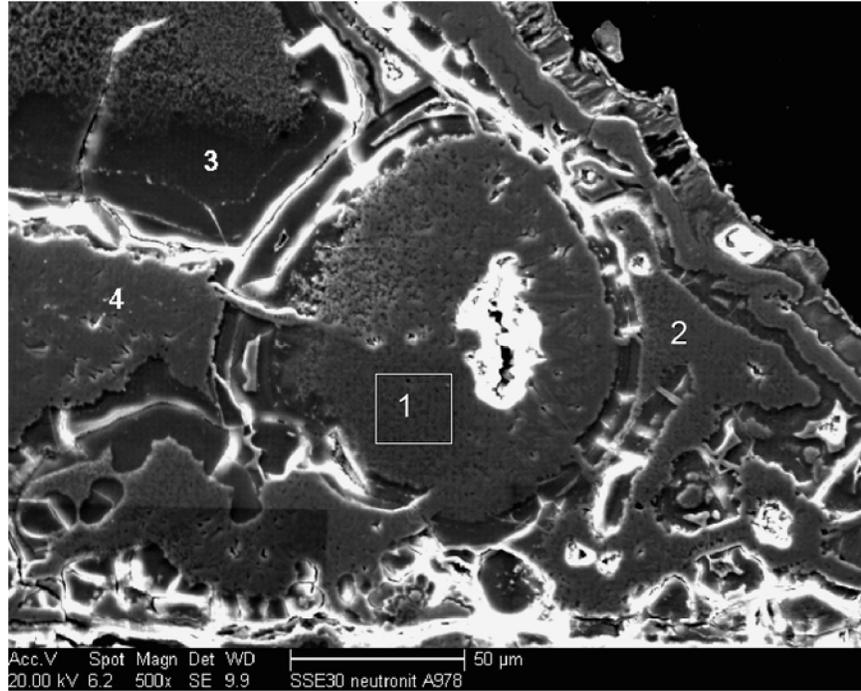
The sample area shown in Figure 35 is the corrosion product deposited above the apparent original-sample surface. The analysis results of the sampled areas are shown in Table 12. The sample areas are iron and chromium-corrosion-product oxides in which boron was detected. Boron was found in the four sampled areas of the corrosion product found on the sample surface.

Figure 35. Specimen SSE 30 SE image, corrosion product analysis.

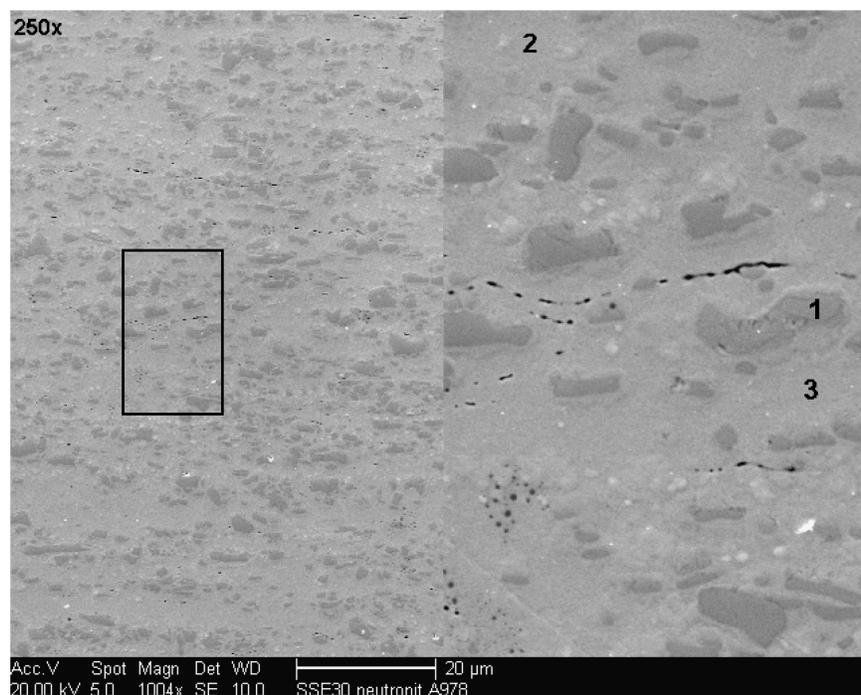
An area of the bulk metal (unetched) below the corroded surface is shown in Figure 36. The analysis results for the sampled areas are shown in Table 13. The secondary-phase particle sampled at spot 1 is a boride, and spots 2 and 3 correspond to the chemistry of the base austenitic structure of this alloy. Spot 3 does identify boron, but this value may be from borides adjacent or underneath the sampled area being measured by the beam.

Figure 36. Specimen SSE 30 SE image, bulk metal boride analysis. (The 20 μm bar corresponds to the image on the right.)

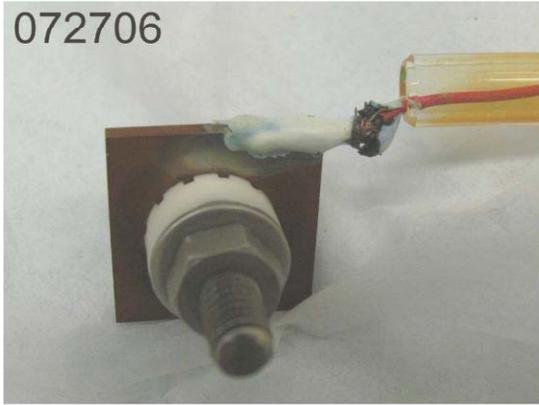
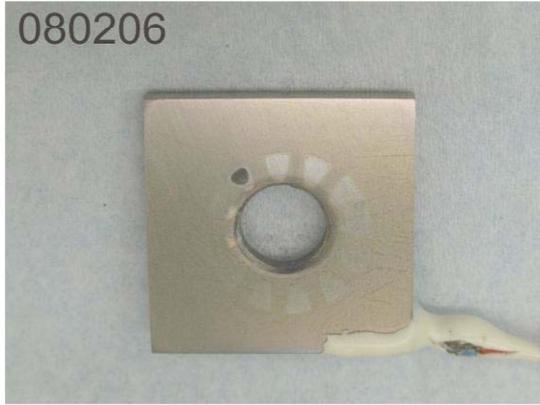
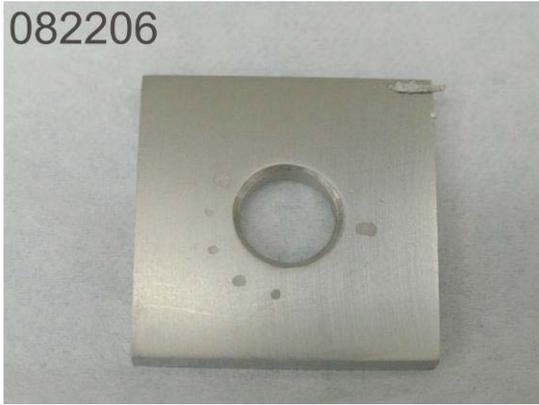
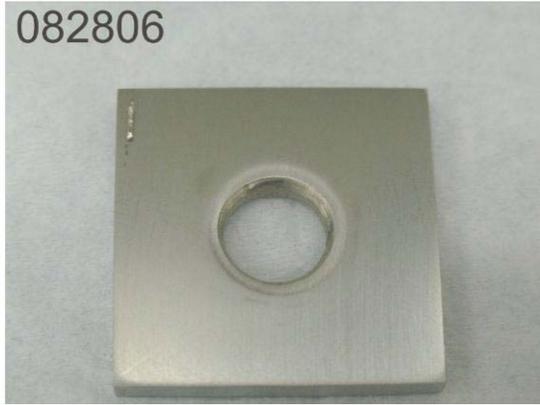
Figure A3 shows the PS data obtained from the four A978 specimens. The two specimens using an epoxy coating have much higher current. After examination of the specimens after the test (see Figure A4), it was noticeable that the contact to the specimens was corroded. The specimens using only a bare, platinum-wire contact showed low negative currents with a short positive current excursion due to localized corrosion. This negative current is evidently due to the exposed platinum wire and is likely an electrochemical reaction with dissolved species. Thus, in all cases a corrosion rate cannot be ascertained because the current is dominated by other reactions at the contact wires. Because the net current was negative, this suggests that the anodic corrosion current for the A978 was low.

Figure A4 shows macro photographs of the specimen surfaces after testing. While the electrochemical data was not very useful, the damage to the surface observed during the test is likely to be what would occur on a test using the properly configured crevice specimen. The exception might be Test 072706. The contact was so corroded that the specimen was not in electrical contact for much of the test. A thick brown film coated the surface of the Test 072706 specimen, and the solution was clouded with precipitate. The film appeared to be from the corrosion of the solder and wire of the contacting lead. Significant crevice corrosion was observed only on Tests 080206 and 082206. LOM of damage to these specimens under the crevice formers is shown in Figure A5. There was no significant damage to Test 072706 and 082806 specimens.

Figure A4. Macro photographs of A978 specimens after testing. Note that part of the platinum wire from the Tests 082206 and 082806 remains in the corner of these specimens.

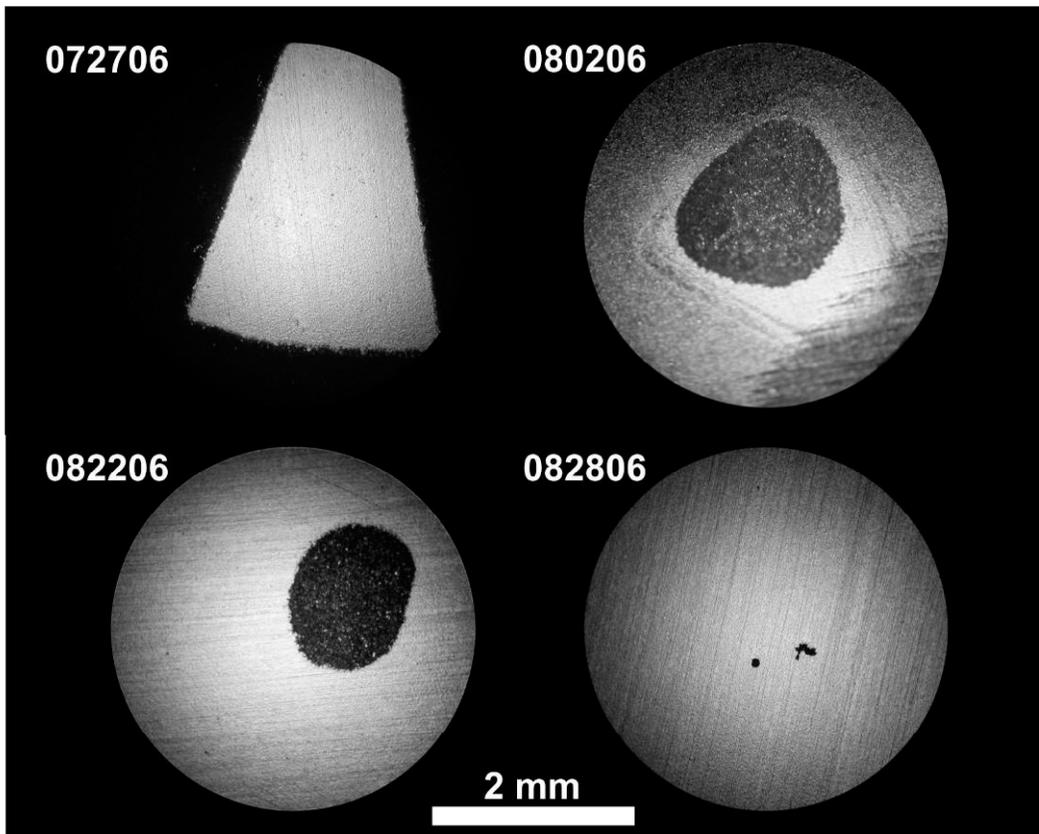
Figure A5. LOM images of A978 specimens after testing.
