Re: Turkey Point Unit 3
Docket No. 50-250
Reportable Event: 2008-003-01
Date of Event: June 1, 2008
Inoperable Steam Generator Blowdown Containment Isolation Valve in Excess of
Technical Specification Required Isolation Time-Supplement

1. FACILITY NAME Turkey Point Unit 3					2. DOCKET NUMBER 05000250		3. PAGE 1 of 9					
4. TITLE Inoperable Steam Generator Blowdown Containment Isolation Valve in Excess of Technical Specification Required Isolation Time-Supplement

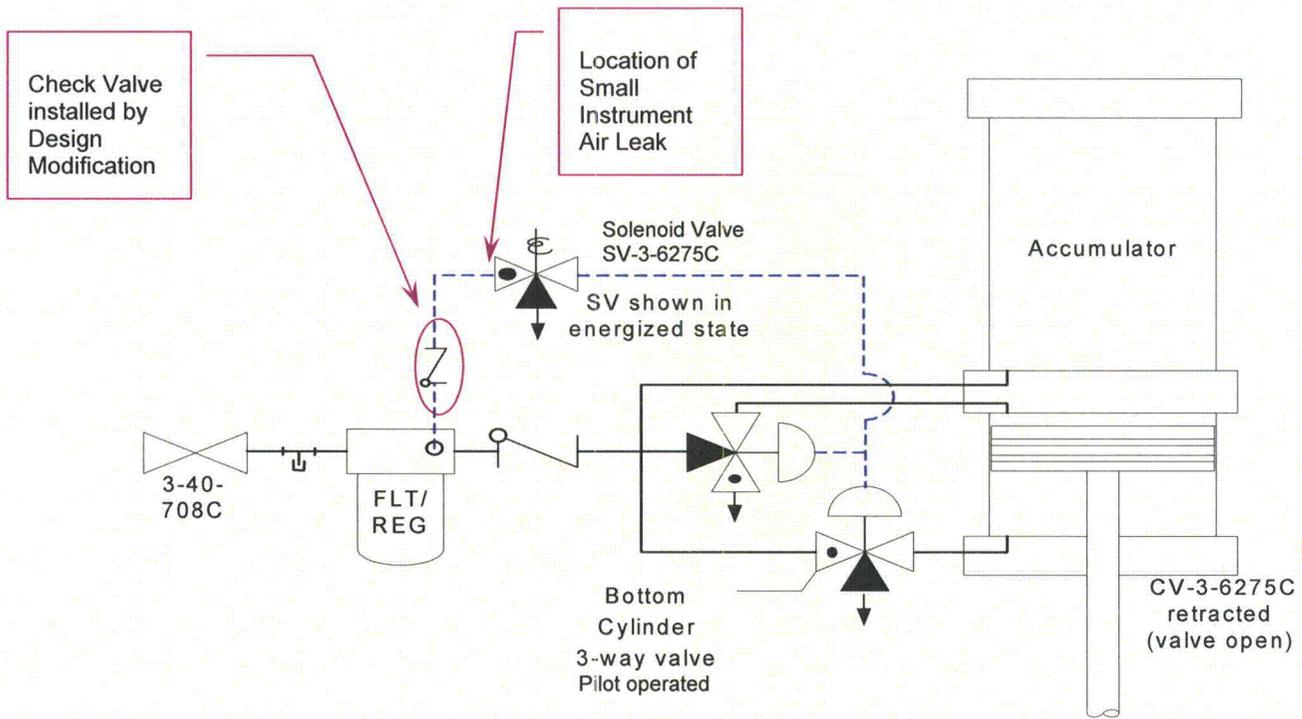
Figure 1

Troubleshooting discovered that CV-3-6275C failed to close due to a small instrument air leak on the inlet swage fitting (Figure 1) upstream of the solenoid valve SV-3-6275C. The slow instrument leak at the fitting allowed the 3-way pilot valves to move to an intermediate position that bled some of the accumulator volume. It was determined that the small air leak was due to the time related work hardening of the tubing from vibration, which had loosened the fitting connection.

In response to the concerns of NRC IN 82-25, Turkey Point modified the valve accumulator design and added a check valve upstream of the solenoid valve in the instrument air supply tubing to the solenoid valve (Figure 1). The effect of this modification was to change the failure position to "fail-as-is" on a loss of instrument air. This added check valve allows the accumulator to remain pressurized by preventing the pilot operated 3-way valves from moving to an intermediate position and avoid bleeding the accumulator to atmosphere on a slow loss of instrument air.

- Discovered and repaired the small instrument air leak that caused the test failure.
- Provided communications to Operations regarding the significance of the safety related function of the accumulator and the impact it had in rendering a containment isolation valve inoperable.
- Incorporated the SG blowdown accumulator check valve surveillance in the In-Service Testing program and provided TS references and appropriate guidance to identify required action upon test failure.
- A valve design modification is being processed to improve the isolation capability on loss of instrument air.
- Procedures have been revised to require a minimum of two AFW pumps to be operable during the SG blowdown isolation valve surveillance testing.
