Document No: 51 - 9111710 - 000

Calvert Cliffs Unit 2, Spring 2009 – 180 Day Steam Generator Report

CALVERT CLIFFS NUCLEAR POWER PLANT UNIT 2
180-DAY REPORT ON THE SPRING 2009
STEAM GENERATOR TUBE INSPECTION

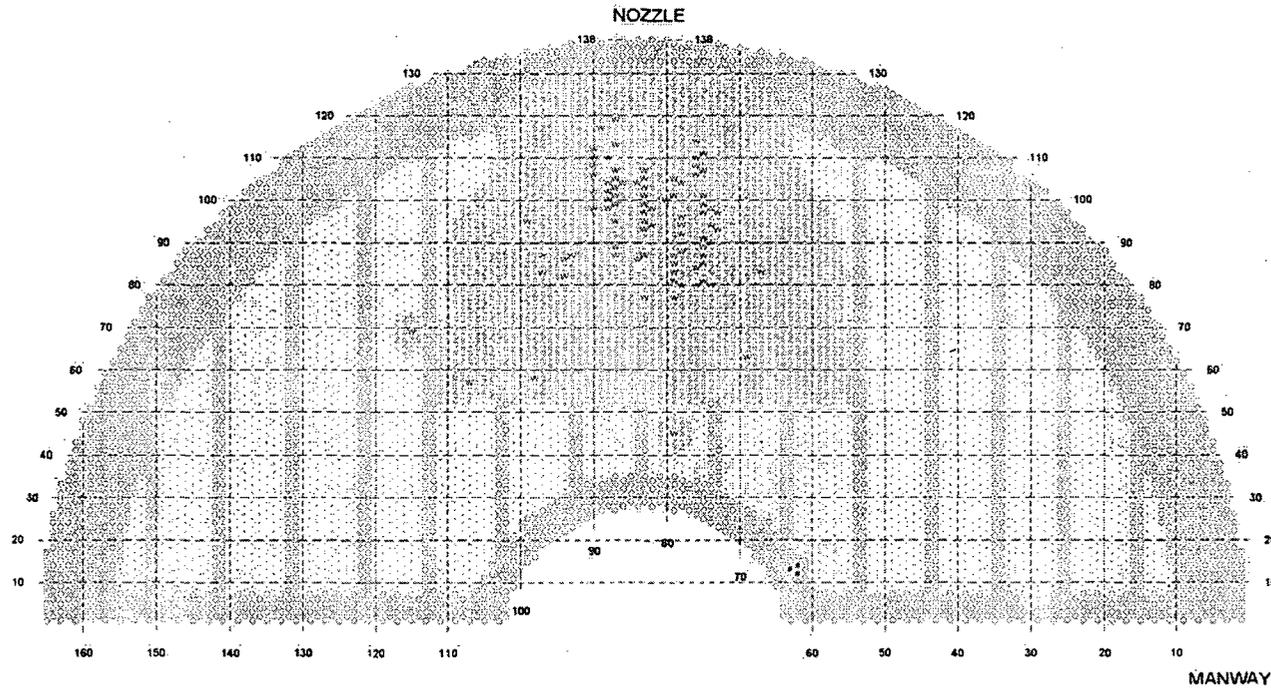
Figure 1 SG 21 Susceptible Fan Bar Wear Zone and Bobbin Inspection Scope

- Full length eddy current bobbin probe examination of 5262 tubes (~62%) including:
 - o All tubes within the pre-defined fan bar wear susceptible region (1948 tubes; see Figure 1)
 - o All bundle periphery and no-tube lane locations approximately 5 to 10 tubes deep including:
 - Initial scope of 1138 tubes, and
 - Expanded scope of an additional 1026 tubes
 - o Bounding of previously plugged tubes (5 tubes)
 - o Random sample of 1145 tubes (~21.3%) of the remaining uninspected population

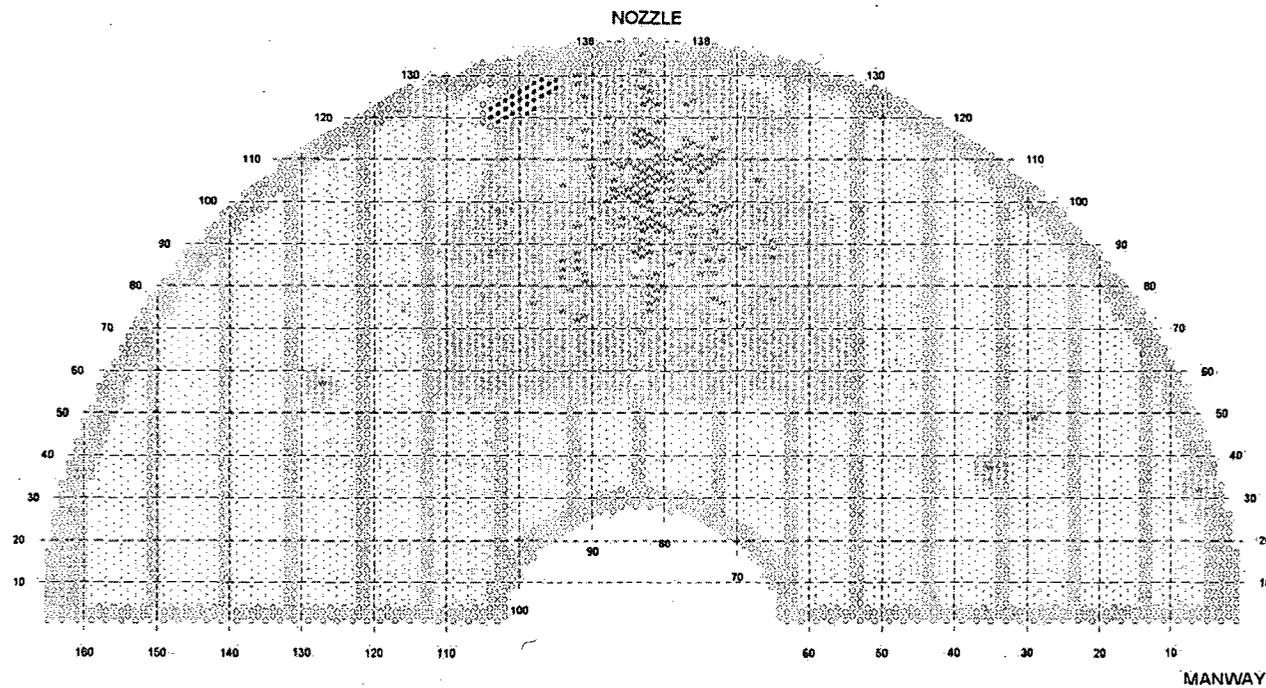
Figure 2 SG 22 Susceptible Fan Bar Wear Zone and Bobbin Inspection Scope

- Full length eddy current bobbin probe examination of 4236 tubes (50%) including:
 - o All tubes within the pre-defined fan bar wear susceptible region (1987 tubes; see Figure 2)
 - o All bundle periphery and no-tube lane locations 2 to 4 tubes deep (1115 tubes)
 - o Bounding of previously plugged tubes (12 tubes)
 - o Random sample of 1122 tubes (20.9%) of the remaining uninspected population

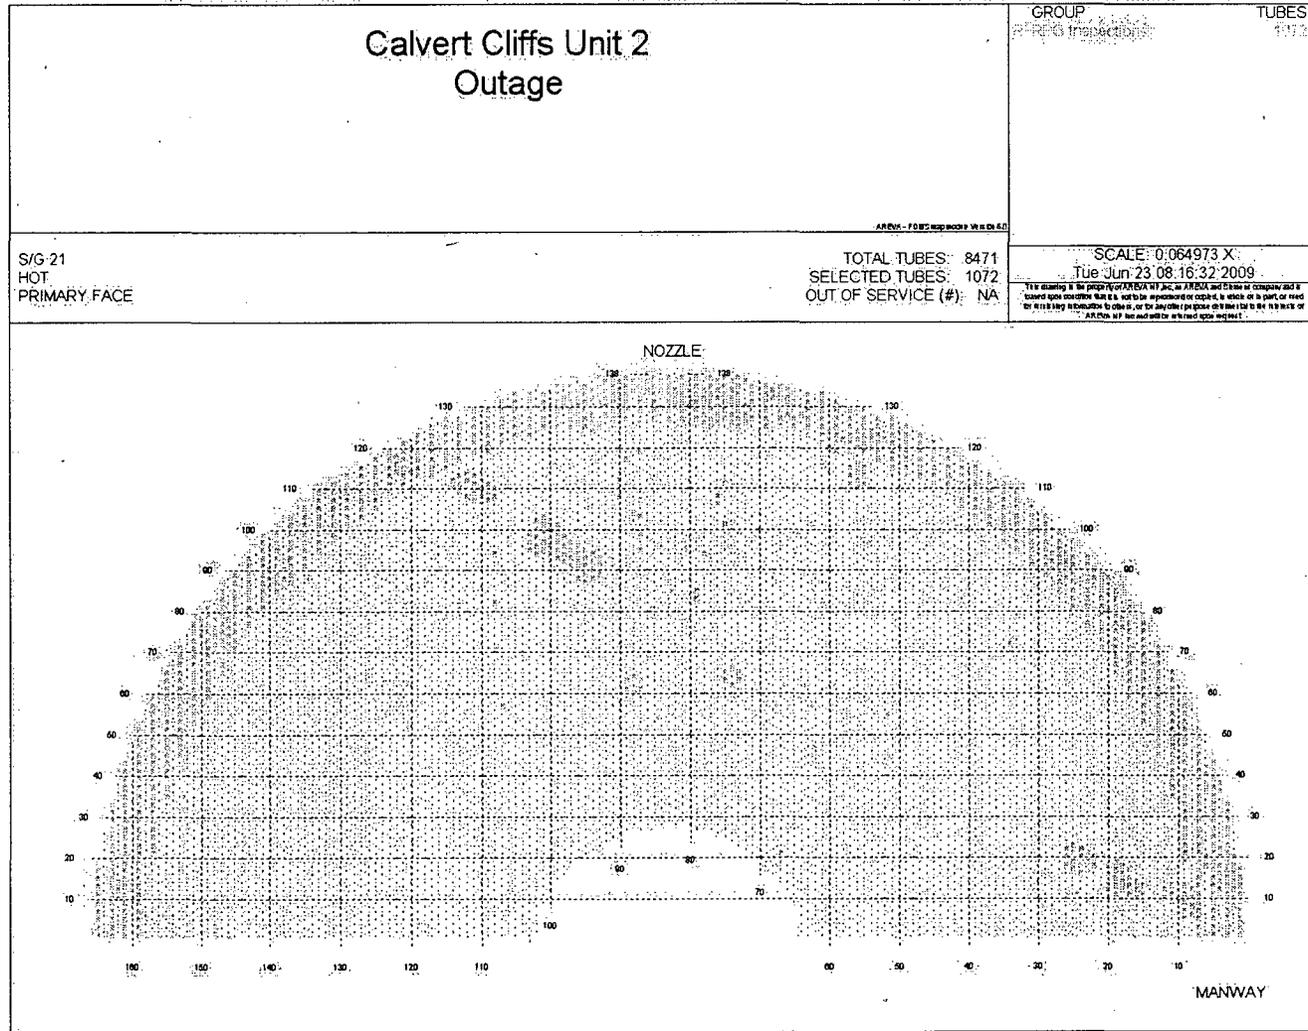
Figure 3 SG 21 Rotating Probe Inspection Scope

- Rotating eddy current probe examinations of 1825 locations including (see Figure 3):
 - o All fan bar wear indications sized 15%TW or greater (19 locations in 18 tubes)
 - o All bobbin I-Codes (22 locations in 22 tubes)
 - Bobbin I-Codes reported included NQI's (Non-Quantifiable Indications) and DTI's (Distorted Tubesheet Indications). These are bobbin signals indicative of possible degradation that are not attributable to fan bar wear.
 - o One bobbin PLP (Potential Loose Part) location
 - o 288 locations to bound locations of foreign objects and/or foreign object wear, including foreign objects discovered during the visual secondary side exam
 - o 732 peripheral tubes at the top of the hot leg tubesheet
 - o 763 peripheral tubes at the top of the cold leg tubesheet.

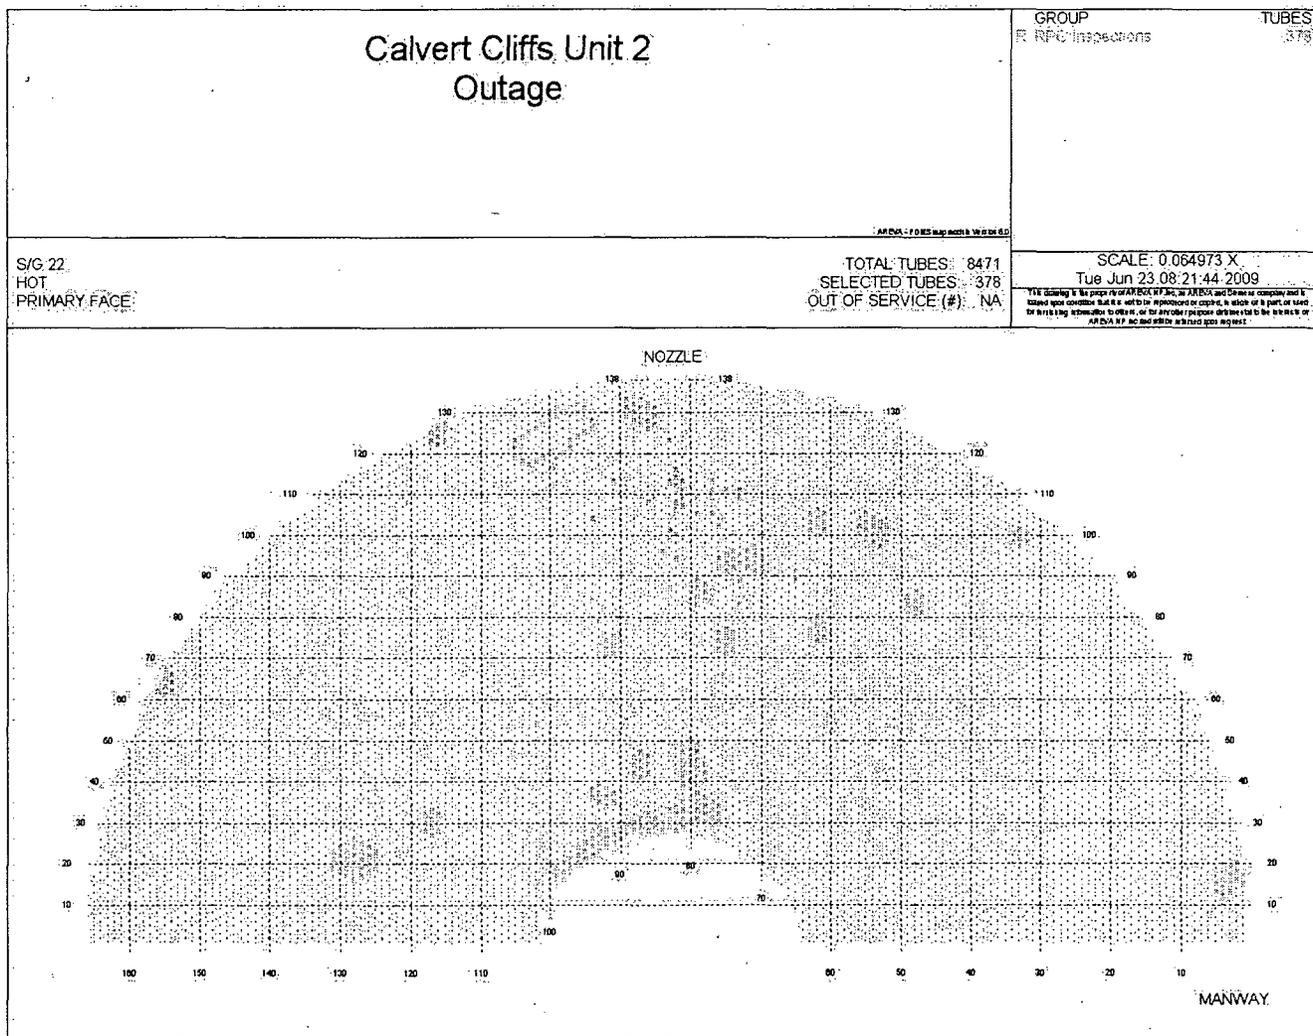
Figure 4 SG 22 Rotating Probe Inspection Scope

- Rotating eddy current probe examinations of 385 locations including (see Figure 4):
 - o All fan bar wear indications sized 15%TW or greater (36 locations in 33 tubes)
 - o All bobbin I-Codes (3 locations in 3 tubes)
 - Bobbin I-Codes reported included NQI's (Non-Quantifiable Indications) and DTI's (Distorted Tubesheet Indications). These are bobbin signals indicative of possible degradation that are not attributable to fan bar wear.
 - o One bobbin PLP (Potential Loose Part) location
 - o 37 tubes at the top of the cold leg tubesheet to bound tubes that were previously plugged due to a foreign object
 - o 308 locations to bound locations of foreign objects and/or foreign object wear, including foreign objects discovered during the visual secondary side exam

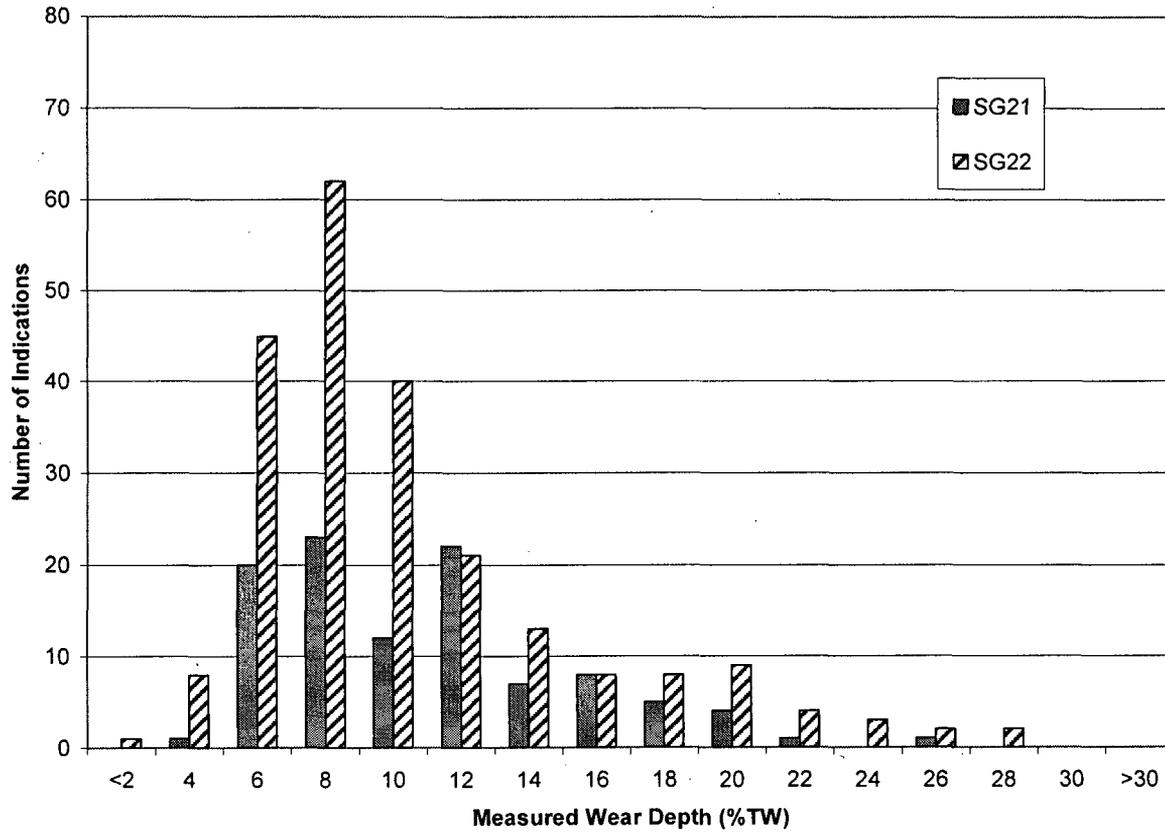
Figure 5 Fan Bar Throughwall Depth Distribution

Fan bar wear (FBW) is a mechanical degradation process which produces volumetric tube wear at the interface between the unbend anti-vibration supports (fan bars) and the tubes. In total, 330 fan bar wear (FBW) indications in 258 tubes were identified in the CCNPP Unit 2 steam generators during the 2R18 inspection. 131 of the indications were newly reported during 2R18. This represents an increase of about 66% since the first inservice inspection in 2005 (2R16). None of the reported indications exceeded the Technical Specification plugging limit of 40%TW, and none were plugged. The maximum depth reported was a 28%TW indication in SG22. The largest newly-reported indication was a 19%TW indication in SG21. Figure 5 shows the distribution of the fan bar wear depths for both steam generators as reported with the bobbin coil. As shown in the figure, SG22 contained more indications and also contained the majority of the indications greater than 20%TW.

As expected, the growth rates for the fan bar wear indications decreased significantly from the growth rates observed during the first cycle of operation. The median growth rate of FBW reported during both the 2009 and 2005 inspections was 0.31 %TW/EFPY in both SGs compared to median growth rates during the first cycle of 7.48 %TW/EFPY in SG21 and 6.71 %TW/EFPY in SG22. The upper 95th percentile growth rates were also determined using Benard's equation as discussed in the EPRI SG Integrity Guidelines. The upper 95th percentile growth rate for indications reported during both the 2009 and 2005 inspections was 2.34 %TW/EFPY in SG21 and 2.08 %TW/EFPY in SG22. The upper 95th percentile growth rates during the first cycle of operation were 12.39 %TW/EFPY in SG21 and 13.42 %TW/EFPY in SG22.

Fan bar wear is caused by the relative motion between the tubes and adjacent fan bars due to flow related forces. As wear depths increase, the contact area between the tubes and fan bars increases, which slows the rate of throughwall growth. As a result, the growth rate of previously detected indications is expected to decrease with more time in service. The Unit 2, 2R18 inspection found fewer new indications and a lower growth rate than what was found after the first in-service inspection. This is consistent with the current understanding of fan bar wear.

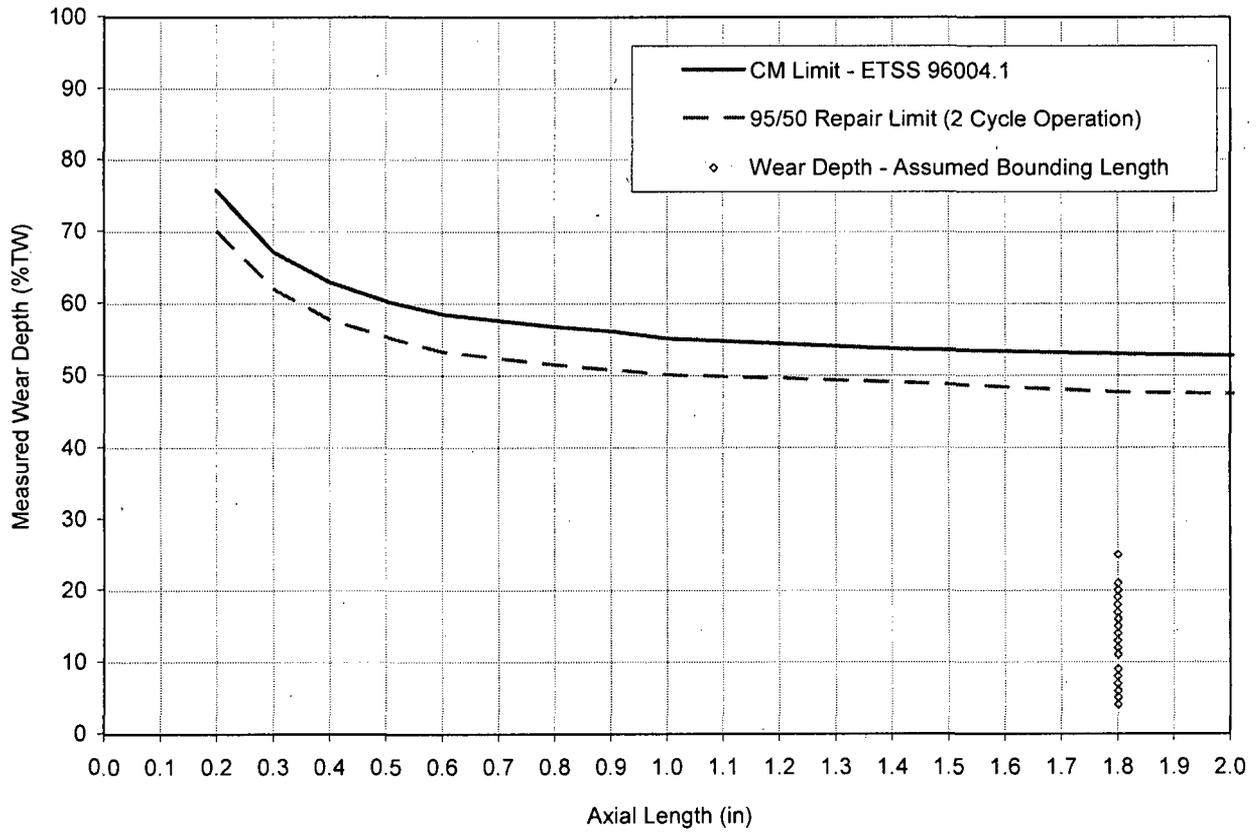
Figure 6 SG21 Fan Bar Wear Condition Monitoring

The condition monitoring assessment is summarized in Figures 4 through 8. The figures provide the condition monitoring limit curves corresponding to the NDE technique employed for each degradation type. All reported degradation falls below the applicable condition monitoring curve and therefore satisfies the Technical Specification structural performance criteria. For volumetric indications, meeting the structural performance criteria also provides reasonable assurance that the accident leakage performance criteria would be satisfied at the lower steam line break pressure differential. Since this conclusion could be reached analytically using NDE inspection results with a full accounting of significant uncertainties, no in-situ pressure testing was required to demonstrate structural and leakage integrity. During the past operating cycle, no measurable primary-to-secondary leakage was observed, thereby satisfying the operational leakage performance criteria.

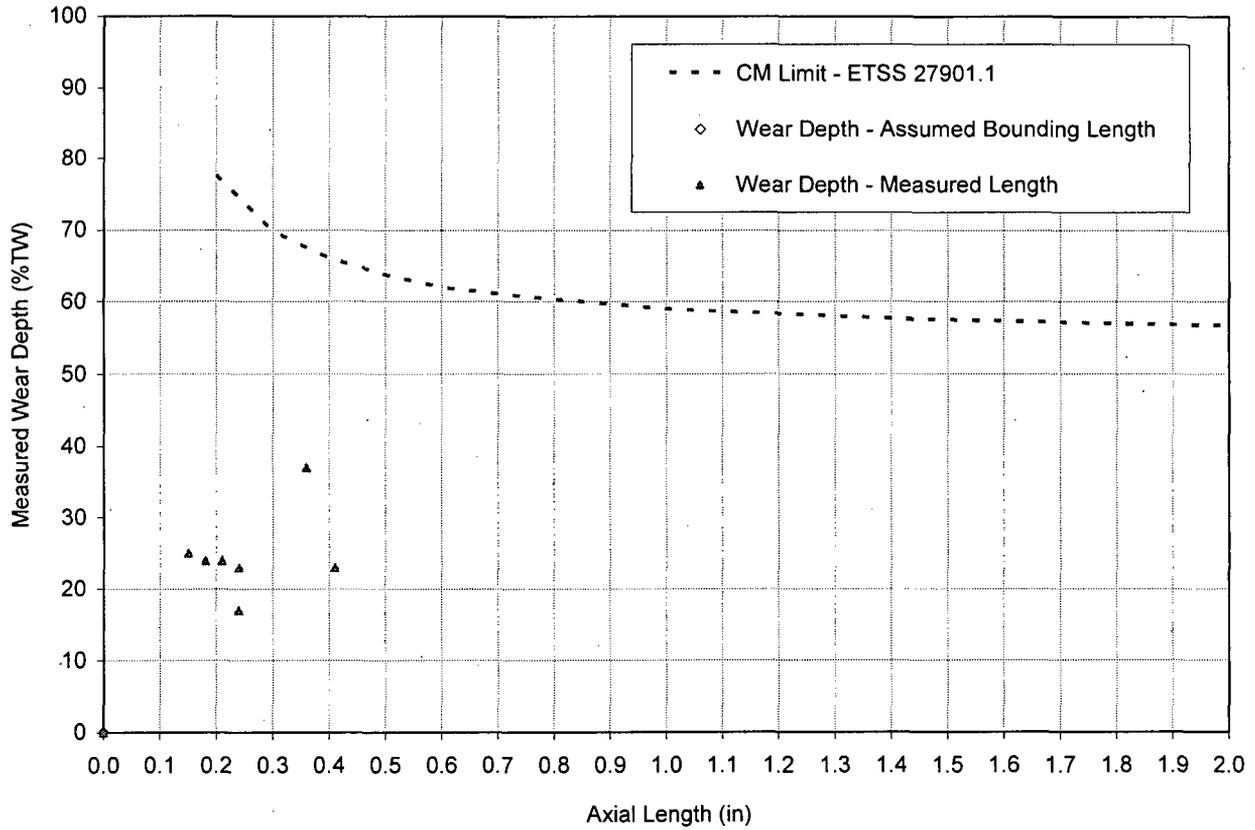
Figure 10 SG 22 Foreign Object Condition Monitoring with Part not Present

In SG22, there were seven indications of loose part wear detected. Six of these seven indications were related to previously detected loose part wear. The one exception was an indication in SG22 R112 C82 located at an elevation of 05H -4.02". This indication had a measured depth of 23%TW. In all seven cases, the foreign object was not detected by eddy current. This is consistent with the results from the 2005 inspection in SG22.
