H. B. ROBINSON STEAM ELECTRIC PLANT, UNIT NO. 2 DOCKET NO. 50-261/LICENSE NO. DPR-23

LICENSEE EVENT REPORT NO. 2009-002-00 FAILURE TO COMPLETE TECHNICAL SPECIFICATIONS REQUIRED ACTION WITHIN THE ALLOWED COMPLETION TIME

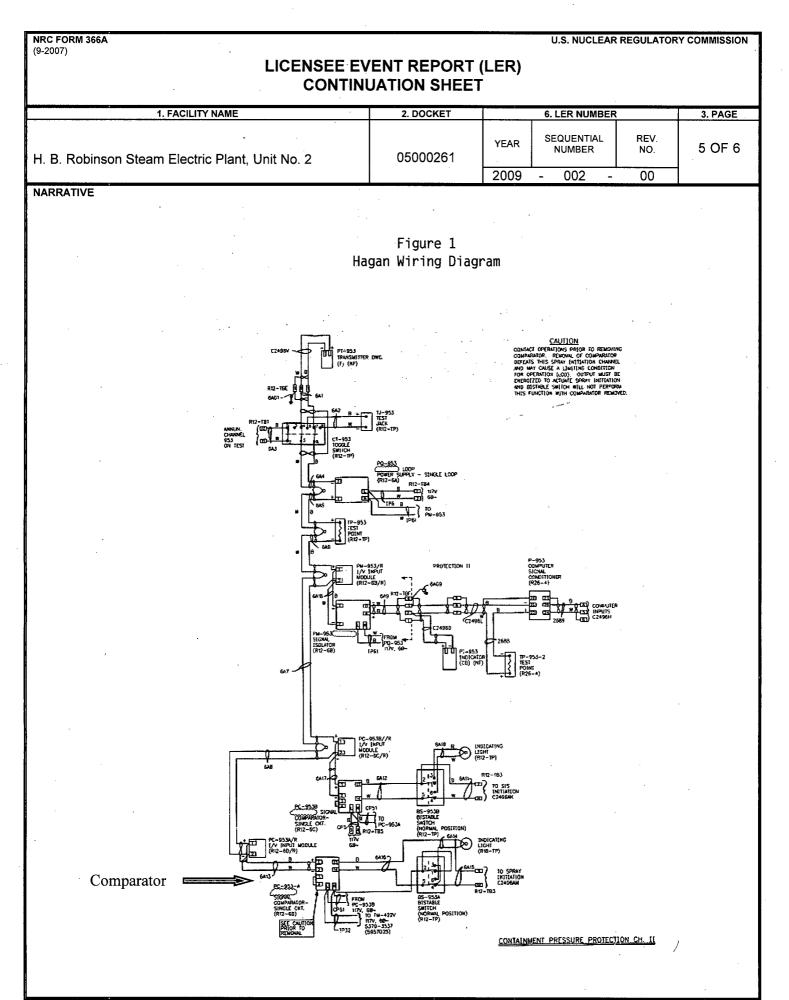
The bistables [JE,10] for containment pressure protective function circuitry have a unique design (See Figure 1 and Figure 2). The Containment High-High Pressure function is "energize-to-actuate," such that interruption of the power supply for maintaining the channel in trip results in a failure to keep the channel in the desired trip condition. The replacement of the PC-953A comparator resulted in the loss of the power supply and hence the channel was removed from the trip condition at 1611 hours EDT for approximately two minutes. With the comparator removed, the channel was unable to perform its safety function. This condition resulted in the failure to meet the required actions associated with TS LCO 3.3.2 Required Actions D.1 and E.1, "Place channel in trip," and Required Actions D.2.1 and E.2.1, "Be in Mode 3." TS LCO 3.3.2 Required Actions D.2.1 and E.2.1 have Completion Times of 6 hours. TS LCO 3.3.2 Required Actions D.2.1 and E.2.1 have Completion Times of 12 hours. The Completion Times were not met and therefore resulted in a condition that was prohibited by the plant's TS and unknowingly placed the plant in TS LCO 3.0.3 because the removal of the channel from the trip condition occurred greater than 12 hours from the time the action statement was entered.

Additionally, the investigation determined that the trip function of Containment Pressure Channel PC-953A was lost for approximately two minutes, during the time the comparator was removed from the circuit. This is due to the Containment High-High Pressure Function being an energize-to-actuate function and the comparator provides the power supply to maintain the channel in trip.
