MICROSTRUCTURAL CHARACTERIZATION OF PRIMARY WATER STRESS-CORROSION CRACKS IN ALLOY 182 WELDS FROM PWR COMPONENTS AND LABORATORY TESTS

L.E. Thomas, M.J. Olszta, B.R. Johnson and S.M. Bruemmer

Pacific Northwest National Laboratory, PO Box 999, Richland, WA, 99354, larry.thomas@pnl.gov

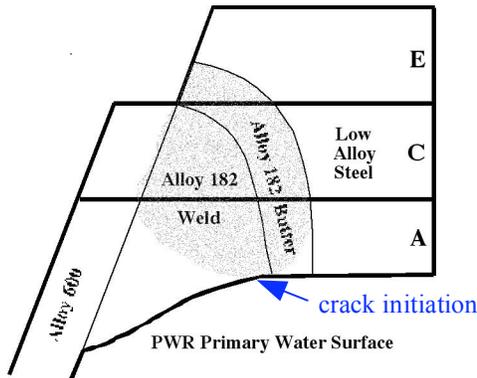
The North Anna 2 sample came from a control rod drive mechanism (CRDM), Nozzle 31, with cracks in the alloy 182 J-weld joining an alloy 600 penetration pipe to the low-alloy pressure vessel steel. Figure 1 schematically illustrates the nozzle structure and crack location. Metallographic examinations of sections cut from the nozzle showed that multiple cracks had initiated from the primary-water surface of the weld and propagated axially to intersect both the alloy 600 and the pressure vessel steel. The cracks also reached the air gap between the pressure vessel steel and the alloy 600 pipe.

Figure 1. Axial crack location (shaded) in weld from North Anna-2 Nozzle 31. Letters refer to metallographic sections.

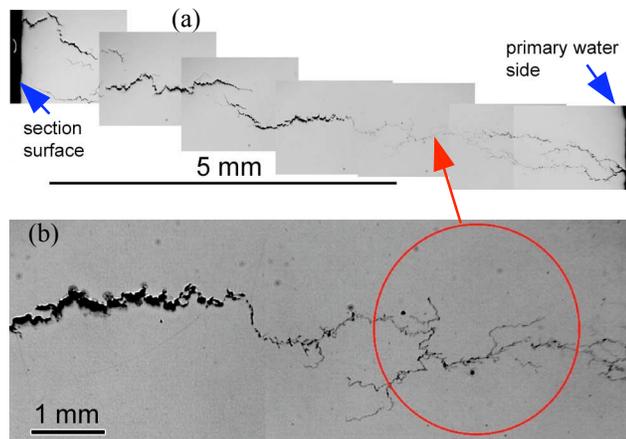
Metallographic examinations of polished sections from the North-Anna-2 J-groove weld showed that multiple cracks had initiated at the primary-water surface in the weld butter region, and had propagated through the weld metal to intersect both the alloy 600 and the pressure vessel steel. Figure 4 gives a low-magnification view of the cracks and a detail view of one region that was

targeted for TEM sample preparation. The periodically segmented appearance of the crack in this section may reflect the weld structure or stresses, although this is not known for certain. Relatively wide crack openings suggested that the cracks had opened under high stresses. Despite the appearance of discontinuous cracks on cross sections, the presence of corrosion products throughout the cracks indicated an interconnected crack network that had been fully penetrated by high-temperature water.

The metallographic examinations also showed that the cracks coincided with grain boundaries in the weld metal. These boundaries had a characteristically wavy, serpentine appearance reflecting formation by dendrite impingement during solidification. Apart from minor occurrences of grain-boundary migration, the boundaries where cracking occurred were both crystallographic grain boundaries and interdendritic boundaries.

Figure 4. Optical micrographs of North Anna CRDM cross section showing main crack running through entire section thickness. Scale marker length 5 mm. Circle in lower figure represents size of 3-mm-diameter TEM disk.

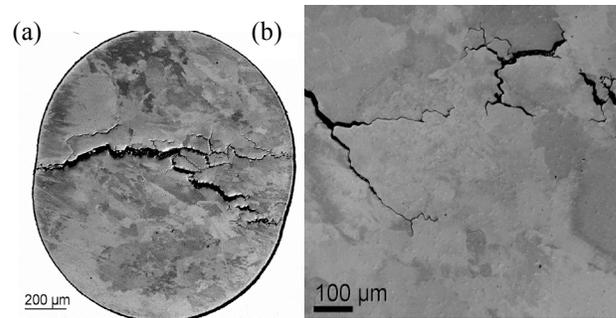
Since the crack traversed the entire width of the section and thus did not contain a unique primary tip, TEM samples were prepared from the middle of the section. Extensive crack branching yielded many secondary tips that were suitable for ATEM. SEM/BSE images of a TEM sample, shown in Figure 5, further illustrate the appearance of the cracks and their relation to grain boundaries. The mottled crystallographic contrast of the grain images is characteristic of strained material. Zooming in on the higher magnification micrograph in Figure 5 reveals scattered 0.2- to 1- μ m-diameter second-phase particles throughout the grains and along the grain boundaries the white-appearing particles are predominantly Nb carbides and the dark particles were mainly TiC. As shown later, the grain boundaries were heavily decorated by fine NbTi carbide and Cr-carbide particles. These smaller particles were generally too small to observe at the relatively low magnifications of the SEM.

Figure 5. SEM/BSE images of TEM samples prepared from crack area North Anna 2 CRDM weld. Taken from dimple-polished side with support washer after brief ion milling.

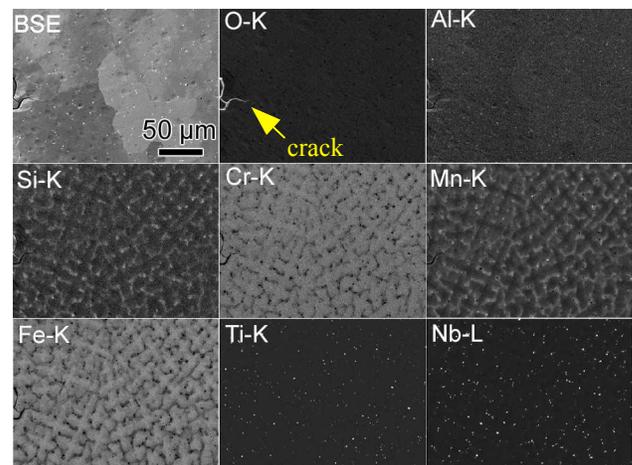
EDS maps taken in the SEM reveal the weld compositional microstructures in relation to the grain boundaries and cracks. Low-magnification maps and the corresponding BSE image shown in Figure 6 provide an overview of the weld dendritic structures. A secondary crack tip appears at the left side of the image area, and the O-K map indicates that the crack was filled with oxide. The major feature of this map set, however, is the dendritic structure revealed as patterns of constitutional segregation. The Fe-K map, in particular, clearly shows the dendritic structures of the individual grains. These compositional structures each have a regular alloy framework of Fe- and Cr-rich regions with interstitial Mn and Si-rich regions of the last-solidified material. Qualitative compositional analyses from the SEM/EDS data indicated that the high-Mn regions were enriched by ~3-5 wt%, and the high-Si regions were enriched by ~2 wt%, compared to the Fe-Cr-rich regions. The elemental maps reveal Nb, Ti, Mn, Al-rich particles.

Figure 6. SEM/EDS elemental maps showing weld segregation and precipitation in North Anna 2 sample.

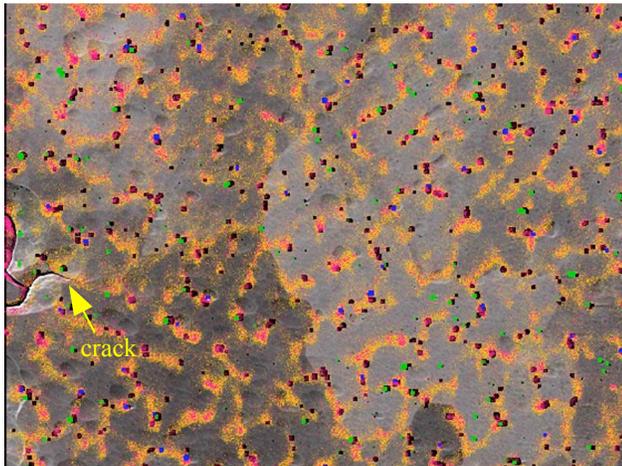
Figure 7 shows a color composite image made by combining several maps to further demonstrate important relationships between the $\mu\text{-m}$ -size second-phase particles, the dendrite structures, and the grain boundaries. This image is a composite of maps for Nb (black), Ti (green), high Mn (blue) and low Mn (yellow), and is superimposed on the BSE image. Blue spots in the high Mn map indicate MnS particles. (EDS point analyses were used to identify the S in the MnS particles because spectral overlap between S-K and Nb-L x-rays prevented directly mapping the S). The Nb (carbide) and MnS particles can be seen to coincide with the Mn-Si alloy regions of the dendrites. The Ti-rich particles (probably TiC or Ti(C, N)) show a weaker correlation with the dendrite segregation, usually appearing in the Mn-Si-rich regions, but sometimes also in the Fe-Cr-rich areas.

Comparing the Mn-Si-rich regions with the BSE image shows a moderate correlation of these areas with the grain boundaries. About 50% of regions along the grain boundaries coincided with high Mn and Si locations, but many others coincided with the high Fe and Cr locations. Other areas containing cracks showed a similarly weak correlation between grain boundaries and the constitutional segregation and $\mu\text{-m}$ -scale precipitation from the dendrites. The $\mu\text{-m}$ -size carbides and MnS particles produced during weld solidification appeared at approximately the same frequency along the grain boundaries as they did in the grain interiors. Further comparisons made by overlaying various elemental maps indicated no O in the intragranular particles and no correlation of the Al-rich particles with the other particles.

Figure 7. Color composite of SEM/EDS maps illustrating correlations between weld dendritic microstructure, second-phase particles and grain boundaries. color key: yellow -Mn; pink -Si, black -NbC particles; green -TiC particles; blue -MnS particles

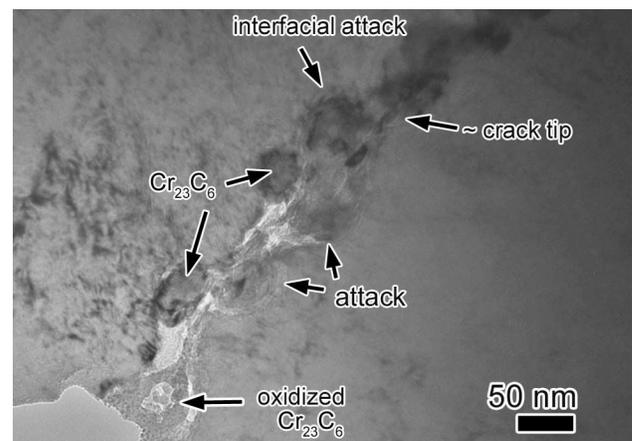
TEM examinations of the North Anna weld samples focused mainly on the crack tips and leading grain boundaries. As illustrated by Figures 8 and 9, the

cracking occurred along grain boundaries that were decorated by closely spaced 30- to 50 nm-diameter Cr-carbide particles and 5- to 10-nm-diameter NbTi carbides.

Electron diffraction analyses identified the Cr carbides as cubic Cr_{23}C_6 and the NbTi carbides as cubic MC. The STEM/EDS maps in Figure 9 distinguish the particles by their compositions, and illustrate how the particles become interfacially attacked, convert to oxide, and begin to dissolve in the crack. For descriptive purposes, the leading edge of the oxidation along the attacked grain boundaries and particle interfaces is referred to as the crack tip.

Interfacial attack around the Cr carbide particles near the crack tip can be seen by comparing the particle images in the O-K and Cr-K maps. Due to partial spectral superposition of Cr-L and O-K x-rays, the oxidized and unoxidized regions of the particles both appear highlighted on the O-K map. The oxidized shells around the attacked particles appear brighter than the unoxidized cores. In the Cr-K map, the oxidized shells appear fainter than the cores.

Figure 8. Crack tip region in North Anna 2 TEM sample. Shows degraded carbide particles behind crack tip and interfacial attack along the particle interfaces at the tip.

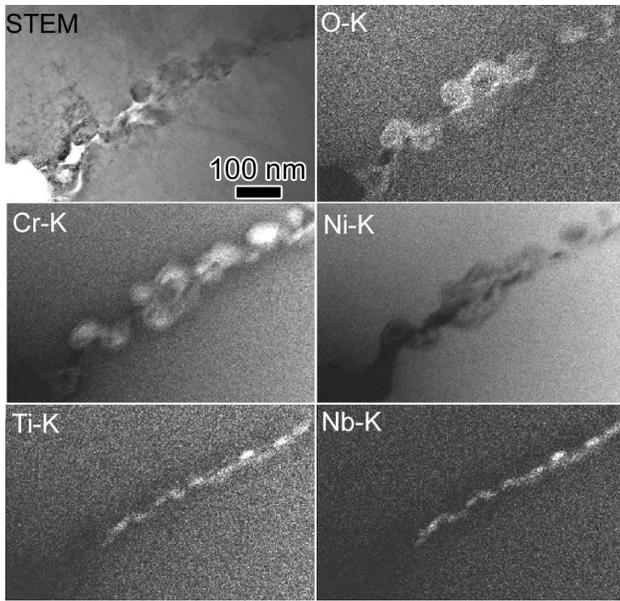
Another effect shown by the EDS maps is the apparent dissolution of the carbide particles in the crack, starting at short distances behind the crack tip. This is indicated by a decrease in particle intensities on the Cr, Nb and Ti maps.

Figure 9. STEM EDS maps of crack tip area in previous figure. Shows interfacial attack (oxidation along particle interfaces at the tip) and apparent dissolution of degraded carbides in crack.

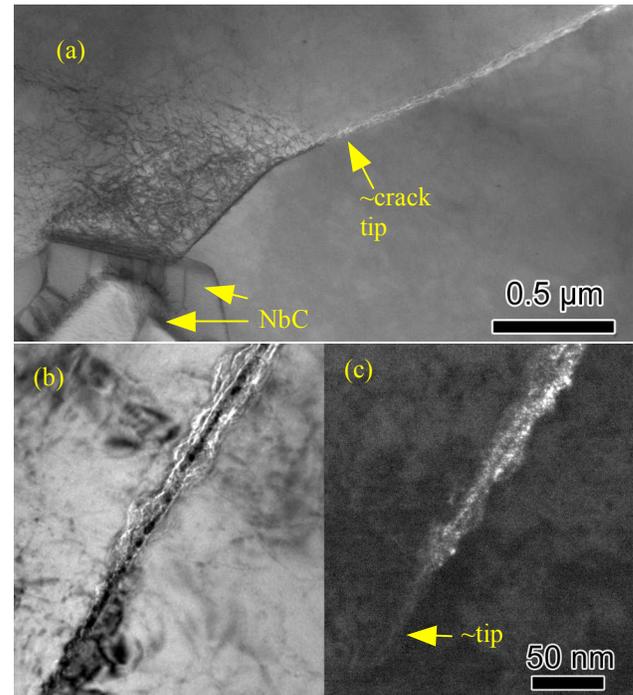
In another tip example, shown in Figure 10, the crack ended along a locally straight section of grain boundary near a cluster of μm -size NbC particles. The tangled dislocation structure of the weld metal can be seen in a strongly diffracting region just ahead of the crack tip. Higher magnification brightfield and oxide darkfield images of the tip region in Figure 10(b) and (c) highlight the interfacial attack around fine IG carbide particles, and polycrystalline MO-type oxide in the crack. The exact location of the tip is hard to pinpoint, but is best judged from the oxide darkfield image. The oxide narrowed to less than 10 nm wide at the tip.

Figure 10. Second crack tip in North Anna weld sample. (a) STEM overview with grain boundary on edge. (b) TEM brightfield and (c) MO oxide darkfield images.

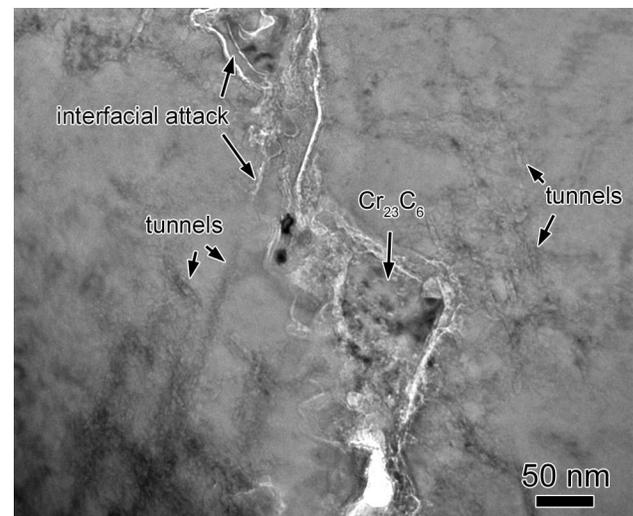
Crack regions near the tips were filled with corrosion products oxide and remnants of the attacked IG carbides. Figure 11 shows an example of the attacked and degraded structures ~ 0.5 to 1 μm behind the crack tip. Degraded microstructures in this area included the oxide corrosion products and remnants of the attacked IG carbide particles in the crack, and filamentary corrosion tunnels in the adjacent metal. ATEM analyses indicated a complex set of corrosion products in these structures. Although further analyses would be needed to identify all the oxide phases in this area, diffraction analyses identified polycrystalline cubic MO-structure oxide as the main corrosion product in the cracks. The oxidized shells around altered Cr-carbide particles were tentatively identified as Cr_2O_3 .

The oxide-filled corrosion tunnels observed in the metal near the crack tips appeared similar to those reported earlier from alloy 182 welds in the Ringhals and Davis-Besse PWR samples. These tunnels were 5 to 8

nm in diameter and extended to ~ 100 -150 nm below the surfaces of the cracks. The oxide in them had a spinel structure with the same orientation as the metal matrix. Darkfield images taken with spinel reflections showed the oxide in the tunnels as discrete 5-8-nm diameter crystallites. The tunnels evidently formed along dislocations in the metal.

Figure 11. Degraded microstructures near crack tip in North Anna weld. Shows interfacially attacked carbides in crack, and oxide-filled 'tunnels' formed along dislocations in the adjacent metal.

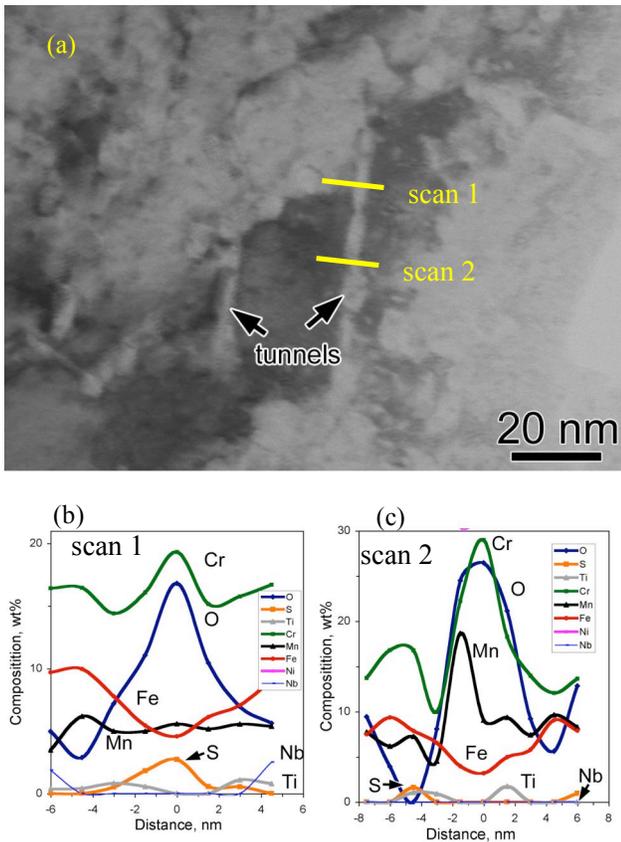
Figure 12 shows the results of fine-probe EDS line scans taken across the corrosion tunnels. The composition profiles indicated Cr and Mn enrichment of the spinel crystallites in the tunnels. Scans taken along tunnels (results not shown) indicated that the tunnel structures consisted of the Cr-Mn-rich spinel crystallites separated by Ni-rich metal. As also indicated by the results, the tunnels also contained spots of concentrated S (up to ~ 2 wt.% through the local foil thickness). High S concentrations were also observed previously in similar corrosion tunnels from the Davis-Besse alloy 182 weld sample. Scans taken across unattacked dislocations ahead of the tunnels showed no detectable segregation of any alloying elements such as Nb or Ti, nor any S segregation at the dislocation cores.

Figure 12. EDS composition profiles across corrosion 'tunnels' near crack tip in North Anna 2 alloy 182 weld sample.

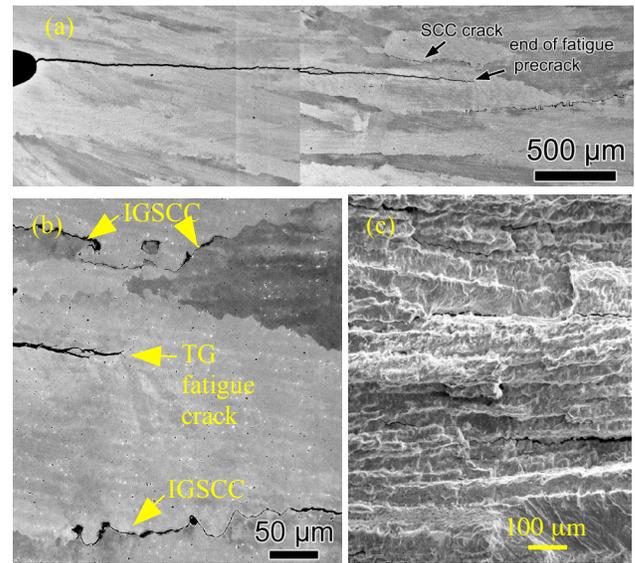
This alloy 182 crack-growth test in simulated PWR primary water produced disconnected-appearing SCC cracks along approximately parallel grain boundaries. As shown by an overview image of the cross-sectioned test sample in Figure 13(a), the cracks occurred parallel to the elongated grain structure of the weld. A higher

magnification view of the tip region in Figure 13(b) shows that initial IGSCC during final crack transitioning and at constant K was highly non-uniform. The cracks had the serpentine appearance of grain boundaries produced by dendrite impingement during weld solidification. Despite the discontinuous-connected appearance of the cracks in cross section, the presence of oxide corrosion products throughout them indicated that the cracks had been completely penetrated by high-temperature water. The post-test SCC fracture surface shown in Figure 13(c) also suggests that the grain boundary where cracking occurred also corresponded to a dendrite boundary.

Figure 13. Cracks in Alloy 182 weld from test in simulated PWR primary water. (a) Low-magnification SEM/BSE overview of metallographic section. (b) TG to IG crack transition region. (c) IG fracture surface illustrating interdendritic fracture morphology.

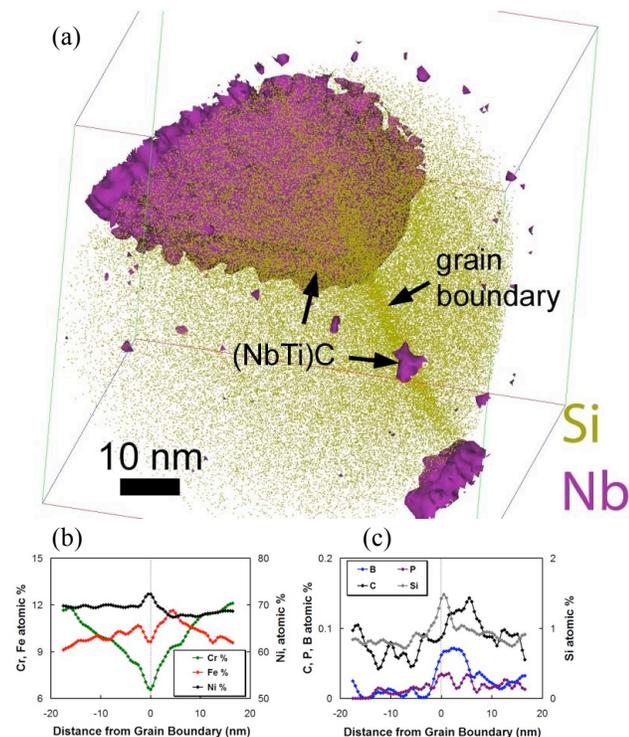
Additional grain boundary characterization has been performed by APT analysis to further probe for evidence of segregation, including light elements such as B and C. This was a pioneering effort that has only yielded preliminary results. As shown by results given in Figure 14, the APT method revealed minor segregation of Si, B, P and C on the grain boundaries. The data reconstruction given at the top of the figure illustrates the Si segregation along a grain boundary between carbide particles. As further shown by reconstructed line profiles at the lower part of this figure, the Si reached ~1.5 at% at the boundary, vs. ~0.8% in the matrix. Boron, C and P were also enriched at the grain boundary, although their maximum concentrations were less than 0.15 at%. No other significant impurity segregation was found. Of the major elements, the results indicated strong local Cr depletion at the boundary, at least in this limited analysis.

Figure 14. APT analysis of grain boundary in Alloy 182 weld. (a) Data reconstruction for Si and Nb, showing grain boundary on edge and Si segregated along boundary. (b,c) Reconstructed line profiles for major and minor elements.

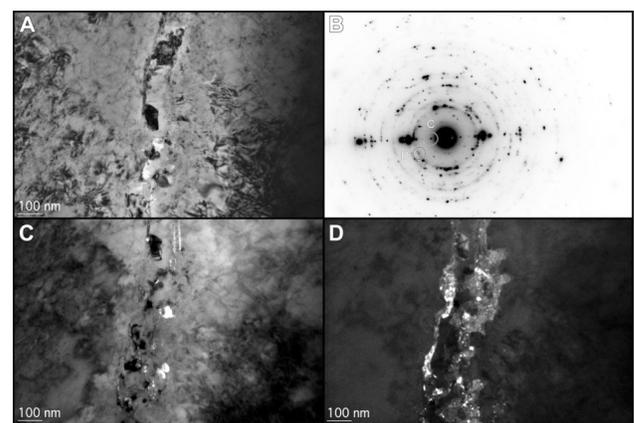
TEM observations of the PWR test sample described here again focus primarily on the crack tip regions. Where the cracked narrowed near their tips, they appeared filled with polycrystalline corrosion product oxides. Diffraction analyses of these regions indicated that both spinel and NiO-type oxides were present, as well as remnants of the original and altered (Nb,Ti)C and Cr_{23}C_6 carbides from the original bulk grain boundaries. Figure

15 shows an example of these structures with selective darkfield imaging used to identify the phases. STEM/EDS maps of the same crack area, in Figure 16, show the extent of the oxide and indicate the partial dissolution of Cr carbide and MC particles in the crack. Remnants of the intergranular MC carbides appear as small Nb and Ti-rich spots at the crack walls.

Figure 15. Analysis of oxide-filled crack region near tip in alloy 182 PWR crack growth specimen. (a) TEM brightfield (a), (b) selected area diffraction pattern, (c) darkfield image taken with a reflection from Cr_{23}C_6 , and (d) darkfield image highlighting polycrystalline MO-structure oxide.

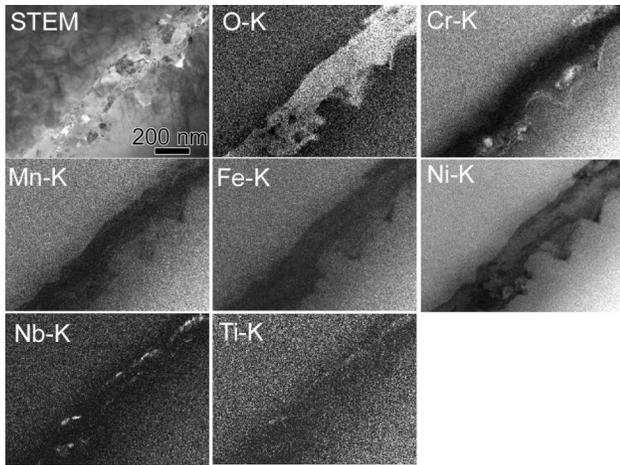
Figure 16. STEM EDS maps of oxide-filled crack region near crack tip in PWR-water test sample

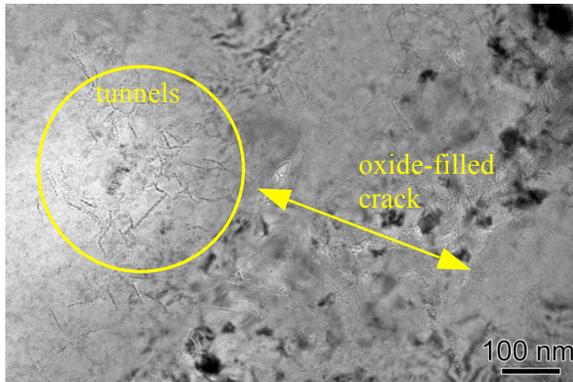
Other TEM images taken under under- or overfocus conditions revealed corrosion tunnels in the metal, similar to those observed along crack walls in all the PWR service samples. The tunnels are shown by an overfocus image in Figure 17. Diffraction patterns from the areas with tunnels showed the presence of oriented spinel oxide in the metal, and darkfield images taken with spinel reflections also showed that the 5- to 8 nm-wide 'tunnels' were filled with this oxide. The observation of these corrosion tunnels in the weld sample that was tested in PWR primary water indicated that the test reproduced one of the most distinctive features of the cracks from service samples. As was also found in the service samples, the tunnels formed in the cracks behind the attack fronts.

Figure 17. Corrosion tunnels in the metal along an oxide-filled crack in PWR-water test sample. Tunnels appear dark in overfocus image.

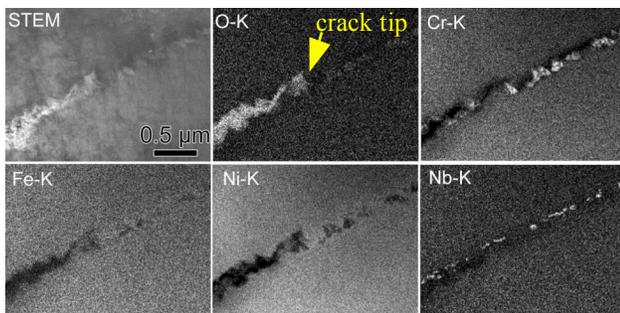
High-resolution STEM/EDS maps in Figure 18 show one of the crack tip regions. The tip location where the oxide ended can be identified from the O-K map. The Cr-K map shows Cr_{23}C_6 particles along the grain boundary ahead of the crack tip, and partially attacked particles immediately after the tip. The MC particles in this region did not show any indication of corrosion attack. Also, no significantly elevated Ni concentrations appeared in the metal ahead of the cracks, in contrast to observations in other Ni-base alloys (such as alloy 600) with cracks produced in PWR water environments. In the grain boundary region ahead of the crack tip in Figure 18, the Cr map highlights the Cr_{23}C_6 particles and indicates a strong depletion of Cr near the particles.

Figure 18. EDS maps of crack-tip region in CT012. Crack appears somewhat inclined in these images.

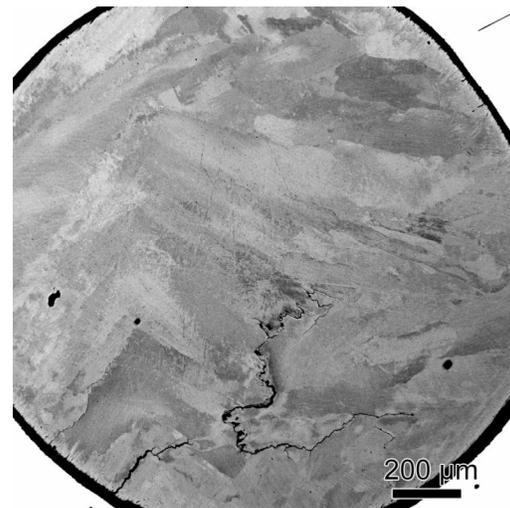
Multiple SCC cracks occurred along the weld grain boundaries ahead of the transgranular precrack in the test sample. Often, these cracks appeared significantly deviated from the direction of the fatigue precrack. Figure 19 illustrates the weld grain structure and typically wavy appearance of the IGSCC cracks that formed near the end of the test. The mottled crystallographic contrast in this image is characteristic of highly strained metal.

Figure 19. Alloy 182 TEM sample from SCC test in oxidizing BWR water plus sulfate.

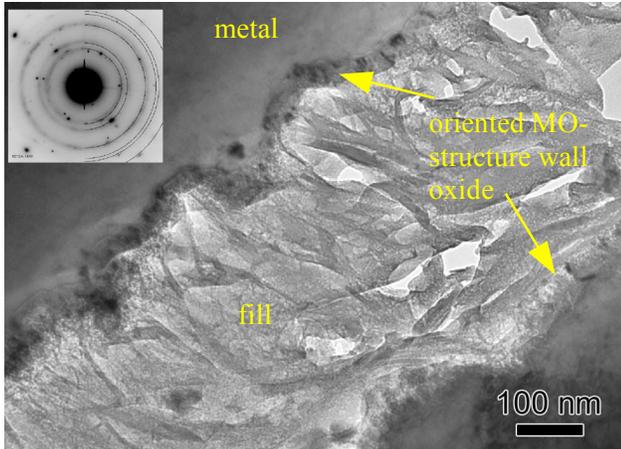
TEM observations of narrow cracks in the BWR-water test sample generally showed uniform, 30- to 50-nm-thick films of oriented cubic MO-type oxide along the walls and polycrystalline corrosion product with a sheet-like structure filling the crack centers. Figure 20 shows the wall oxide films and crack-fill material. Diffraction ring patterns from the crack-fill product did not match any standard patterns in the EDD database (the closest match was to the cubic MO structure). Most likely, this product was an unidentified hydroxide.

Figure 20. Loosely-filled crack in Alloy 182 TEM sample from CG test in BWR water. Inset diffraction ring pattern from fill product approximately matched cubic MO.

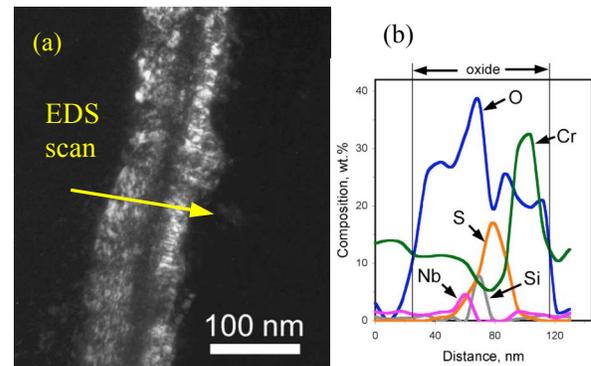
As the cracks narrowed, the oriented wall oxide films became the predominant corrosion product. A narrow band of fine-grained oxide containing high S continued to the crack tips. The crack region shown in Figure 21 contained uniform 30 to 50-nm wide MO-structure films at the walls, and a central layer of nanocracked material. This figure shows a composite MO-darkfield image that was produced by combining oxide darkfield images from both sides of the crack (the images were taken using different MO spots from the diffraction patterns taken at the metal/oxide interfaces of both matrix grains.) Composition profiles across the crack in this area are shown in Figure 21(b). The profiles indicate an asymmetrical crack microstructure with a Cr-rich region at one side corresponding to the location of Cr-carbide particles along the original grain boundary. This, and other profiles obtained from cracks in this sample, suggested that the cracking occurred along one side of the originally carbide-decorated grain boundaries. The profiles in Figure 21 also indicate high S in the material along the crack center, as well as Si and Nb in the central layer. Additionally, the Cr-rich regions along one side of the crack coincided with high O, indicating that the carbides had been at least partially oxidized.

Figure 21. Narrow IG crack in Alloy 182 sample from BWR-water test. (a) Superimposed oxide darkfield images of oriented MO-type oxide films on both sides of crack. (b) Composition profiles from line scan.

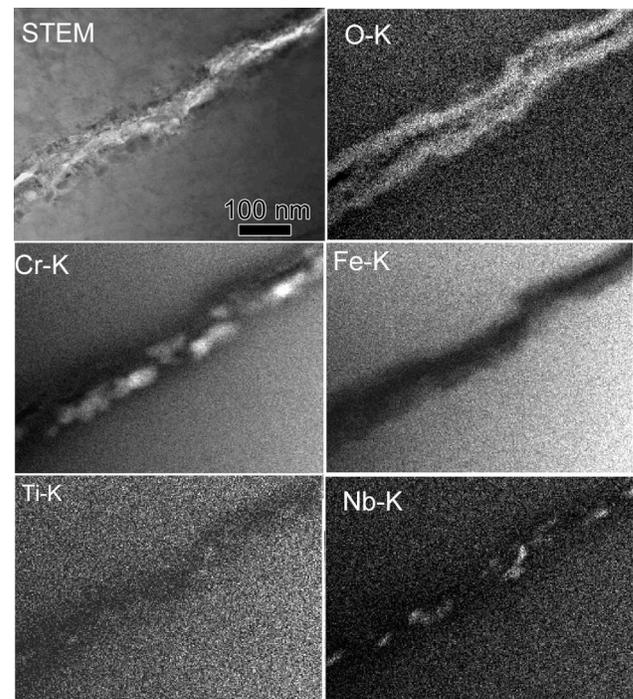
STEM/EDS maps of the same area, given in Figure 22, show the partially oxidized remnants of Cr carbides and smaller MC-type carbides in the narrow crack. The maps also showed losses of Mn, Fe and Ni in the crack.

Figure 22. STEM/EDS maps of near-tip crack in BWR test specimen.

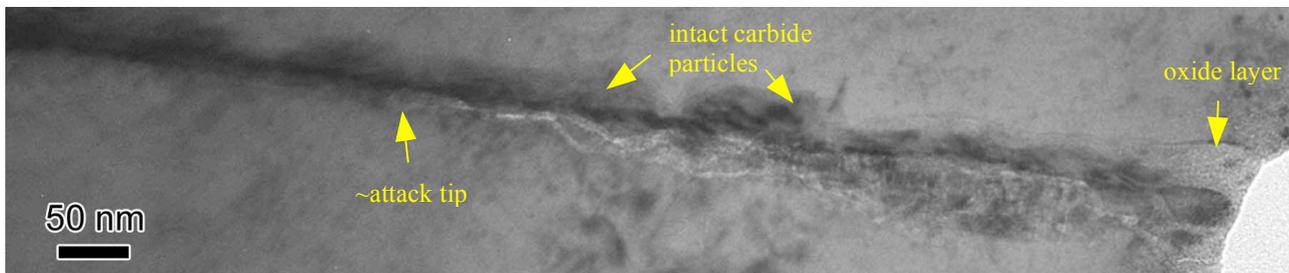
TEM observations of several crack tips in the BWR water test specimen showed the epitaxial MO oxide films along the crack walls tapering very gradually before ending along the carbide-decorated grain boundaries. The epitaxial oxide formation was preceded by one-sided attack along the carbide particle interfaces. This highly localized attack produced 'cracks' only a few nm wide on one side of the carbide particles. Figure 23 shows a tip

example with the image contrast enhanced to improve the crack visibility. It is difficult to tell exactly where the narrow attack ended.

Figure 23. Crack tip in BWR-water test sample. TEM brightfield image enhanced to show asymmetrical attack at tip.

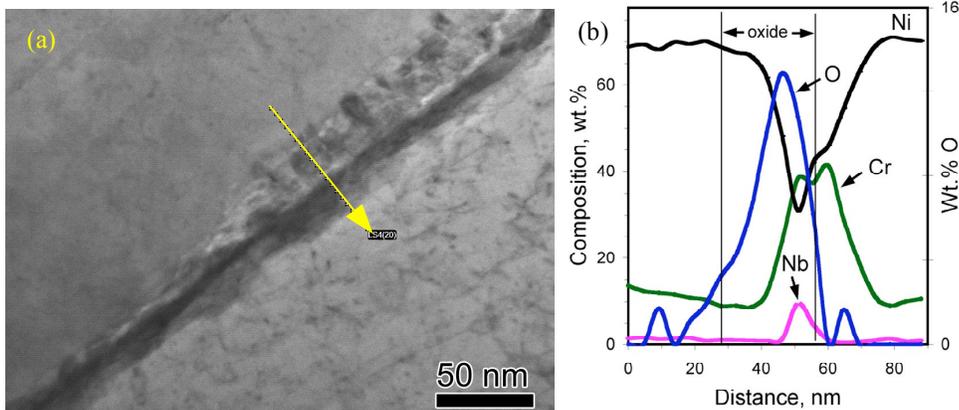
Another crack-tip example in Figure 24 includes results of a fine-probe EDS line scan analysis across the oxidized zone at the tip. The oxide narrowed to a few nm just ahead of where the line scan was made. Composition profiles in this figure show the oxide region displaced to one side of a Cr carbide particle. This analysis also detected Nb and Ti (not plotted) apparently from an MC particle. However, no S was detected this close to the crack tips.

Figure 24. Line scan EDS analysis near crack tip in BWR-water test specimen. (a) STEM image. Arrow indicates scan location. Composition profile in (b) shows asymmetrical oxide formation at IG carbide particle.
