**Pacific Gas and
Electric Company®**

PG&E Letter DCL-09-061

Docket No. 50-275, OL-DPR-80
Diablo Canyon Unit 1
Licensee Event Report 1-2009-002-00
Two Trains of Auxiliary Feedwater Inoperable Due to Protection System Failure

4. TITLE
Two Trains of Auxiliary Feedwater Inoperable Due to Protection System Failure

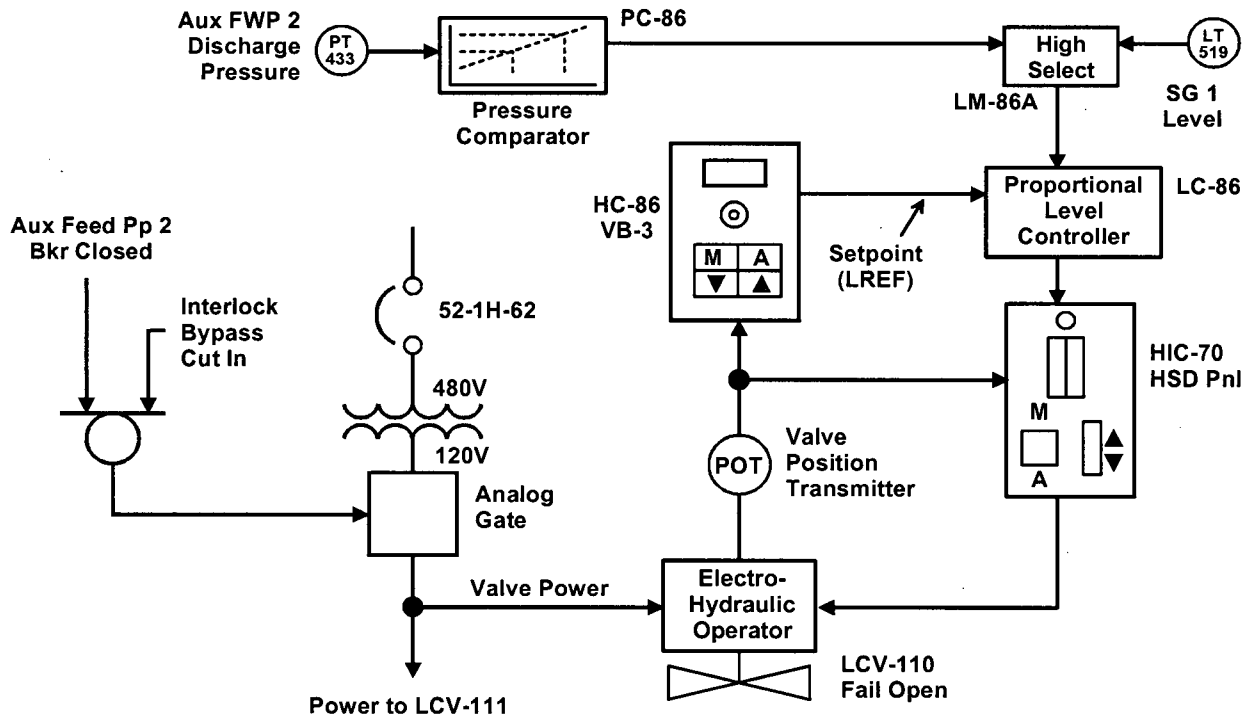
A simplified sketch of the AFW control system is shown below:

During this event, the Eagle 21 Protection Set II, Rack 8, experienced a "lockup" condition when the LCP failed. As designed, the safety-related outputs went to the "trip" condition and the non-safety outputs failed "as-is." This froze the outputs to the normal operating SG level at approximately 65 percent level. Based on the Scaling Calculations for the loop, this represents approximately 50 percent open on the valves. So if the hand controllers (HCs) on the control room Vertical Board were left in Auto during the time that Rack 8 was locked up and a SG lo-lo level trip occurred, the LCV-110 (SG Loop 1) valve would have been demanded to 50 percent open and the LCV-113 (Loop 4) would be demanded to 50 percent open when the motor driven AFW pumps were started. The other two valves (LCV-111 and LCV-115) would be at 100 percent open and then control on the actual active level control signal.

The Eagle 21 LCP failure caused the SG level control output to lockup at the fail-as-is setpoint of approximately 65 percent in accordance with the design intent.

Plant operators entered TS 3.7.5 Condition C and maintained Unit 1 in Mode 1 at normal operating temperature and pressure. The failed Eagle 21 LCP card was replaced.
