**UNITED STATES
NUCLEAR REGULATORY COMMISSION**
WASHINGTON, D.C. 20555-0001

September 8, 2009

SUBJECT: SUMMARY OF SEPTEMBER 2, 2009, POST-SUBMITTAL PUBLIC MEETING WITH EXELON GENERATION COMPANY, LLC, TO DISCUSS BYRON STATION, UNIT NO. 2, RELIEF REQUEST FOR ALTERNATE EXAMINATION FREQUENCY UNDER ASME CODE CASE N-729-1 FOR REACTOR VESSEL HEAD PENETRATION WELDS (TAC NO. ME1066)

Proposed Relief Request from
ASME Code Case N-729-1
Inspection Frequency
Byron Station Unit 2

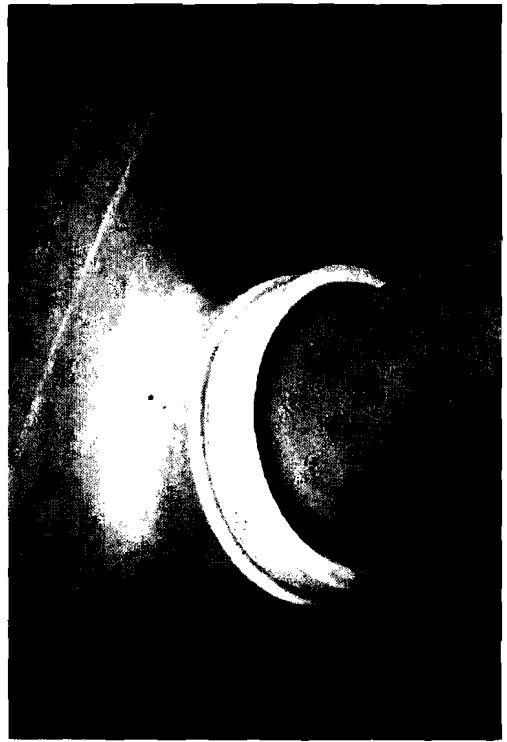
2007 Inspection Results - Byron 2

- 100% volumetric ultrasonic testing (UT)
- UT exam revealed 50% through-wall axial indication ~0.52” long
- Subsequent dye penetrant (PT) exam of J-groove weld identified one rounded and one linear indication
- Leak path assessment did not detect any leaks

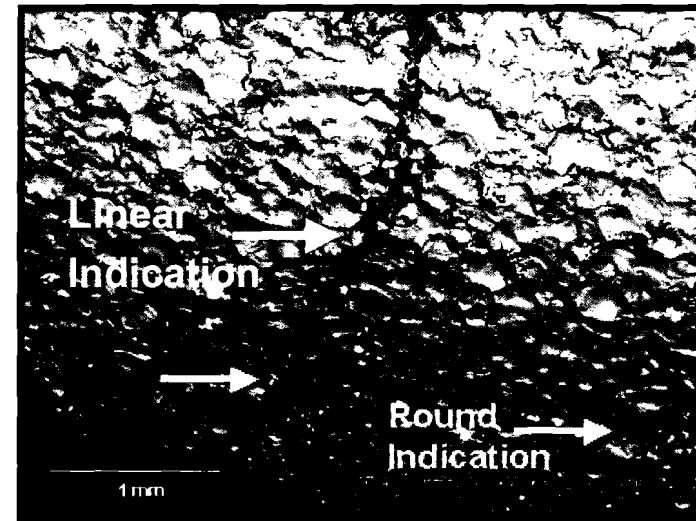
Cut surface of boat sample

SEM Image of inset area above

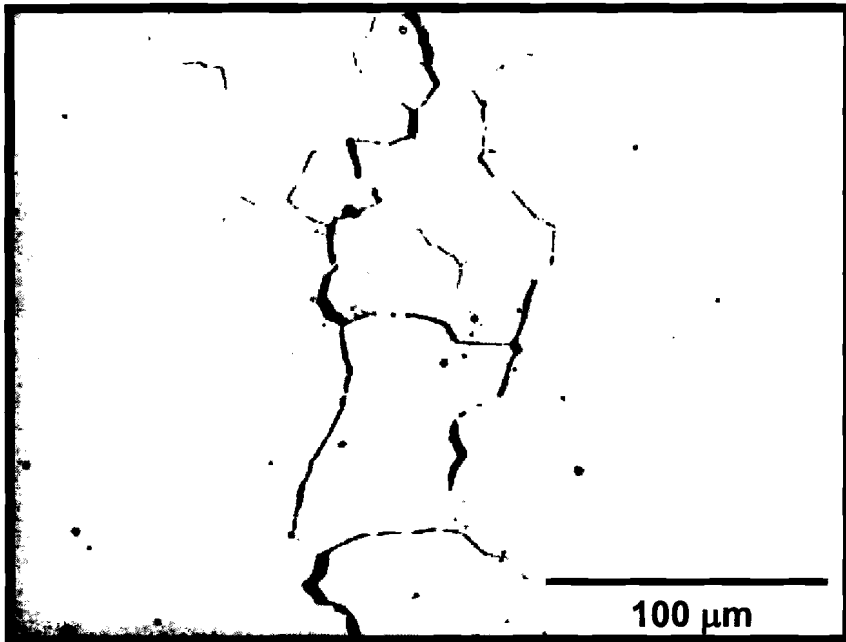
**Intergranular Cracking in Tube Metal
(Unetched)**

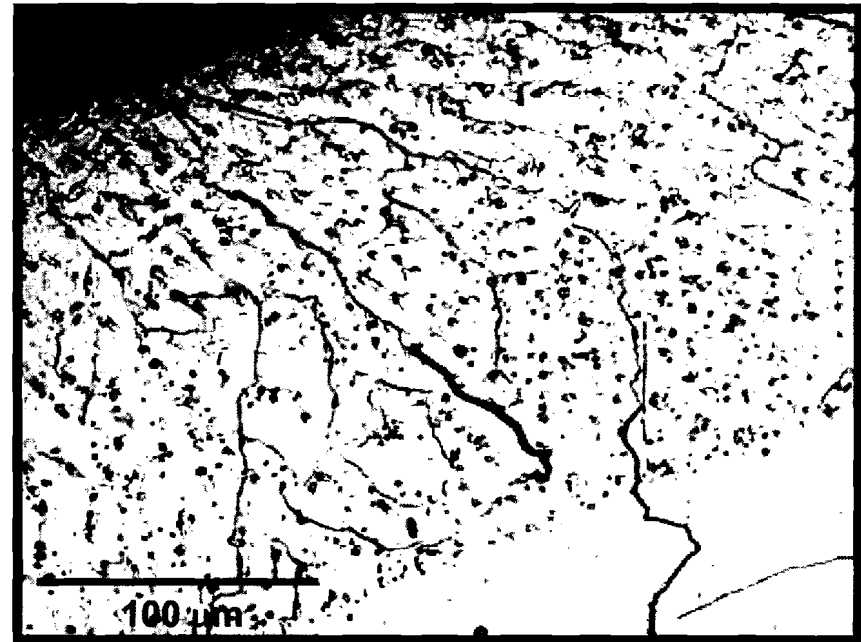
**Intergranular Cracking
in Tube and Weld Metals
(Electrolytic Phosphoric-Nital Dual Etch)**

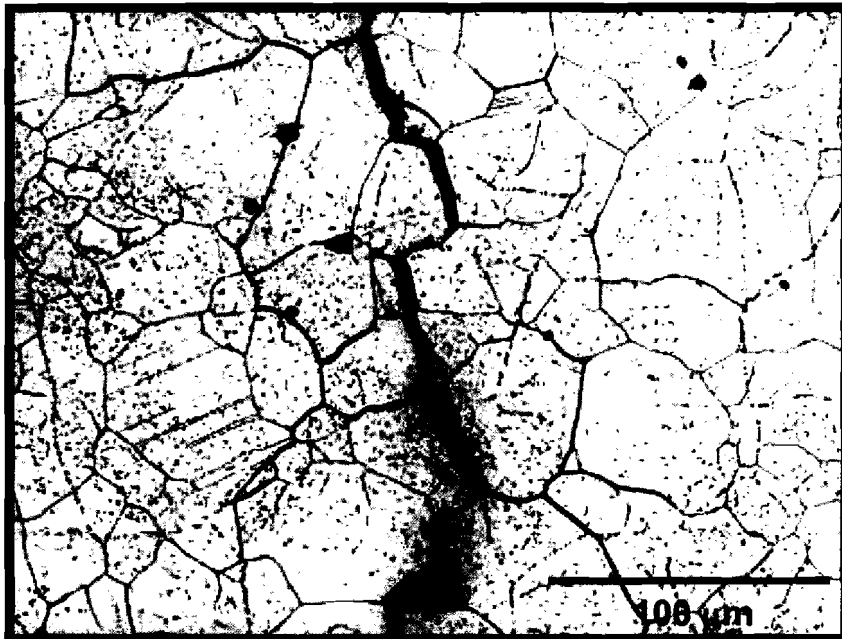
**Intergranular Cracking in Tube Metal
(Electrolytic Phosphoric-Nital Dual Etch)**

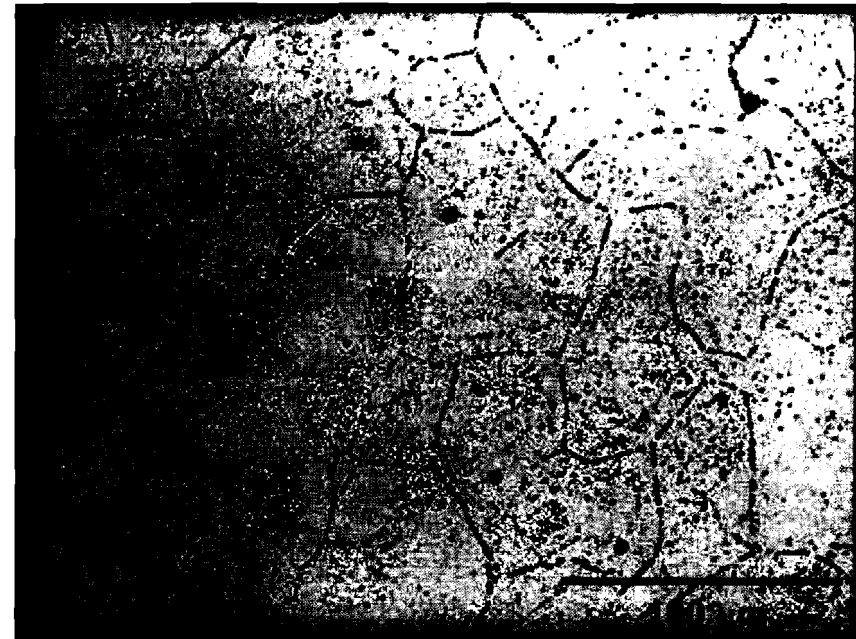
**Susceptibility of Alloy 600 MA Tube Material
(Electrolytic Phosphoric Etch)**

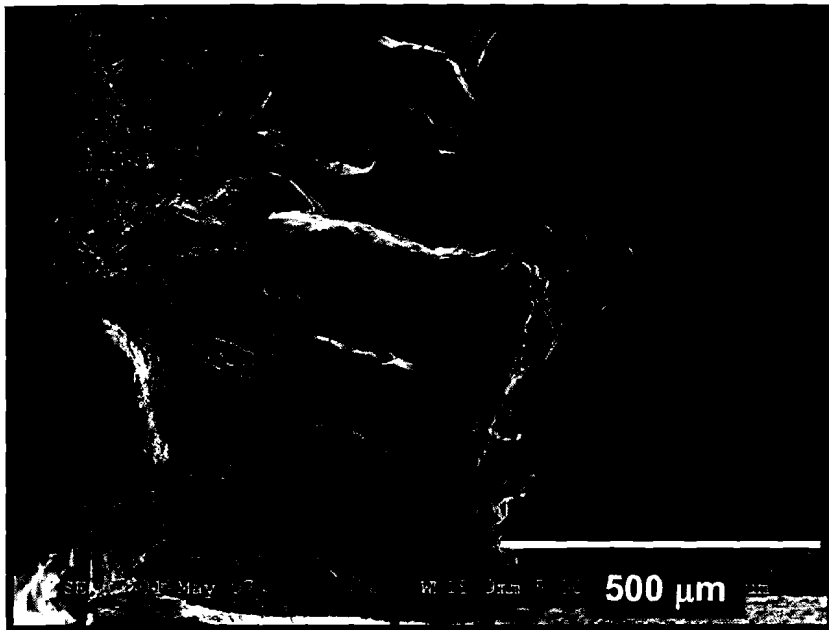
Ductile Tearing at Wetted Surface

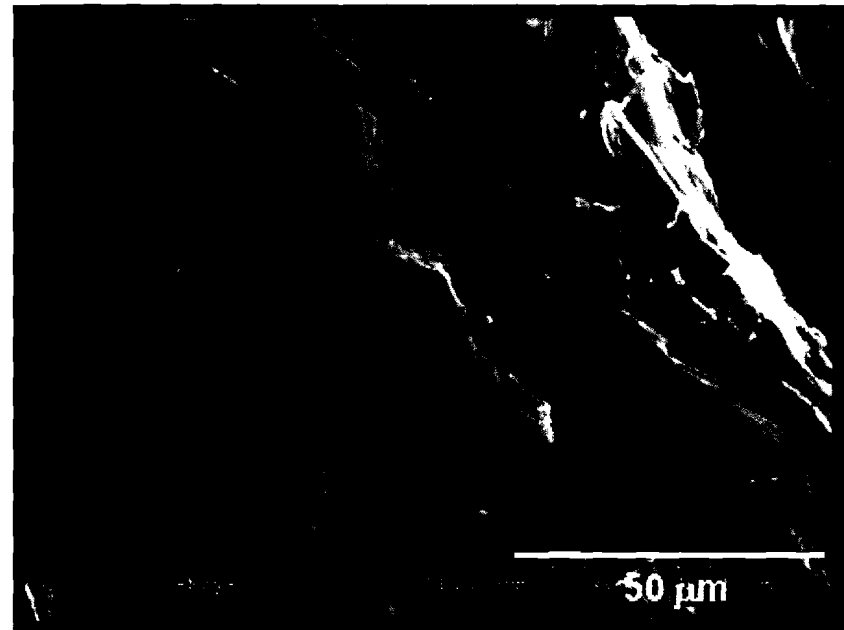
Hot Cracking in Weld

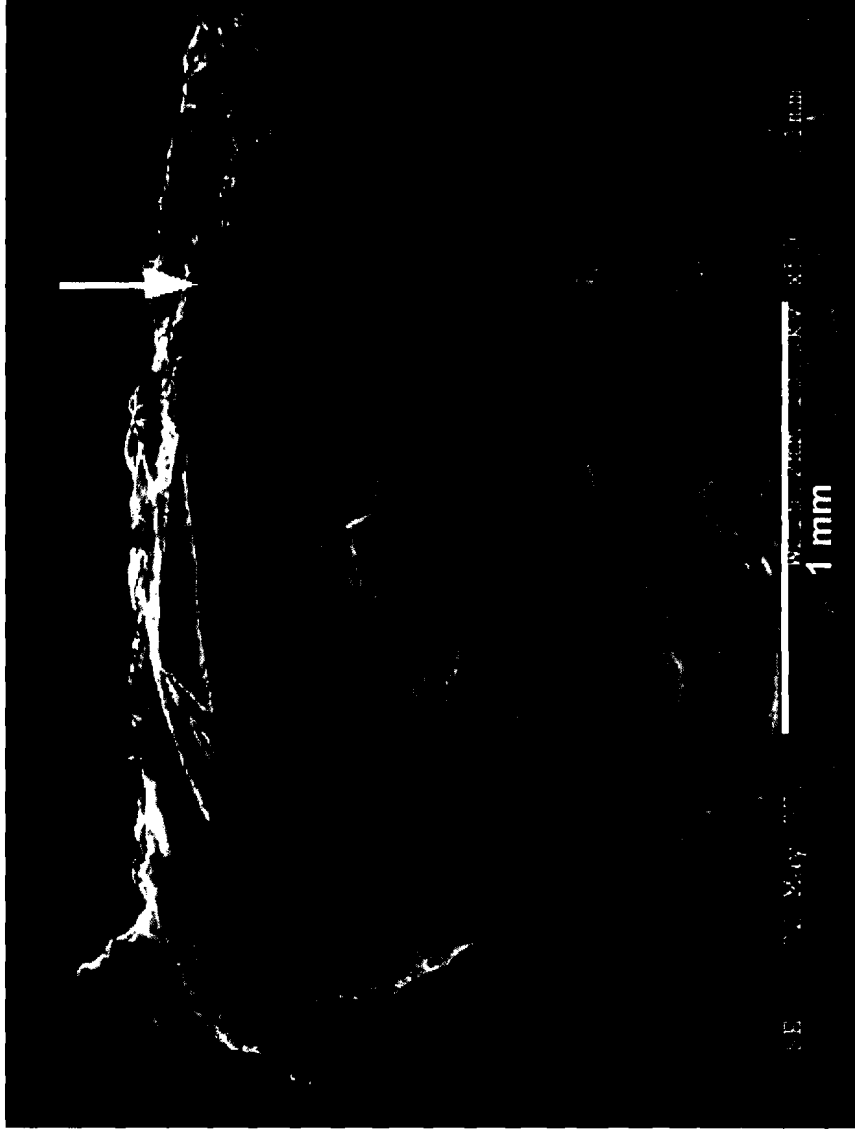
Section A1 -- Crack Surface

Lack of Fusion between Weld Passes

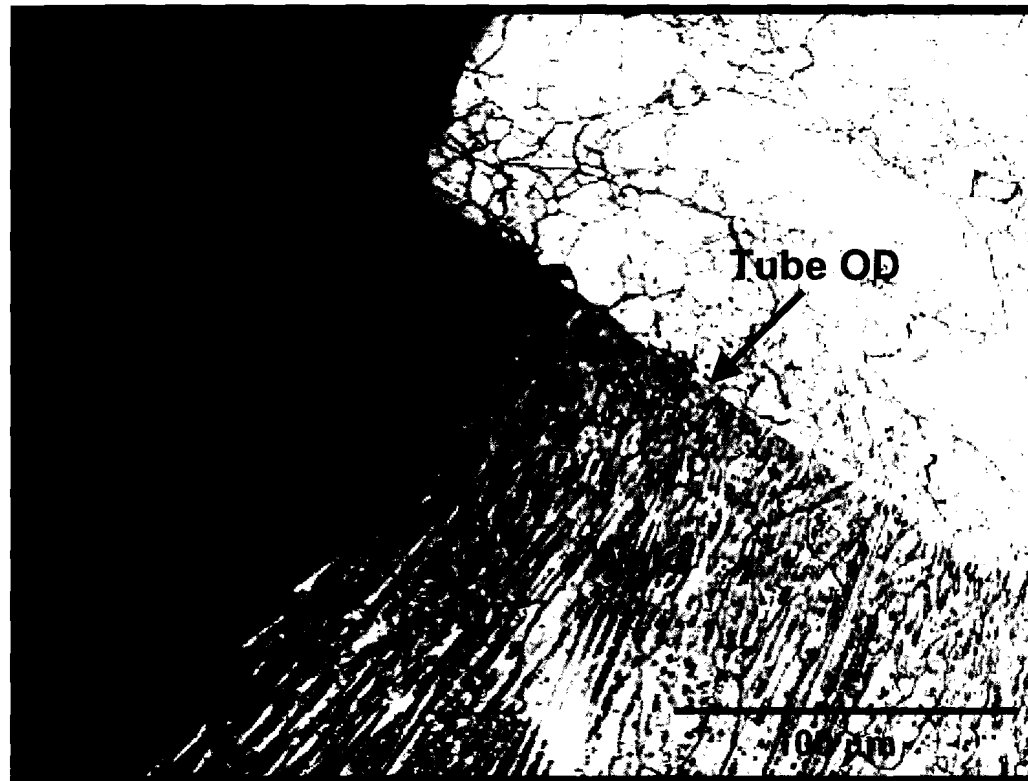
Section A2A -- Weld Defect

- ✓ Rounded subsurface defect captured by the boat sample identified as lack of fusion between the weld and tube surfaces
 - Incipient cracks were observed emanating from the defect
 - Weld defect produced during original fabrication process

Lack-of-Fusion Defect
(Electrolytic Phosphoric-Nital Dual Etch)

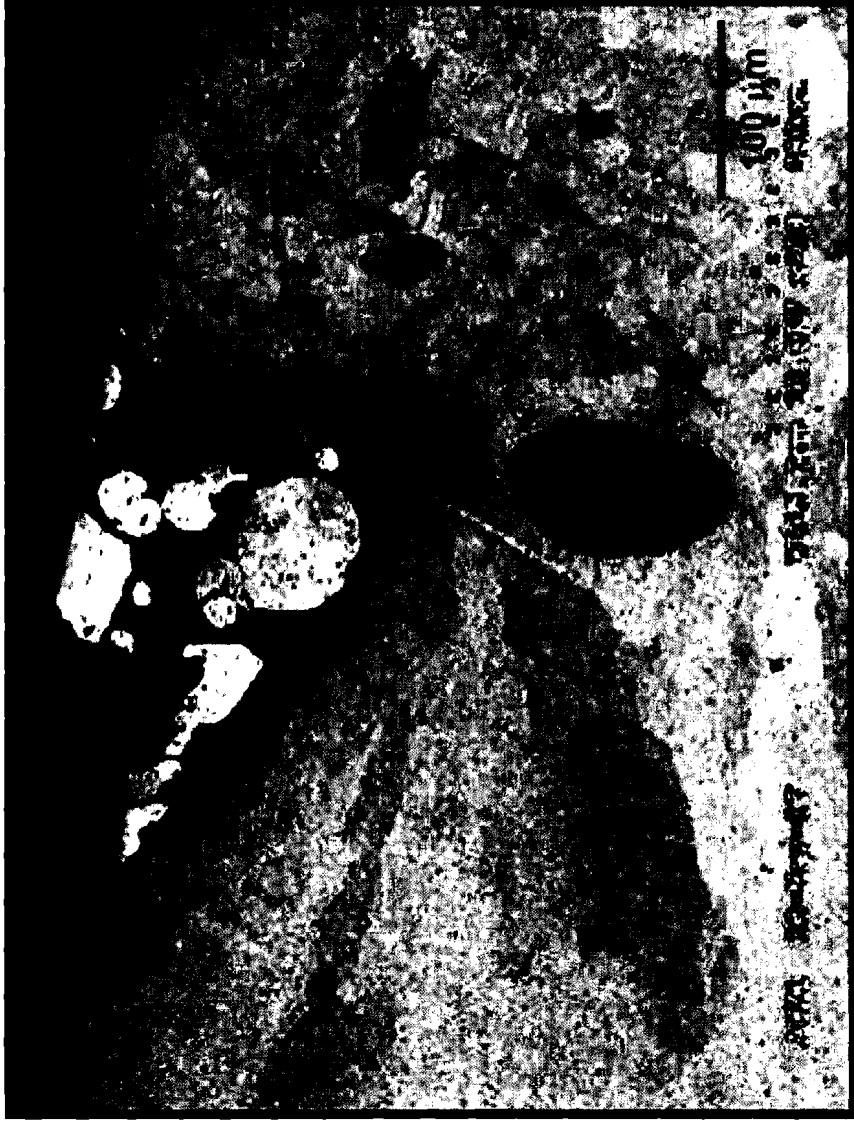
Section A2A -- Defect and Inclusion

Inclusion Revealed after Polishing

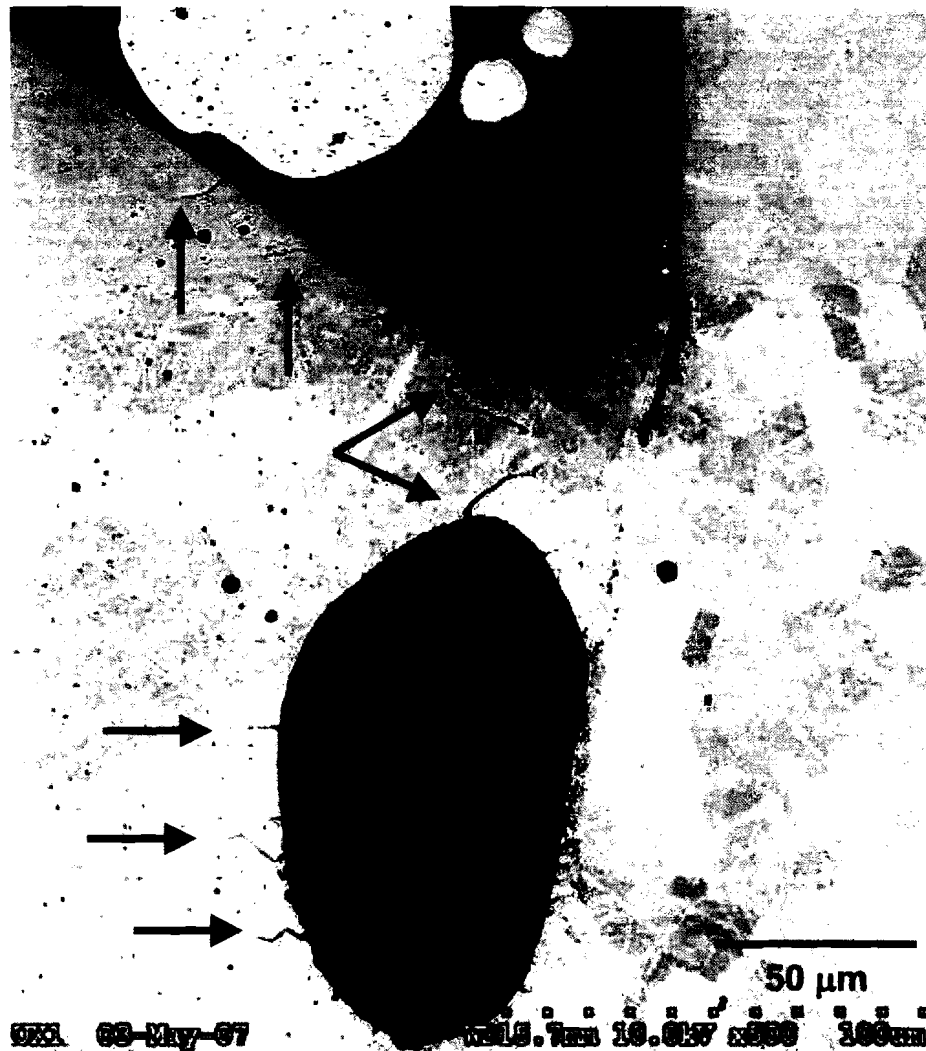
Section A2A -- Defect and Inclusion

- ✓ Inclusions contained Ti, N, and O
- ✓ Crevice contained oxidized W, Fe, Ni, Cr, and Nb
- ✓ Cracks contained Inconel 182 oxidation products
- ✓ No measurable fluorine or other corrosive elements

Incipient Cracks shown by Arrows

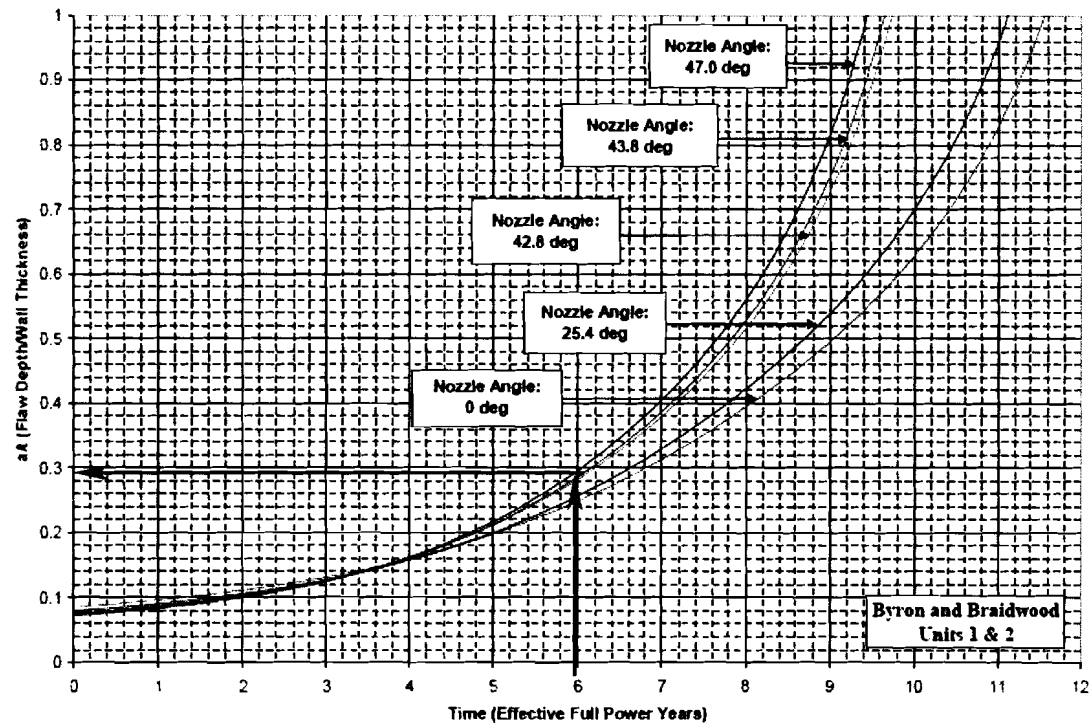
Figure 5-7: PWSCC Growth Projections for an Inside Surface, Axially Oriented Flaw on the Uphill Side at the J-groove Weld

- ✓ PWSCC growth projections for an inside surface, axially oriented flaw on the uphill side at the J-groove weld with initial depth of 0.075" and fixed aspect ratio of 6
- ✓ Maximum flaw depth is projected to be 30% throughwall after 6 years of operation or 4 fuel cycles – providing additional margin to ASME Code structural limit of 75% wall depth

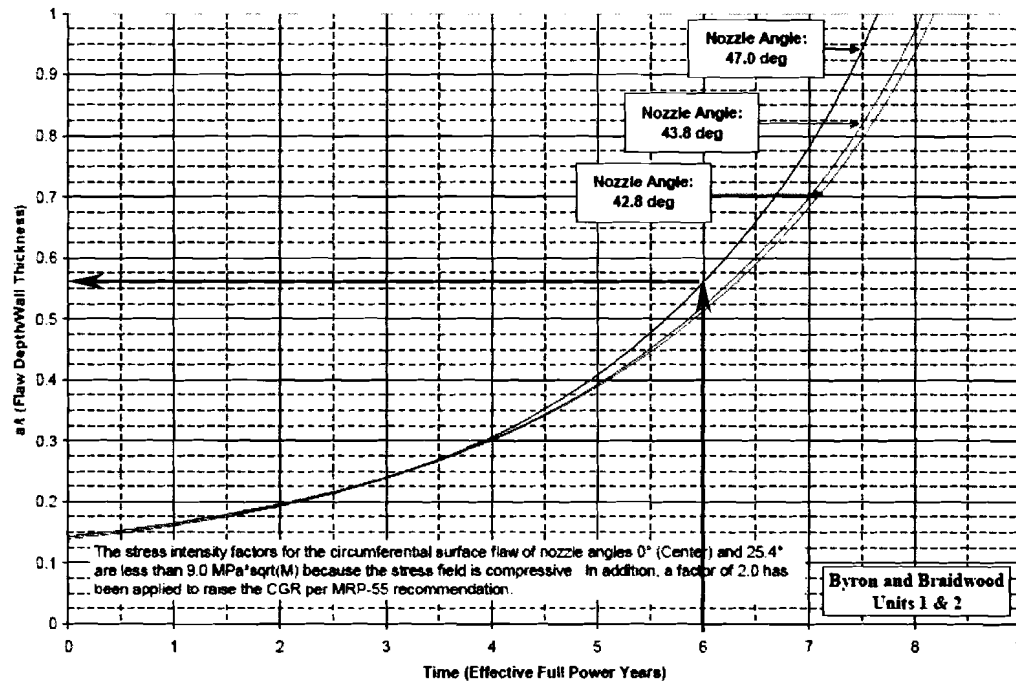
Figure 5-8: PWSCC Growth Projections for an Outside Surface, Circumferentially Oriented Flaw on the Downhill Side Above the J-groove Weld

- ✓ PWSCC growth projections for an outside surface, circumferentially oriented flaw on the downhill side at the J-groove weld with initial depth of 0.075" and fixed aspect ratio of 6
- ✓ Maximum flaw depth is projected to be 56% throughwall after 6 years of operation or 4 fuel cycles – providing additional margin to ASME Code structural limit of 75% wall depth
