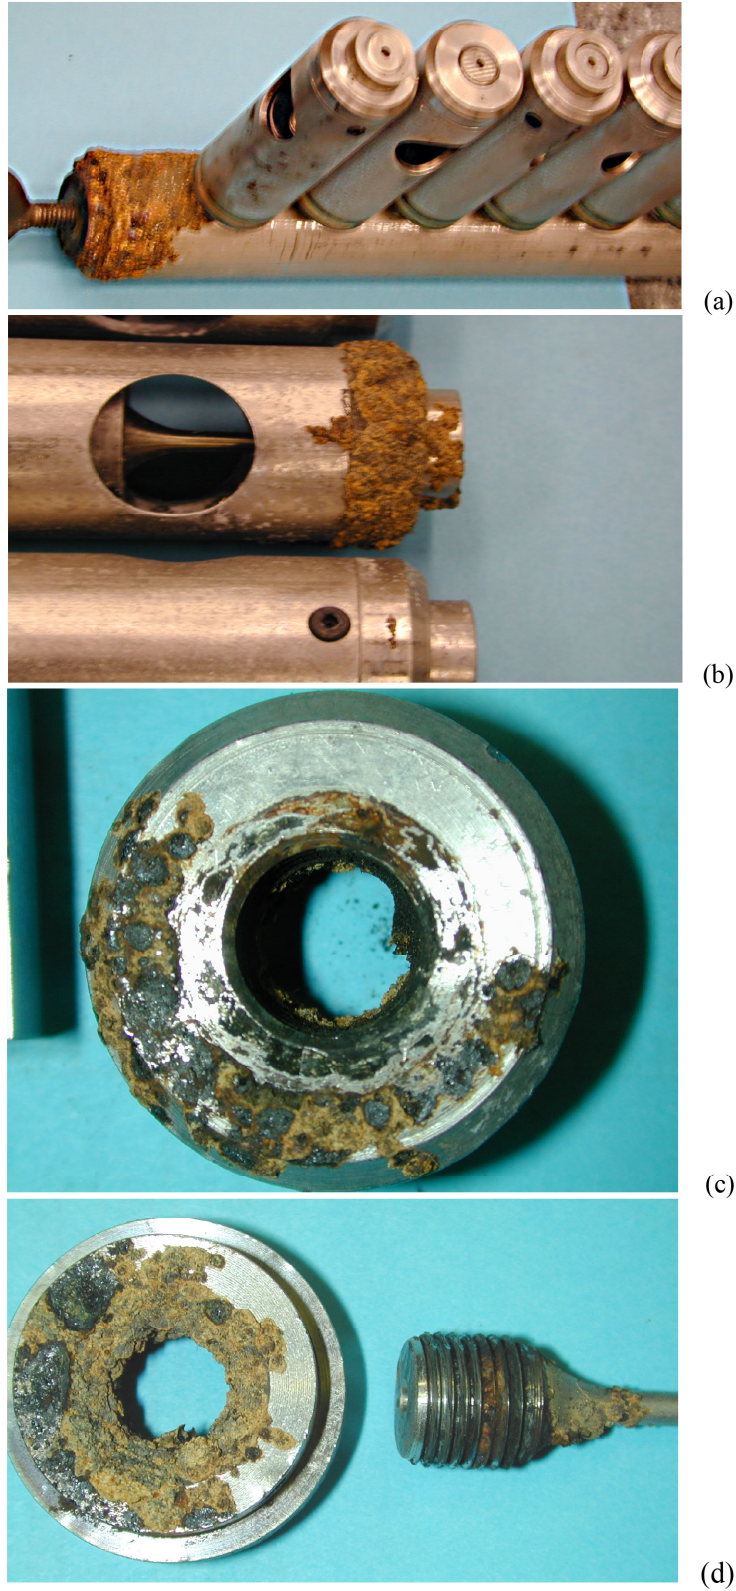
Figure 2-7. Severe corrosion and encrustation was observed (a) at the top of the manifold and (b) - (d) on several module components and 304SS specimens after running the autoclave at 125°C.
