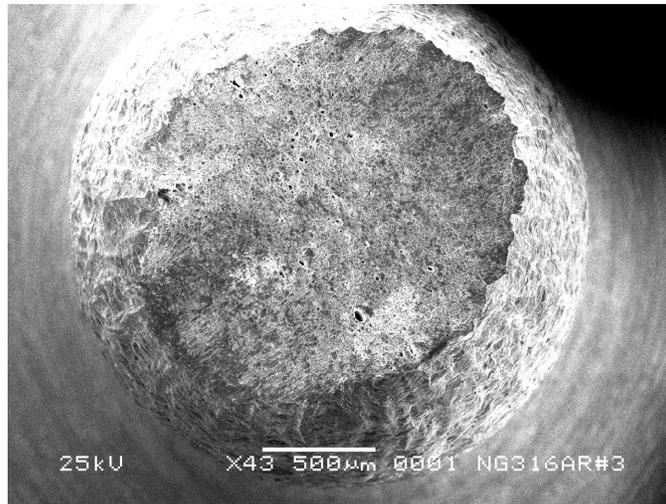
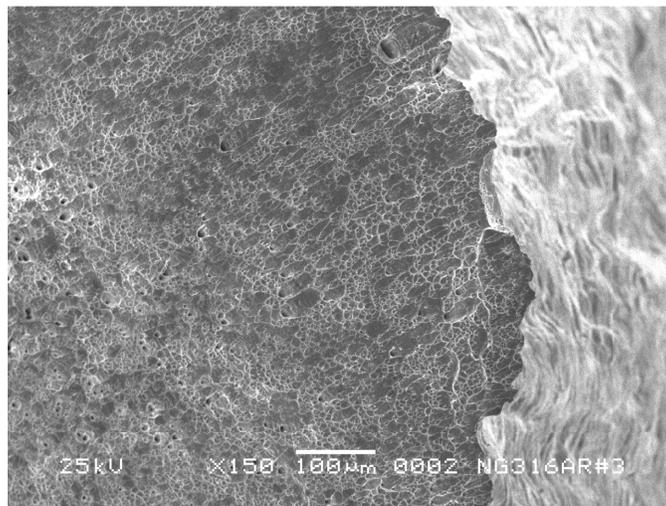
Figure 2-11. Fracture morphology for 316NG SS Keno specimen exposed during Keno Run 1. Failure likely occurred due to specimen overload. No indication of SCC was observed.

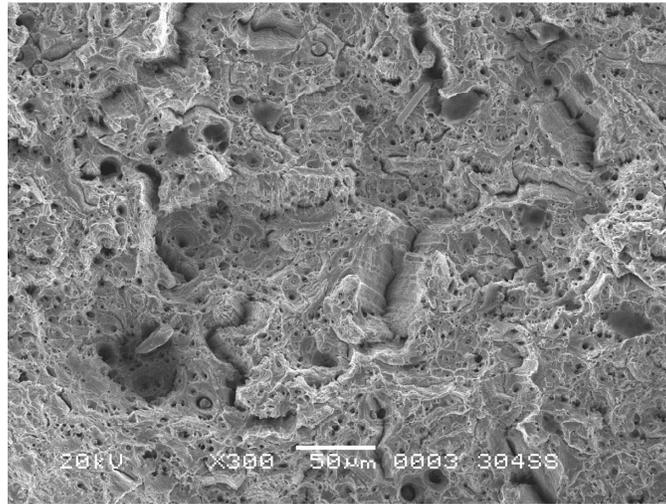
Figure 2-12. Fracture morphology for sensitized 304SS specimens (a) tensile test in 125°C air, (b) and (c) Keno specimen failure (Keno Run 1). Intergranular SCC regions and ductile final failure region are observed in (b).
