San Onofre Unit 3 Replacement Steam Generator

Divider Plate-to-Channel Head Weld Separation

September 15, 2009

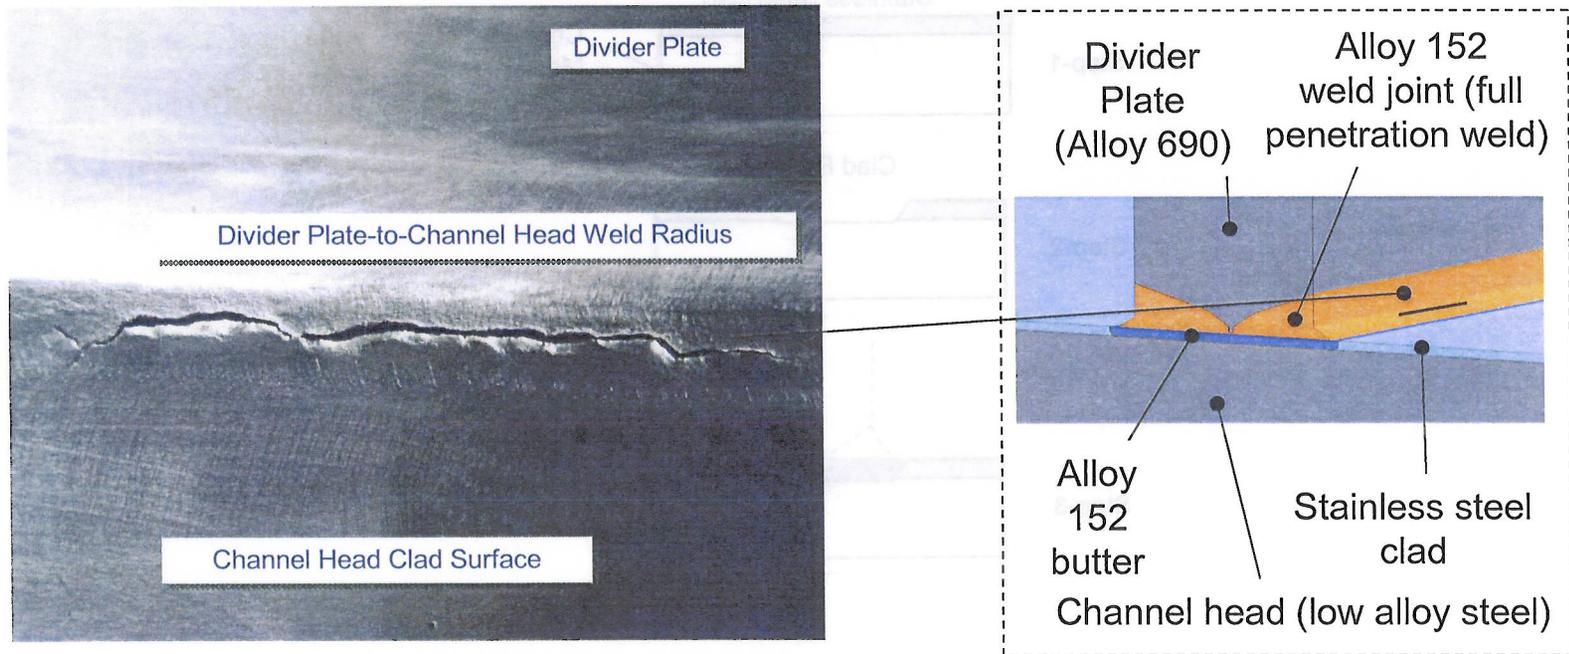
RSG 3B Cold-Side Crack in Divider Plate-to-Channel Head Weld

A crack in the weld between the RSG 3B divider plate and the channel head was reported on March 18, 2009 after completion of the hydrostatic pressure testing.

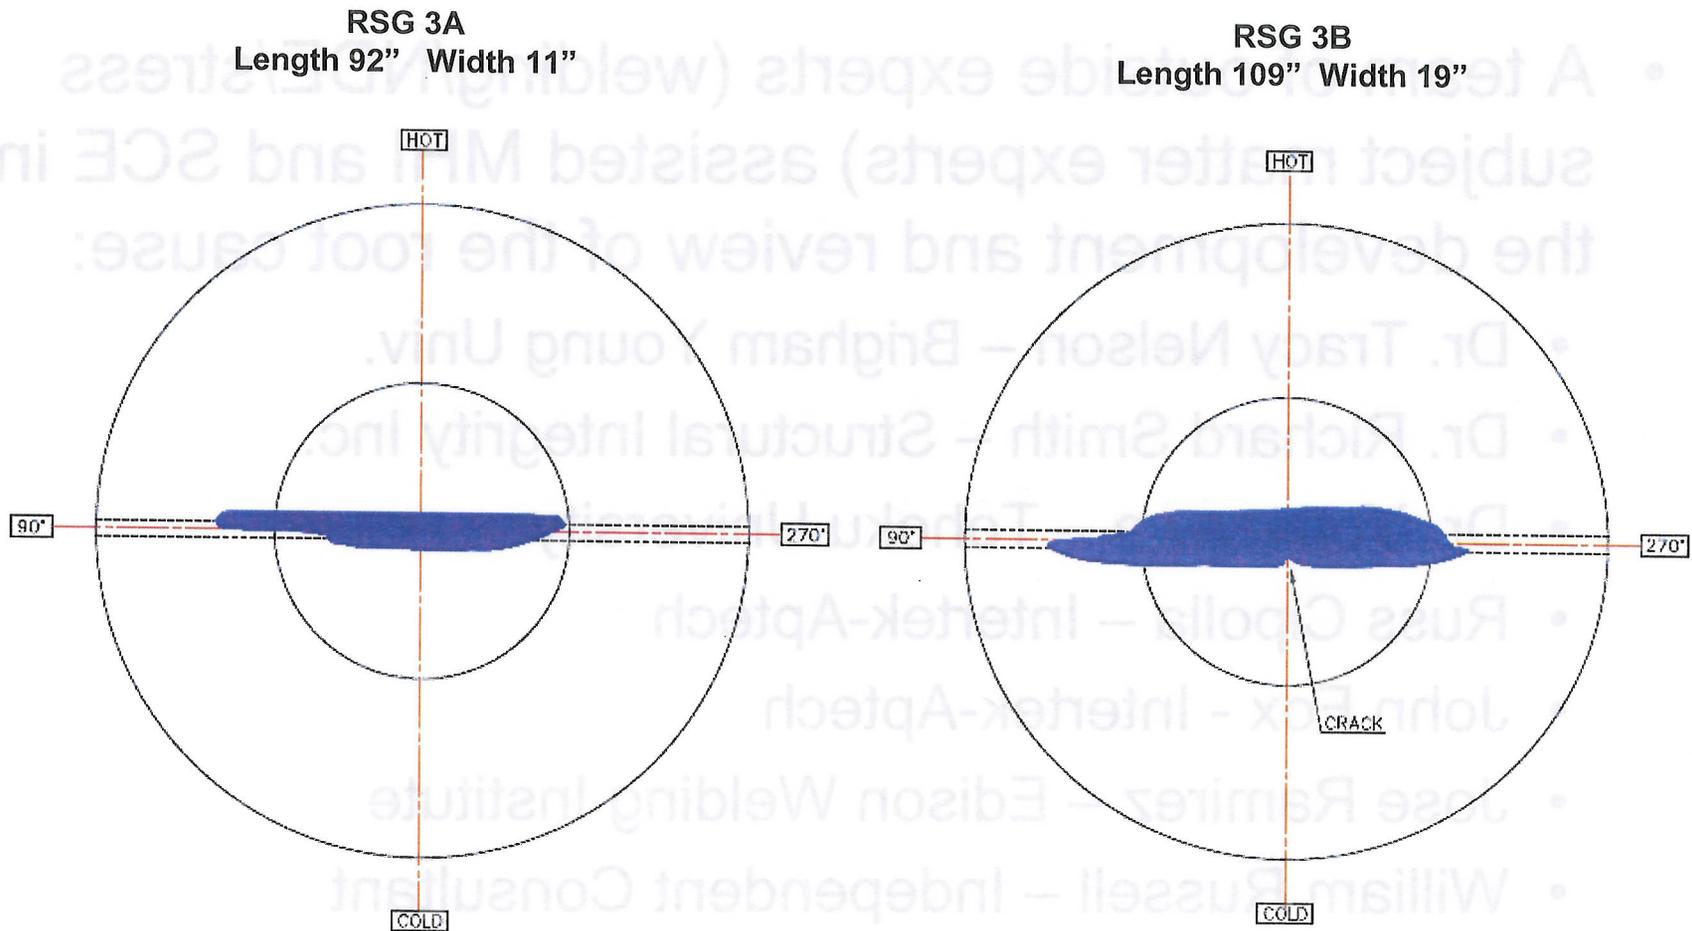
Unit 3 RSG Root Cause Investigation Extent of Separation

- UT examinations – straight beam from accessible areas inside and outside channel head
- Inconel butter and stainless steel clad separation from channel head base material (low alloy steel)
- Affected regions – under and adjacent to divider plate to channel head weld

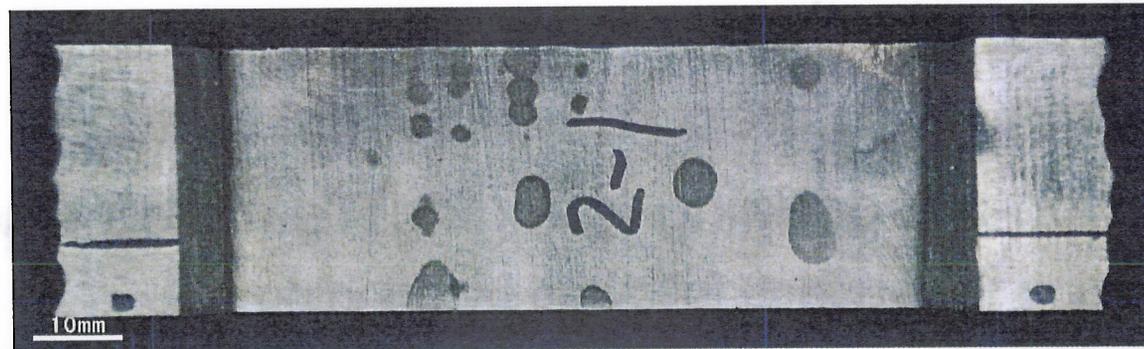
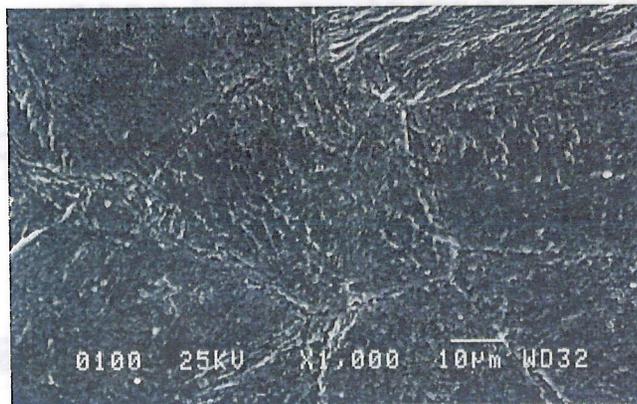
Mockup - gouging showing case hardening locations

Poor bonding – flat, featureless surface
at fusion boundary

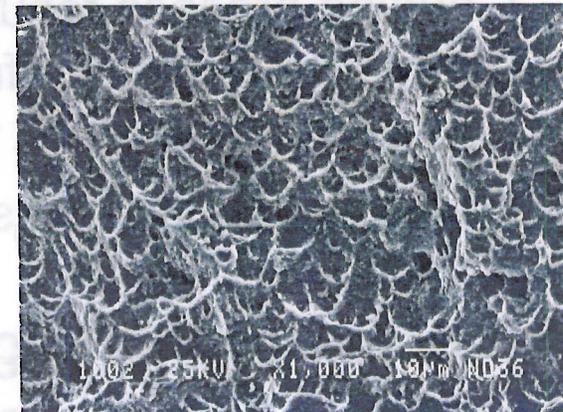
Boat
Sample

Good bonding – ductile failure
in weld
