***San Onofre Unit 3
Replacement Steam Generator***

**Divider Plate-to-Channel Head Weld
Separation**

September 15, 2009

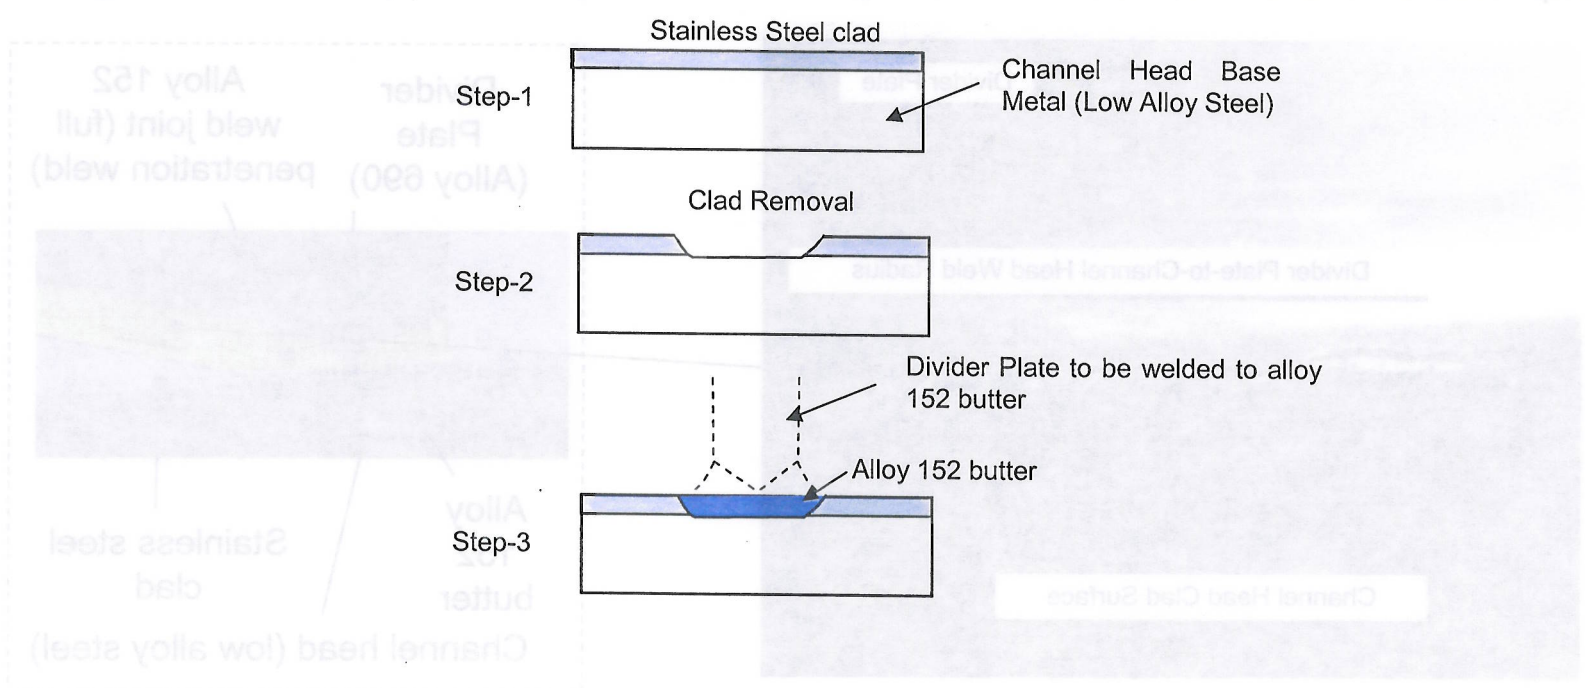
A crack in the weld between the RSG 3B divider plate and the channel head was reported on March 18, 2009 after completion of the hydrostatic pressure testing.

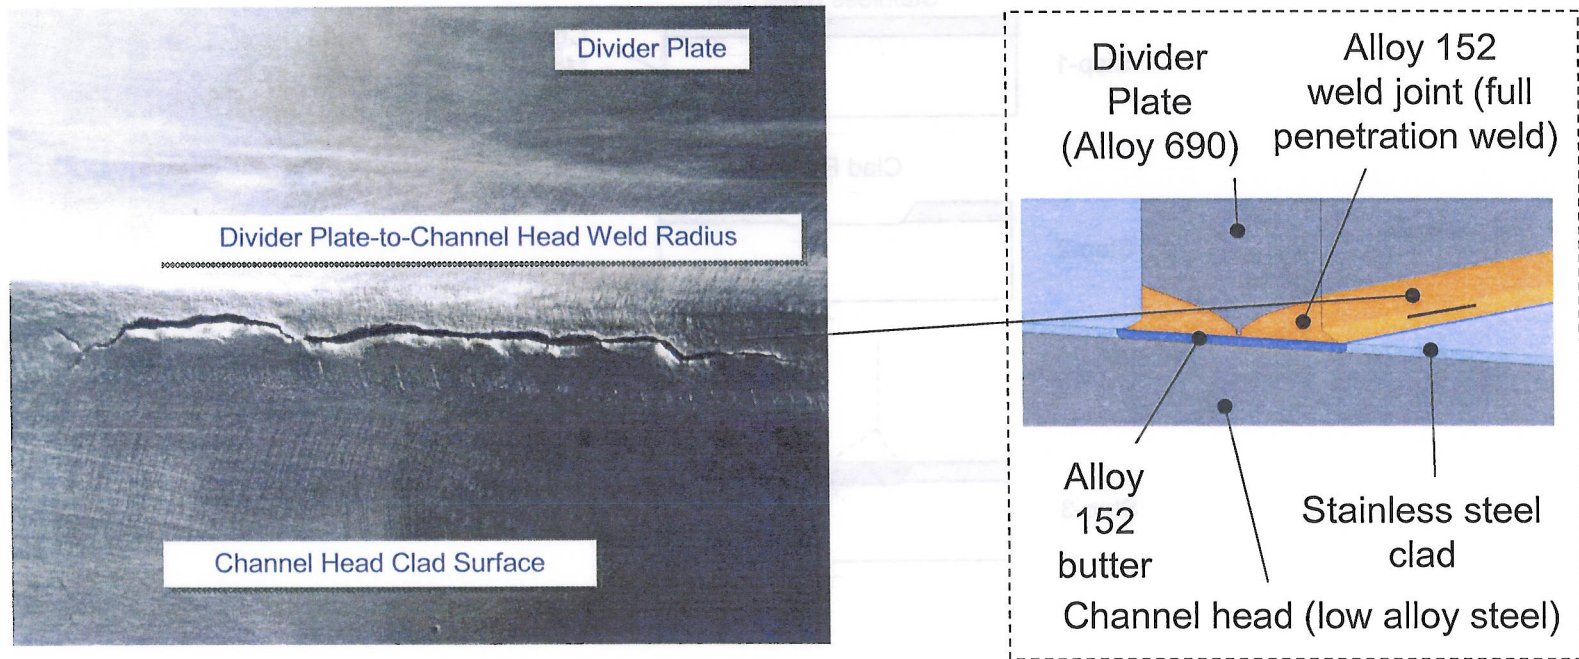
A crack in the weld between the RSG 3B divider plate and the channel head was reported on March 18, 2009 after completion of the hydrostatic pressure testing.

RSG 3B Cold-Side Crack in Divider Plate-to-Channel Head Weld

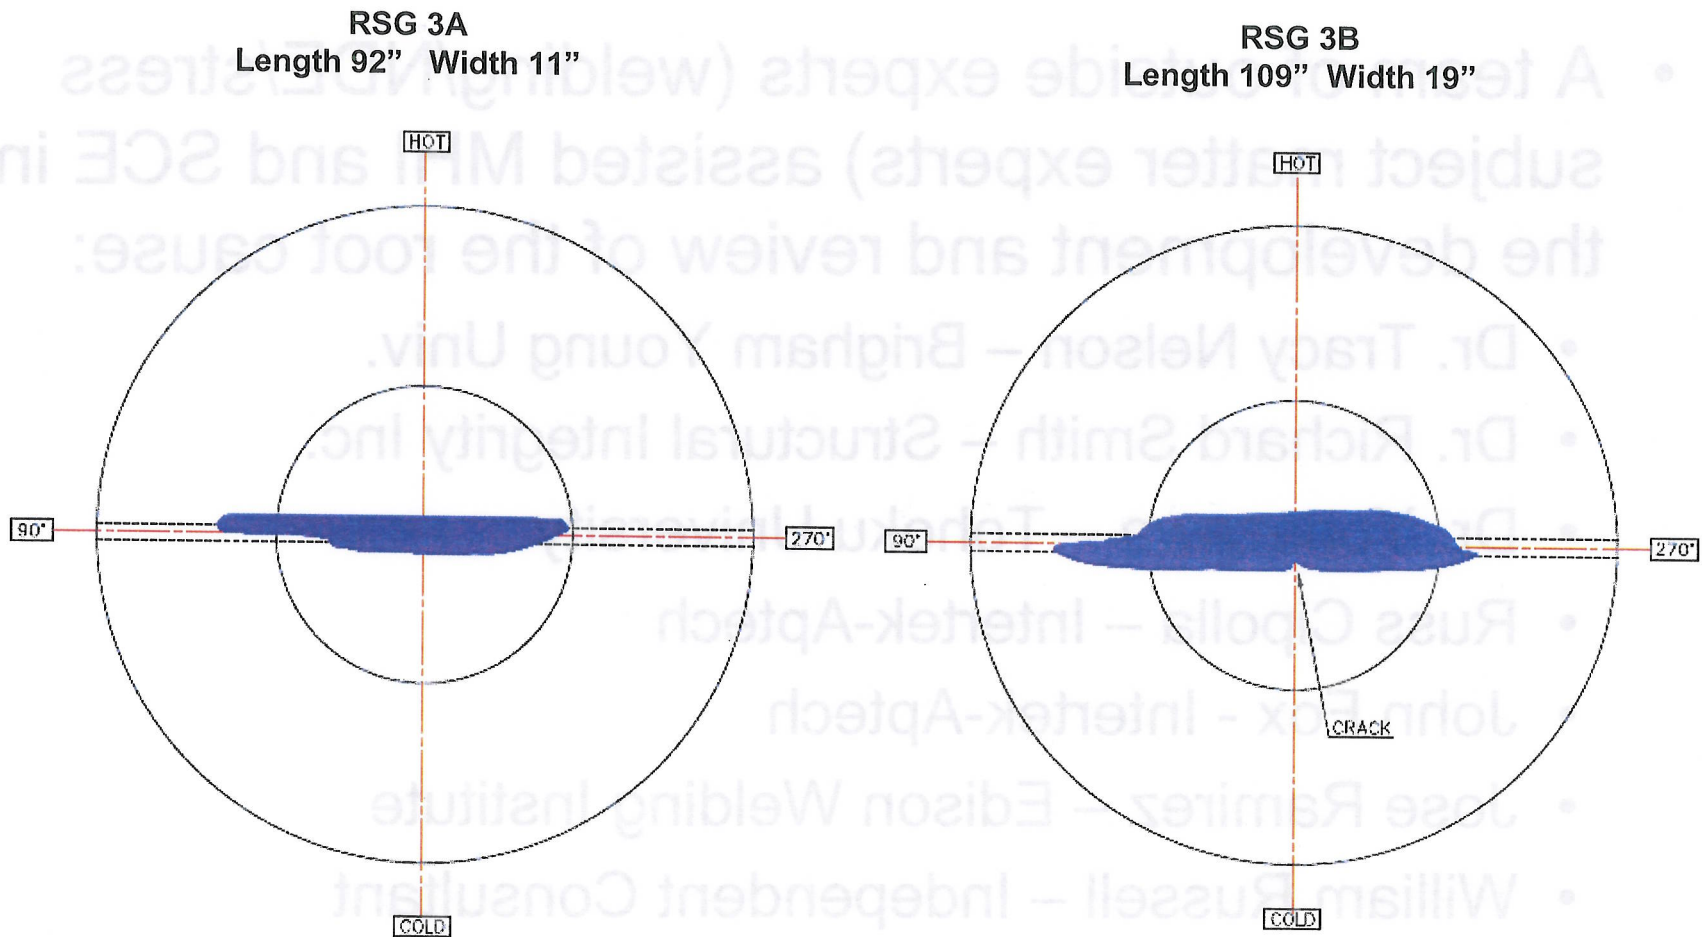
Unit 3 RSG Root Cause Investigation Extent of Separation

- UT examinations – straight beam from accessible areas inside and outside channel head
- Inconel butter and stainless steel clad separation from channel head base material (low alloy steel)
- Affected regions – under and adjacent to divider plate to channel head weld

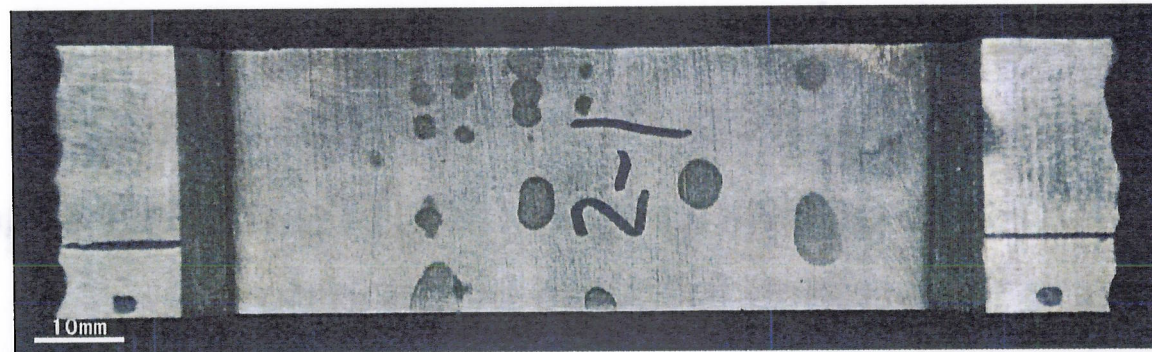
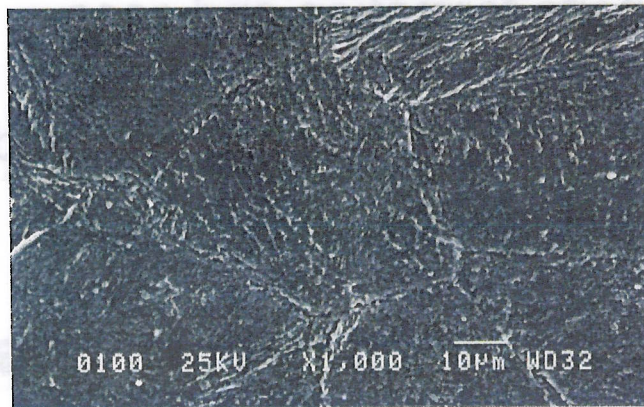
Higher hardness regions and variations in surface conditions led to weak weld bonding with less than design strength

Mockup - gouging showing case hardening locations

Poor bonding – flat, featureless surface
at fusion boundary

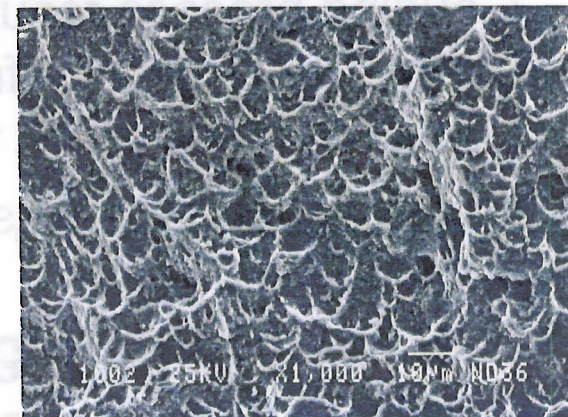
Boat
Sample

Good bonding – ductile failure
in weld
