Serial Number 2731

Subject: Response to NRC Bulletin 2001-01, "Circumferential Cracking of Reactor Pressure Vessel Head Penetration Nozzles"

DAVIS-BESSE NUCLEAR POWER STATION

Response to NRC Bulletin 2001-01 for the Davis-Besse Nuclear Power Station

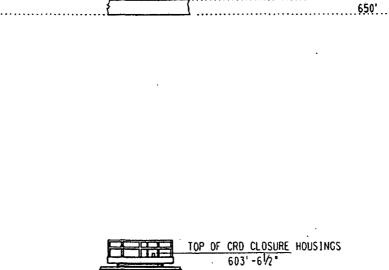
The elevations for the Reactor Coolant Seystem (RCS), including the top of the CRD Closure Housings at the top of the service structure, are shown in the attached Figure 1. The top of the missile shield over the service structure is at elevation 653'0". The missile shield is comprised of 6 concrete removable panels, each 31' 5" x 6' 6" x 3'. It spans across the refueling canal and is supported on both sides by the Steam Generator "D-Ring" walls.
