DEPARTMENT OF THE NAVY  
OFFICE OF THE CHIEF OF NAVAL OPERATIONS  
2000 NAVY PENTAGON  
WASHINGTON, D.C. 20350-2000

SUBJECT: IMPROPER EXPENDITURE OF DEPLETED URANIUM MUNITIONS

### Report of Depleted Uranium Recovery Operations

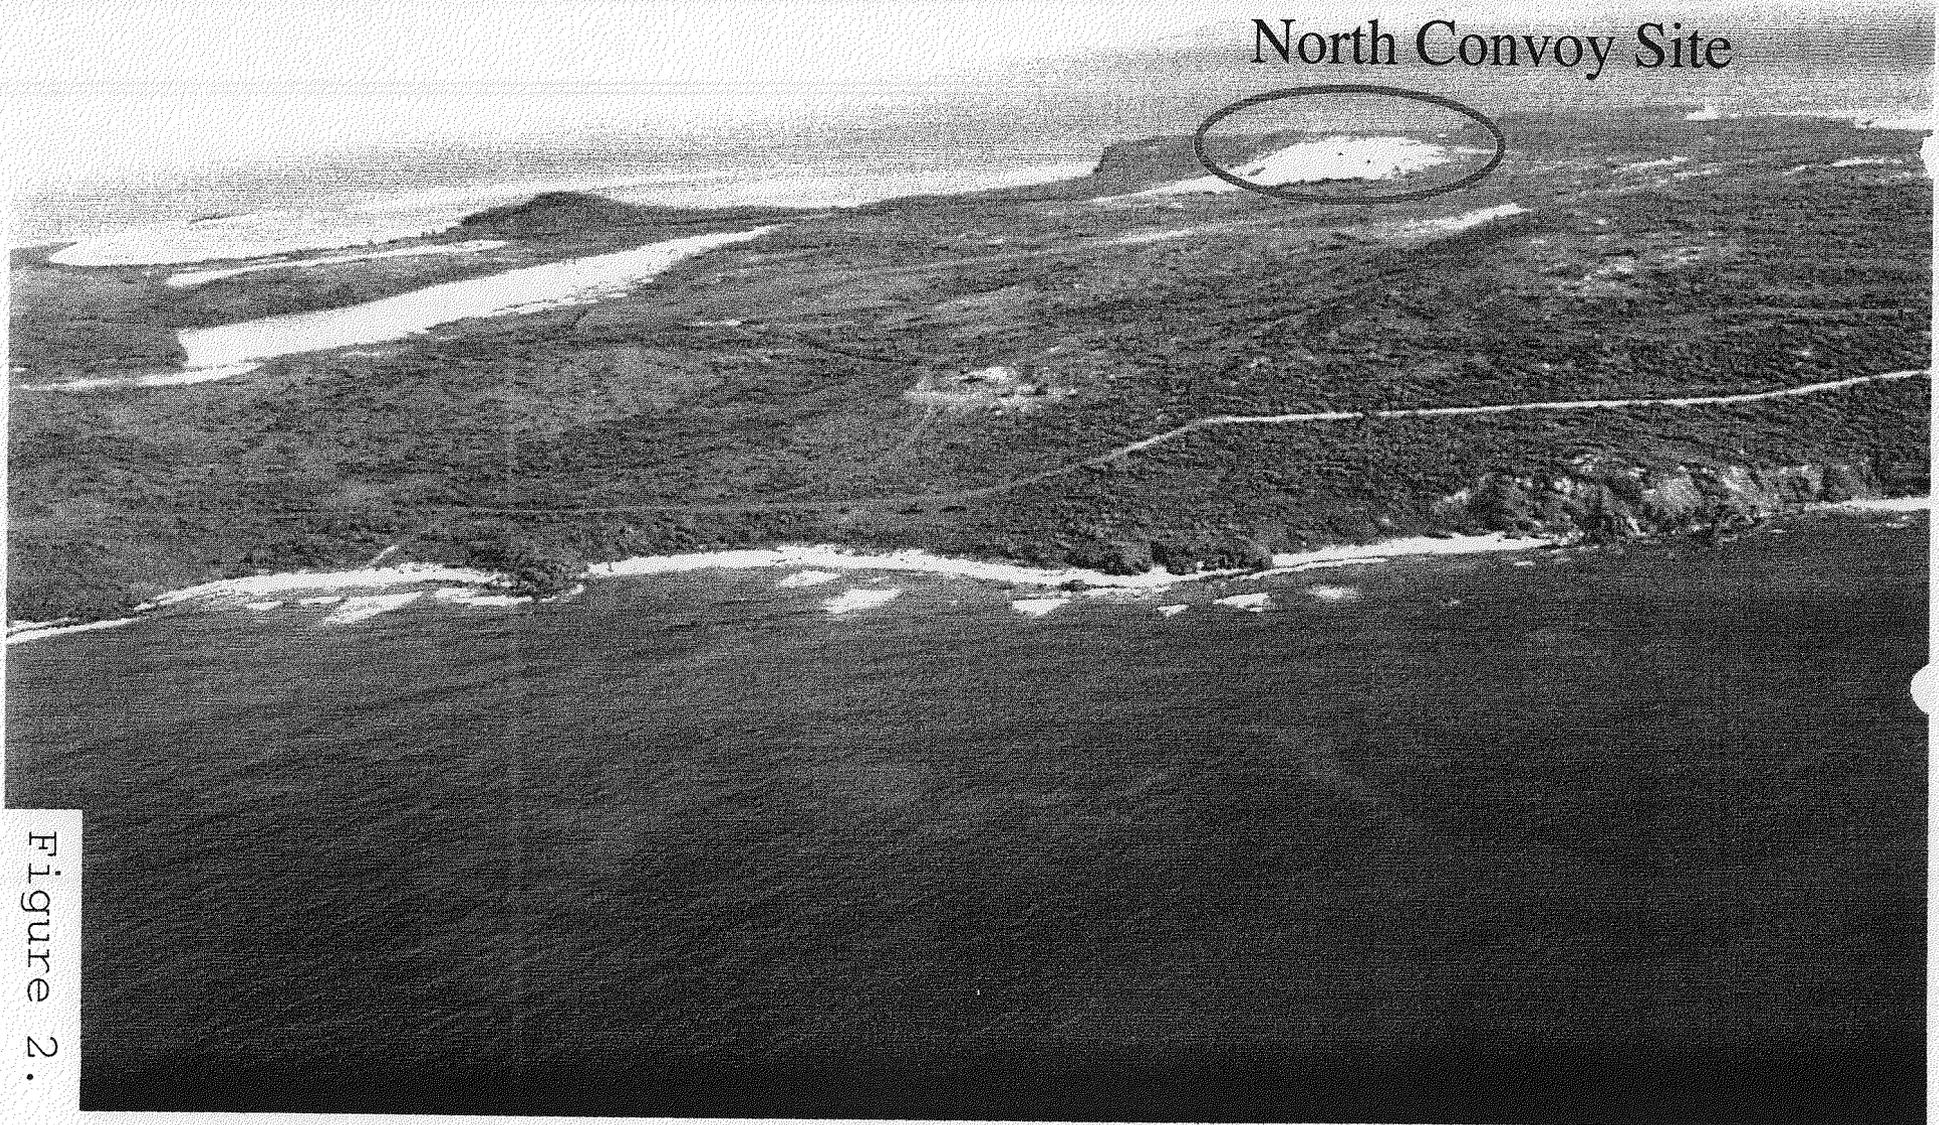
Figure 2.

On February 19, 1999, during a training exercise on the Live Impact Area of the Vieques Inner Range on the island of Vieques, Puerto Rico, two U.S. Marine Corps Harrier aircraft expended 263 depleted uranium (DU) 25mm rounds. Each 25mm round contains 148 grams of DU in the form of a pencil shaped penetrator. The Live Impact Area (LIA) is located on the eastern tip of the Island of Vieques and covers approximately 2.5 square miles (reference Figure 1). Only a few individuals are authorized access to the area and it is guarded 24 hours per day. Interviews with the Marine pilots isolated the affected area to a small portion of the LIA called the North Convoy (reference Figure 2).

North Convoy Site
