U.S. NUCLEAR REGULATORY COMMISSION
REGION IV

Inspection Report: 70-925/94-01

Licensee: Kerr-McGee Corporation
P. O. Box 25861
Oklahoma City, Oklahoma 73125

Inspection At: Cimarron Facility, Crescent, Oklahoma

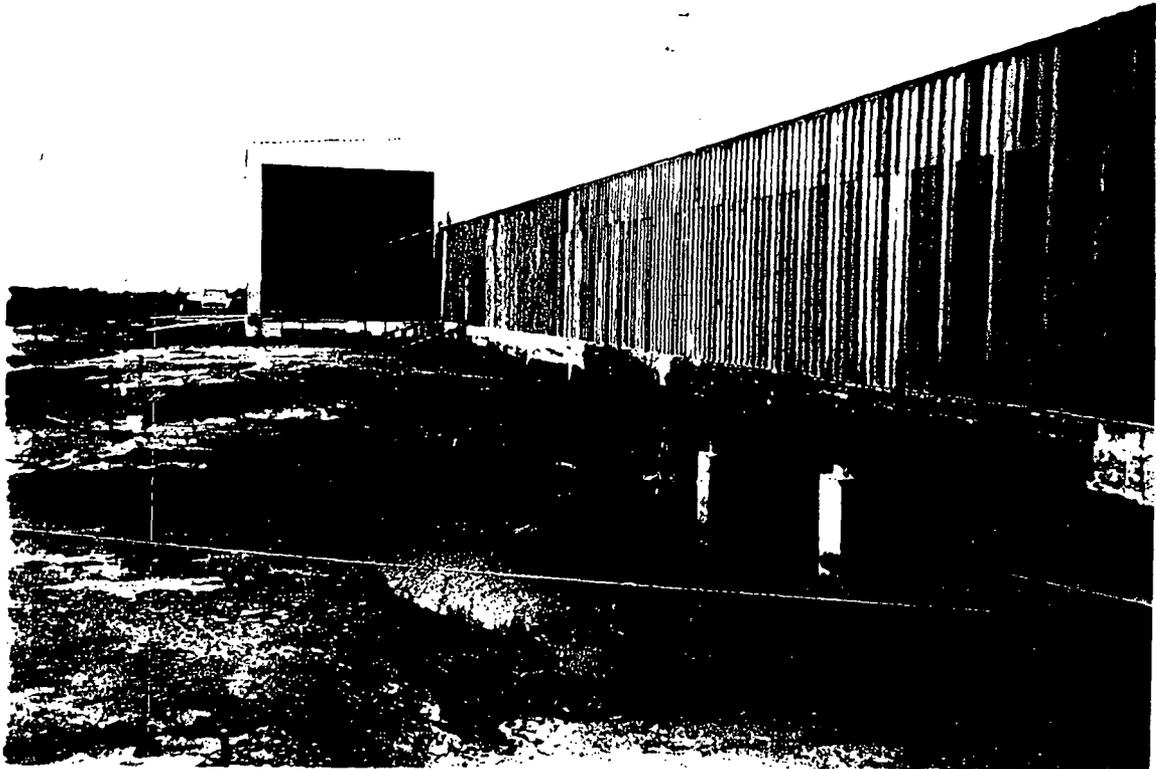
The areas of the facility that were toured included the uranium building, the yard, and the onsite soil disposal cell (also referred to by the licensee as Burial Ground No. 4). Large amounts of building material and soil had been excavated from within and around the uranium building during the remediation process. The licensee stated that the lack of soil in and around the uranium building was creating a foundation support hazard. The inspector noted that some concrete blocks had been fabricated to assist in the support of the building foundation. The licensee was waiting on NRC approval of the final survey results of the remediated area prior to moving foundation support material back into the area.

Photograph 3: Uranium Building (south end). Note excavation of soil around foundation.
