**DOMINION NUCLEAR CONNECTICUT, INC.**  
**MILLSTONE POWER STATION UNIT 2**  
**ALTERNATIVE REQUEST RR-89-67 FOR THE P40A RCP SEAL COOLER RETURN**  
**TUBING**

**ALTERNATIVE REQUEST RR-89-67 FOR THE P40A RCP SEAL COOLER RETURN  
TUBING**

**DOMINION NUCLEAR CONNECTICUT, INC.  
MILLSTONE POWER STATION UNIT 2**

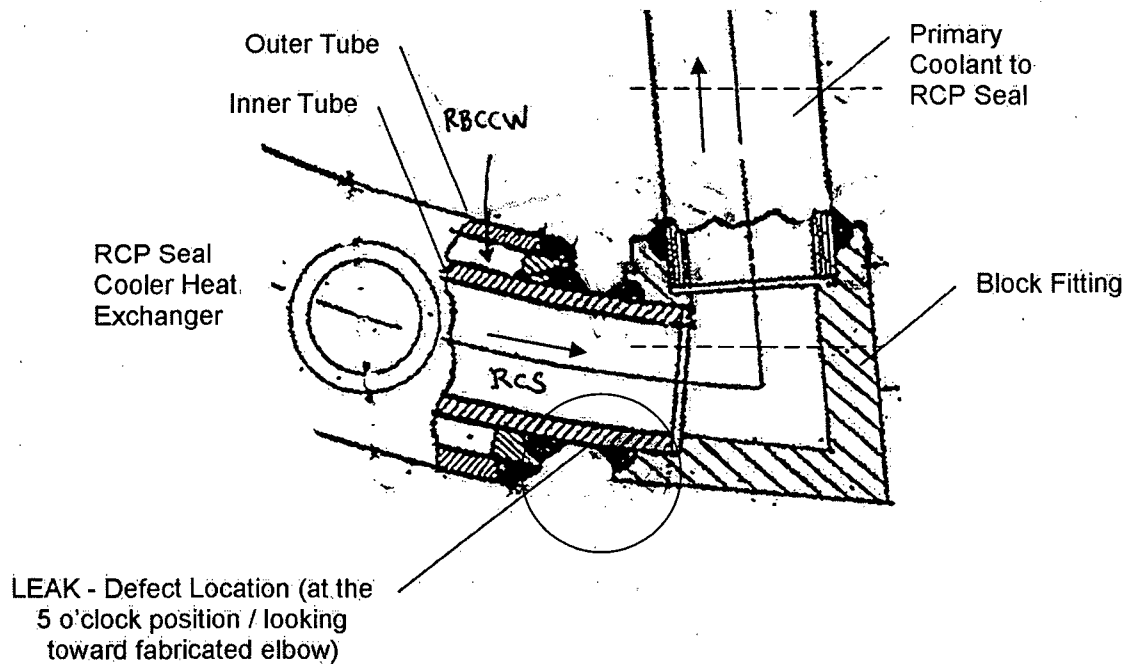
Figure 1: Sketch of Leak

Millstone Power Station Unit 2 (MPS2) - 1½ inch ASME Class 1 tubing located on the seal cooler return side of the P40A Reactor Coolant Pump (RCP) as depicted in the sketch below. Weld is now designated as RCPA-RC-95-W-4 and classified as the following:

Fabrication Process: As shown in Figure 1, the inner tube is attached to the  
block fitting with a J-groove weld reinforced with a fillet.  
Also, the inner tube is attached to a centering spacer with  
a J-groove weld reinforced with a fillet weld. The centering  
spacer is joined to the outer tube with a single bevel  
groove weld with a reinforcing fillet.

On July 13, 2009 prior to start-up from a forced shutdown with MPS2 in mode 3 (hot standby) at 0% reactor power, a Reactor Coolant System (RCS) pressure boundary leak in and around the MPS2 'A' Reactor Coolant Pump (RCP) seal cooler region was identified by a technician conducting a system walk-down at normal operating pressure/normal operating temperature (NOP/NOT). The through-wall leak was located in the weld and went through the weld and through the base metal of the tube. The failure was attributable to a weld defect from original construction.

Weld and base metal repair activities were performed in accordance with ASME Code Section XI, however, due to the close proximity of the repair area to surrounding obstructions and the component configuration, performance of a complete weld replacement was not possible. See Figure 1 and the pictures of the RCP seal cooler in Supplement 1. Because of these restrictions, the required RT was done as a best effort examination and was not in compliance with the image quality requirements of the Construction Code or the 1992 Edition of Section III that was needed to comply with requirements in Code Case N-416-3, Reference 3. Also, because of these same restrictions, an Ultrasonic Test (UT) examination, as an alternative to the RT, was not possible.

The repair area had a progressive (i.e., after each weld pass) PT performed and a best effort RT. Due to the thin wall of the tubing being repaired, the PTs were comprised of a surface examination of the defect removal cavity, the root pass, the second layer, and the final layer with a best effort RT of the final weld. The surface examinations and the best effort RT were performed in accordance with the 1992 Edition of Section III, Reference 4.
