| 8.3.2 Impact (Free-Drop) Test Report

**Test Report:  
Drop Tests of the  
Alpha Omega Services Shipping Cask  
for Radioactive Material**

**Report No. 2007533 Rev 1  
May 25, 2007**

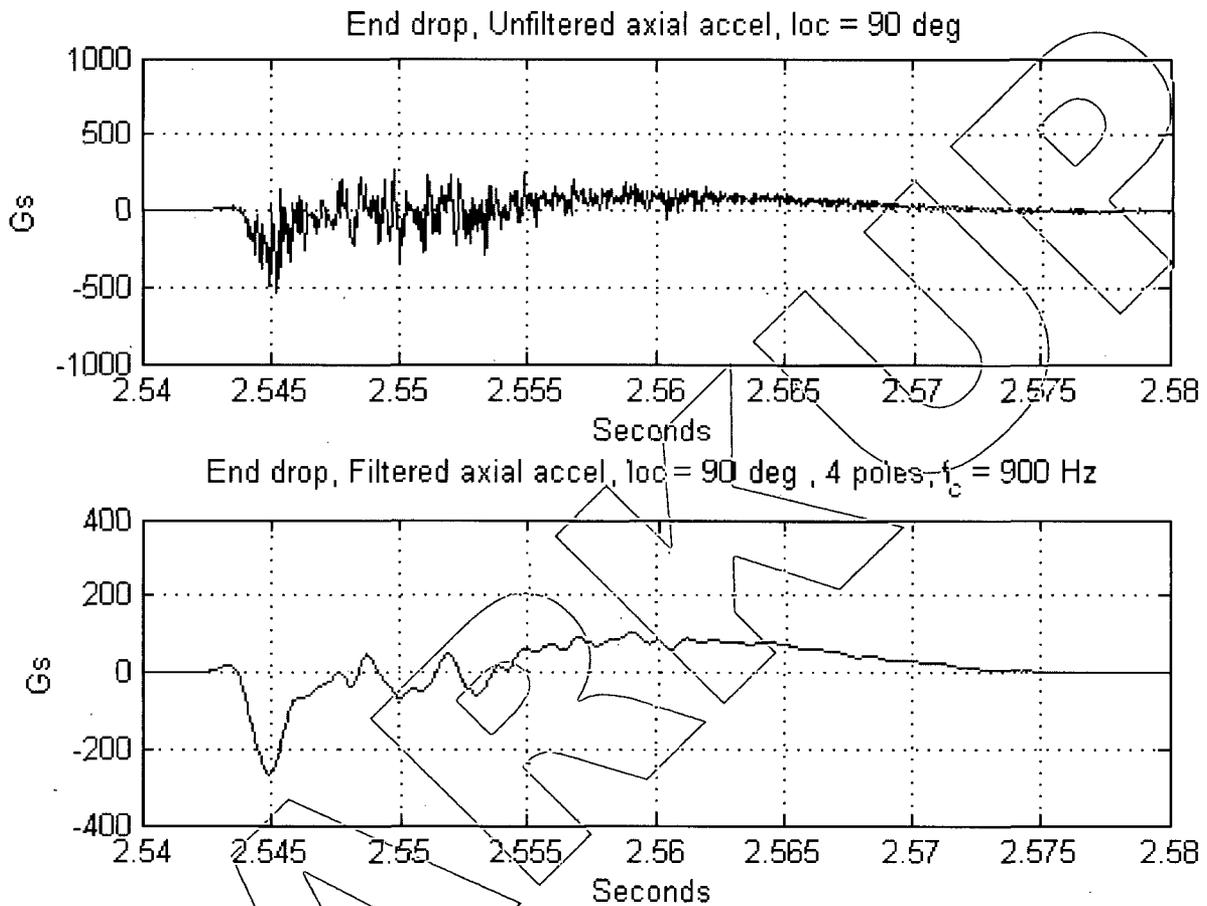
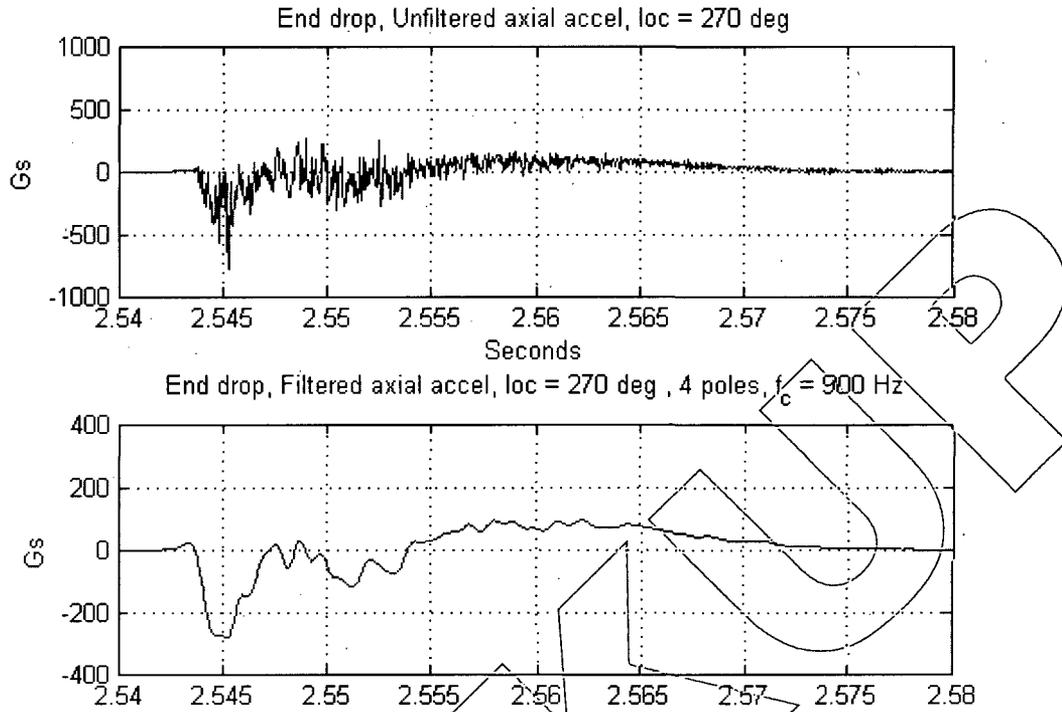
Figure 26 Signal from the axial accelerometer inside the cask on the 90-degree azimuth before (top) and after (bottom) low-pass filtering.

The vertical acceleration signals in Figure 26 and Figure 27 may seem confusing at first. It appears that the big spike in acceleration is in the downward direction. However the signals make sense when one considers the way the cask is constructed. Referring to Figure 16, the brown areas represent voids between the thick stainless steel walls of the cask. These voids are filled with heavy, tungsten “bricks” which are held in place only by steel wool packing. When the cask first strikes the hard surface, there is in fact a small pulse of upward acceleration

Figure 27 Signal from the axial accelerometer inside the cask on the 270-degree azimuth before (top) and after (bottom) low-pass filtering.

corresponding to the initial deflection of the impact limiter and compression of the steel wool packing. However a millisecond later a secondary collision occurs as the packing goes solid and the tungsten bricks strike the lid end of the cask (recall that the cask is upside down) driving it downwards into the ground. The phenomenon is similar to a car accident where the occupants don't have their seat belts buckled, except that in this case the "occupants" are the heavy tungsten bricks. The secondary collision causes the large negative spike. Following that, a much longer period of upward acceleration occurs, which corresponds to the decay in the initial downward impact velocity. The signal corresponding to this latter positive acceleration is slightly attenuated by the AC coupling of the accelerometers themselves and also by the AC coupling of the signal to the data acquisition system.

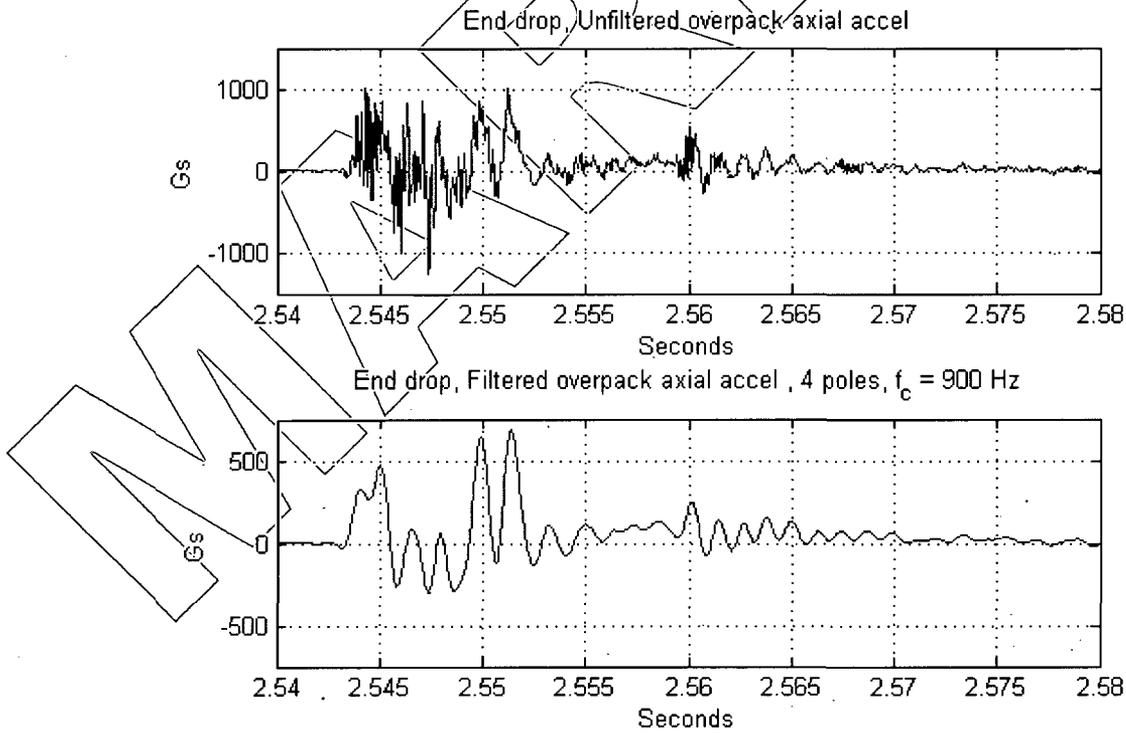
Figure 28 Signal from the axial accelerometer on the impact limiter before (top) and after (bottom) low-pass filtering.

The effect of the secondary collisions is much less pronounced in the axial acceleration measured on the impact limiter (Figure 28), probably because the surface of the impact limiter mounting the accelerometer is only loosely coupled to the cask body. At this surface, the initial pulse of acceleration is quite large and is in the upward direction as one would expect.

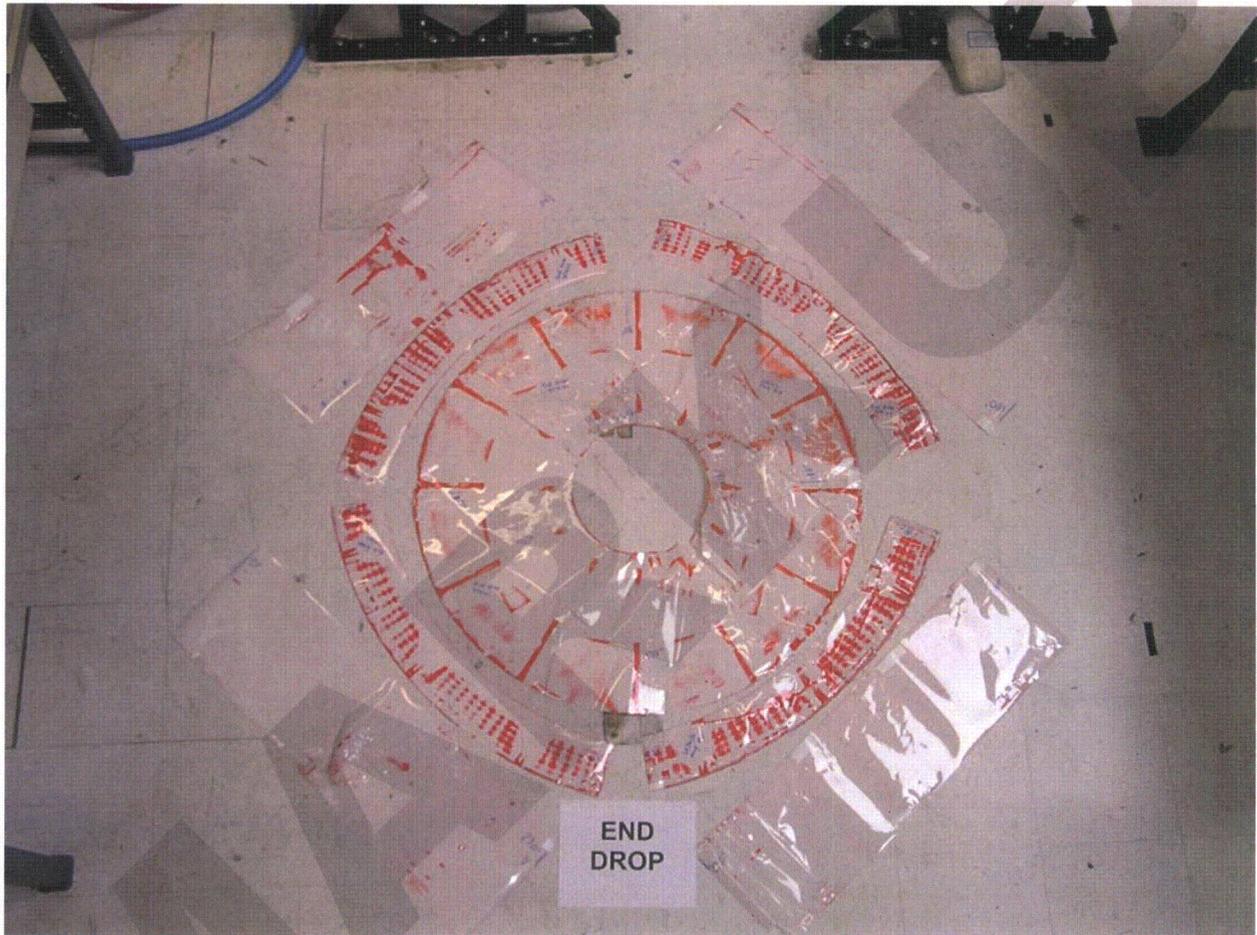
Figure 30 Pressure sensing film removed from the cask after the end drop.

Figure 30 shows the pressure sensing film from the end drop. The band of film that was taped to the cylindrical surface of the cask (Figure 19) has been cut into four equal pieces which are placed in their respective azimuthal locations in Figure 30. In Figure 30 and in the similar photographs from the side and slap-down drops, the surface of the film which faced away from the cask is towards the camera.

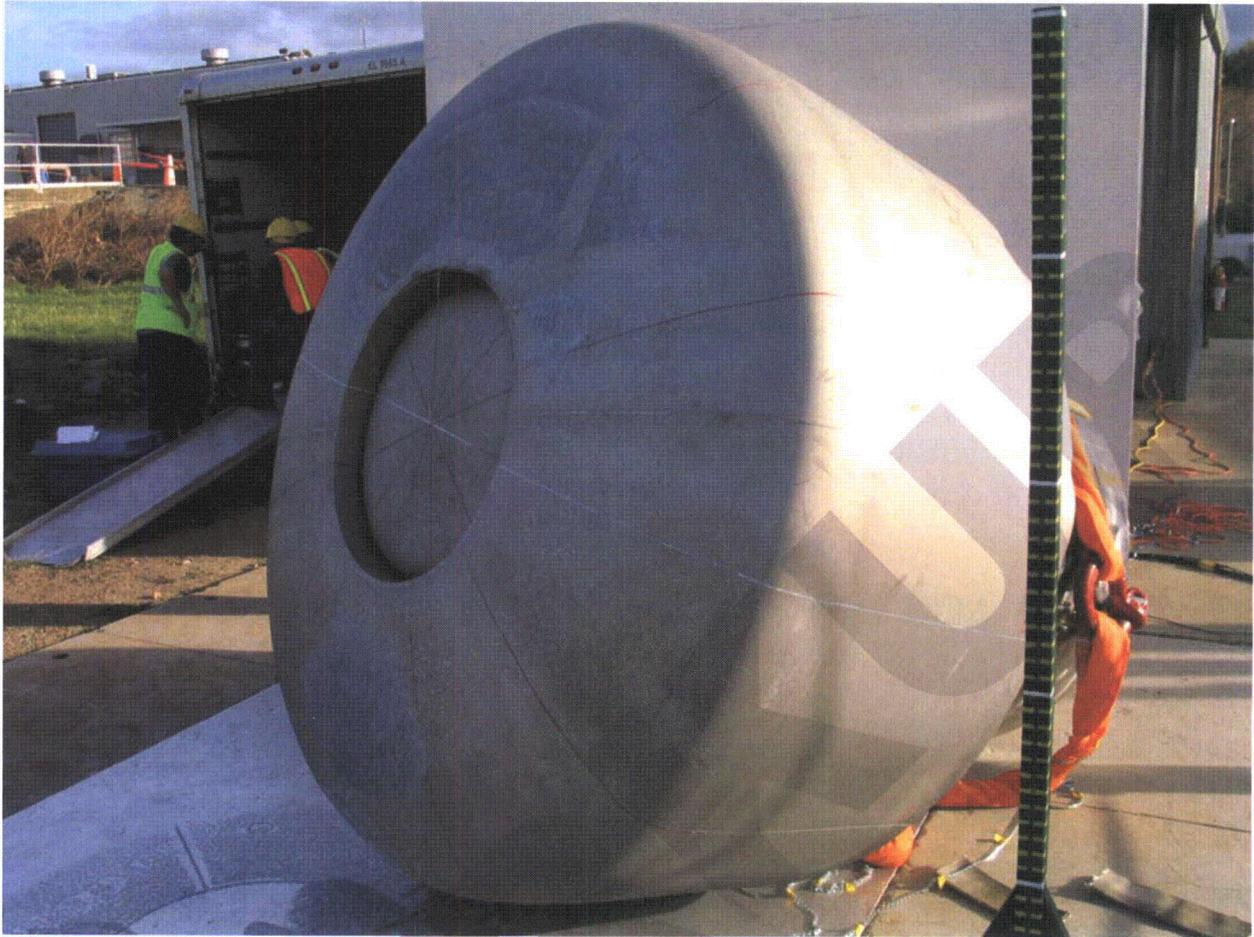
Figure 32 Cask and impact limiter immediately following the end drop.

Figure 32 shows the impact end of the impact limiter after the end drop. The previously flat surface in the large center relief on the end of the impact limiter has been bulged out over four inches by the force from the cask transmitted through the foam. The weld around the edge of the relief has split over a small part of the circumference.

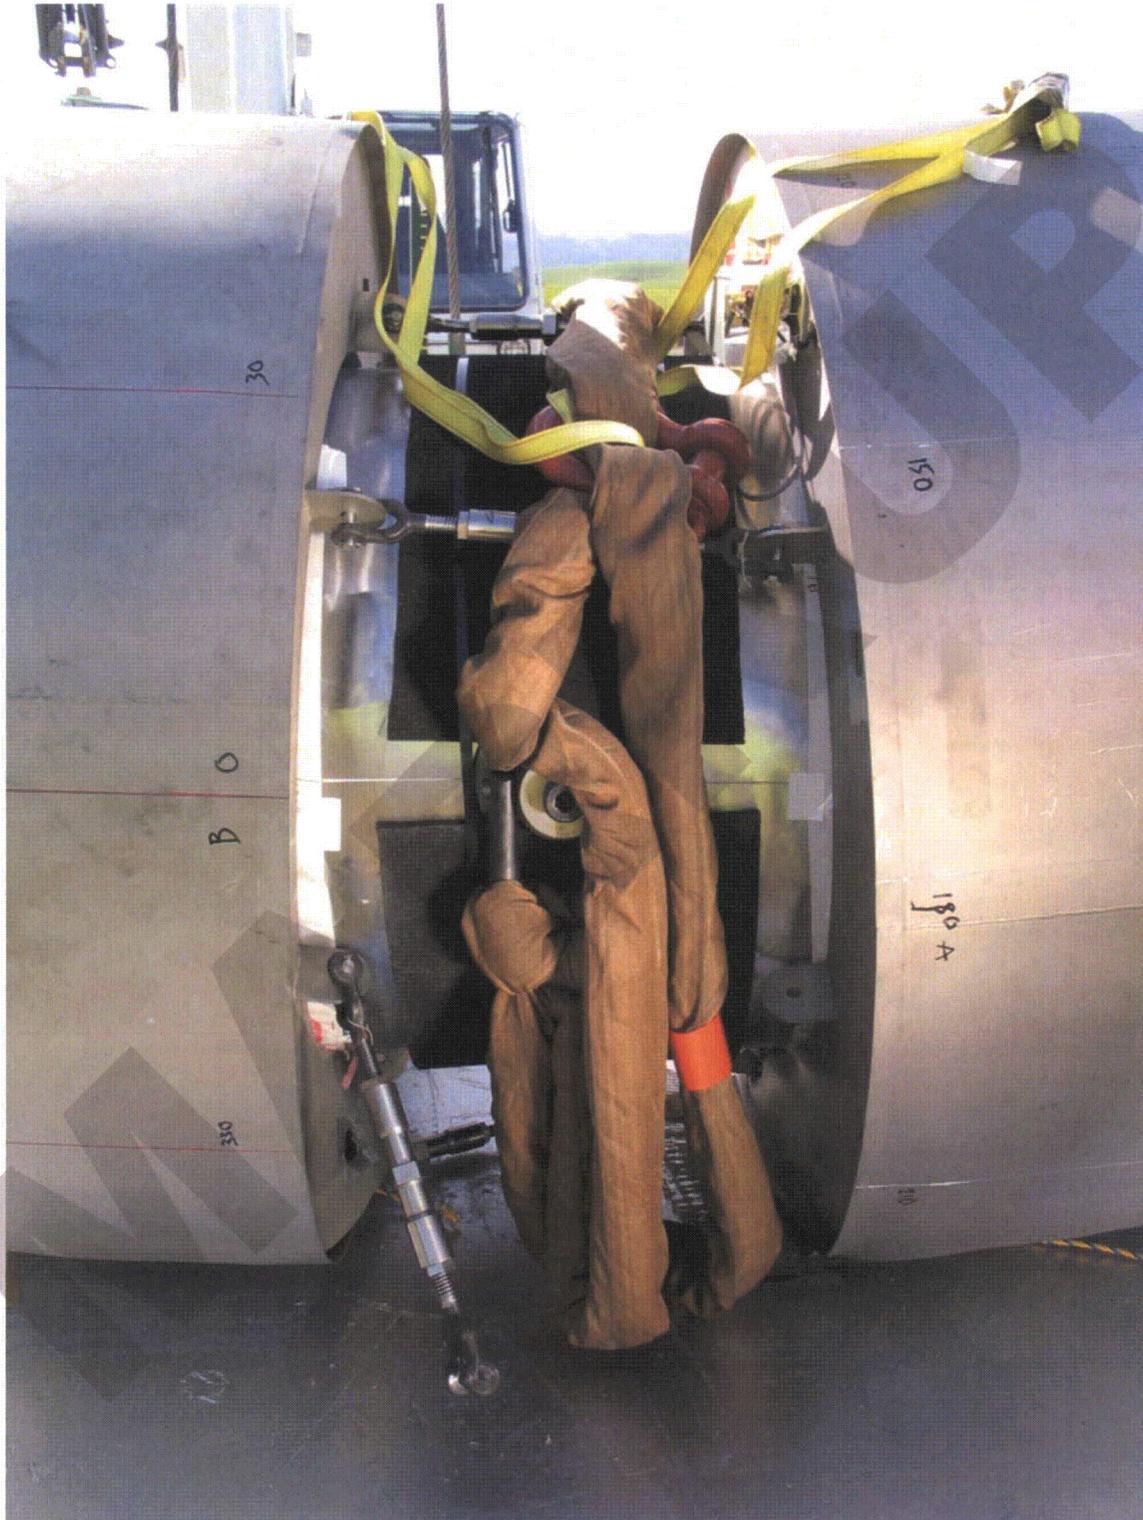
Figure 38 Cask and impact limiters following the side drop.

Figure 38 shows the cask with impact limiters after the drop. Three of the six heavy steel turnbuckles holding the impact limiters against the cask failed when their clevis pins sheared. This allowed the lower parts of the two impact limiters to move away from each other. This may have caused another secondary impact effect when the impact limiters rotated outwards as far as they could and jammed against the cask outer diameter, thus suddenly stopping the descent of the heavy cask.

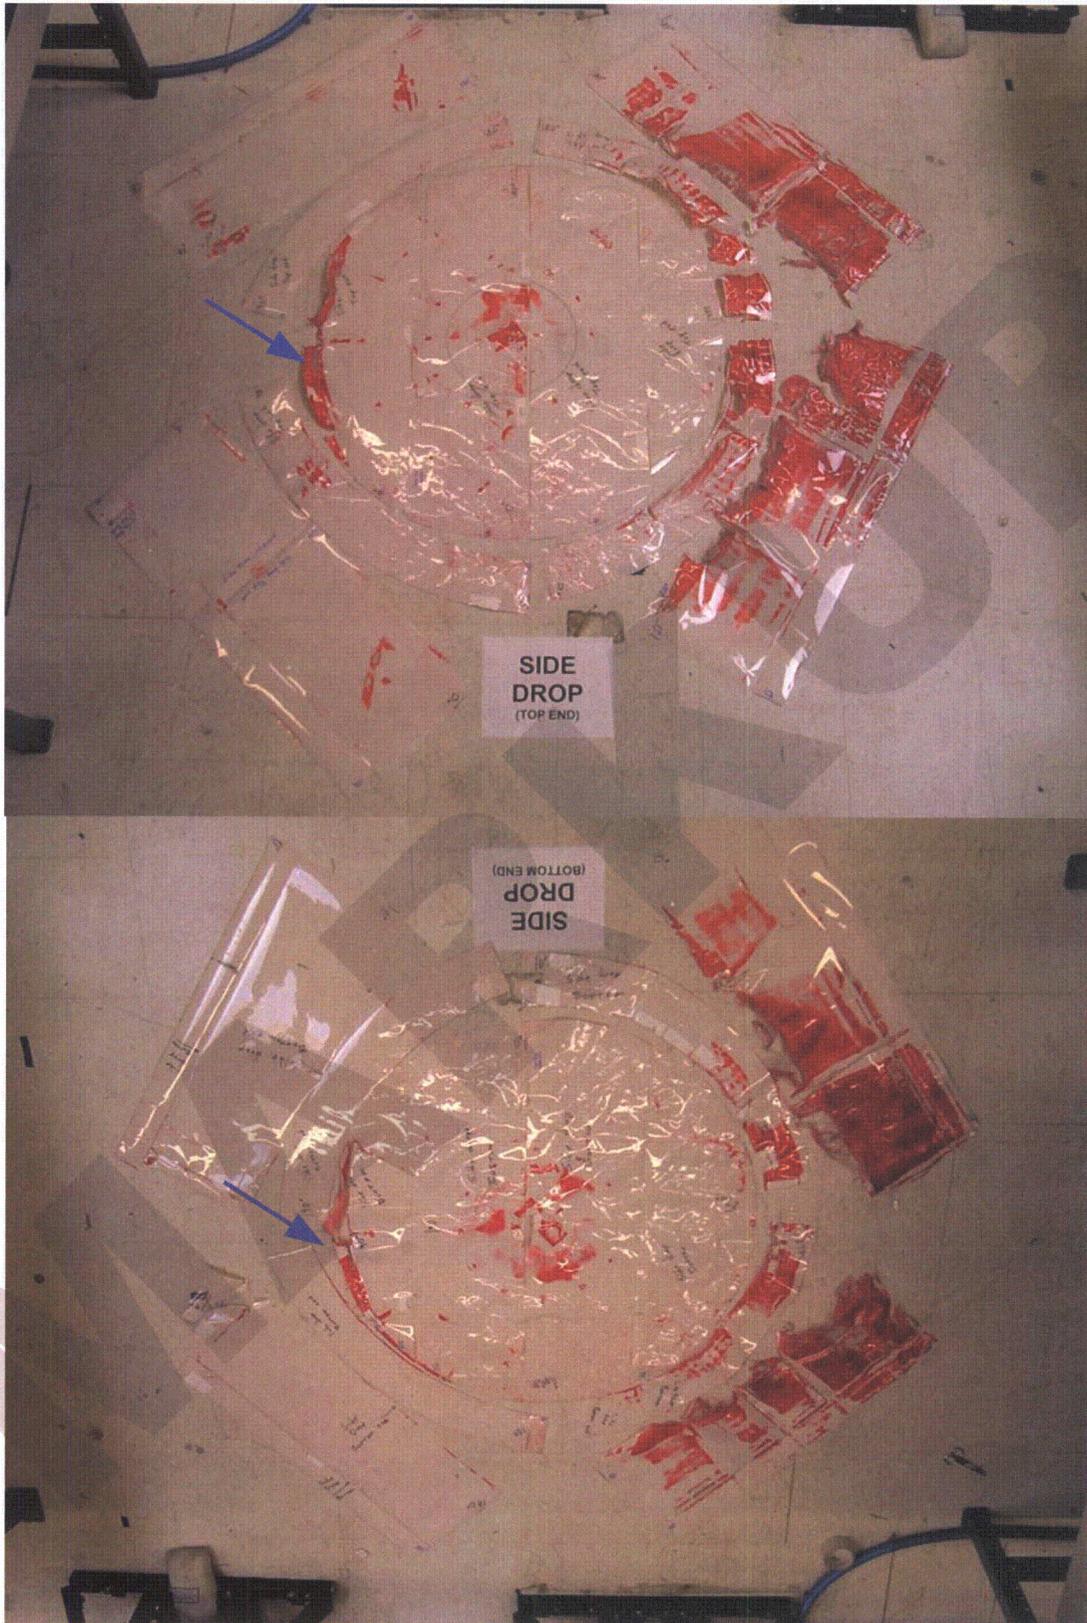
Figure 40 Pressure sensing film removed from the cask after the side drop.

downward facing part of the conical surface, as would be expected. However, there is also a significant amount of red on the paper that was on the uppermost part of the flat, circular end surfaces of the cask (blue arrows in the figure). Pressure against these areas is further evidence of secondary impact after the turnbuckles failed, the impact limiters rotated outwards, and their lower parts moved away from each other.

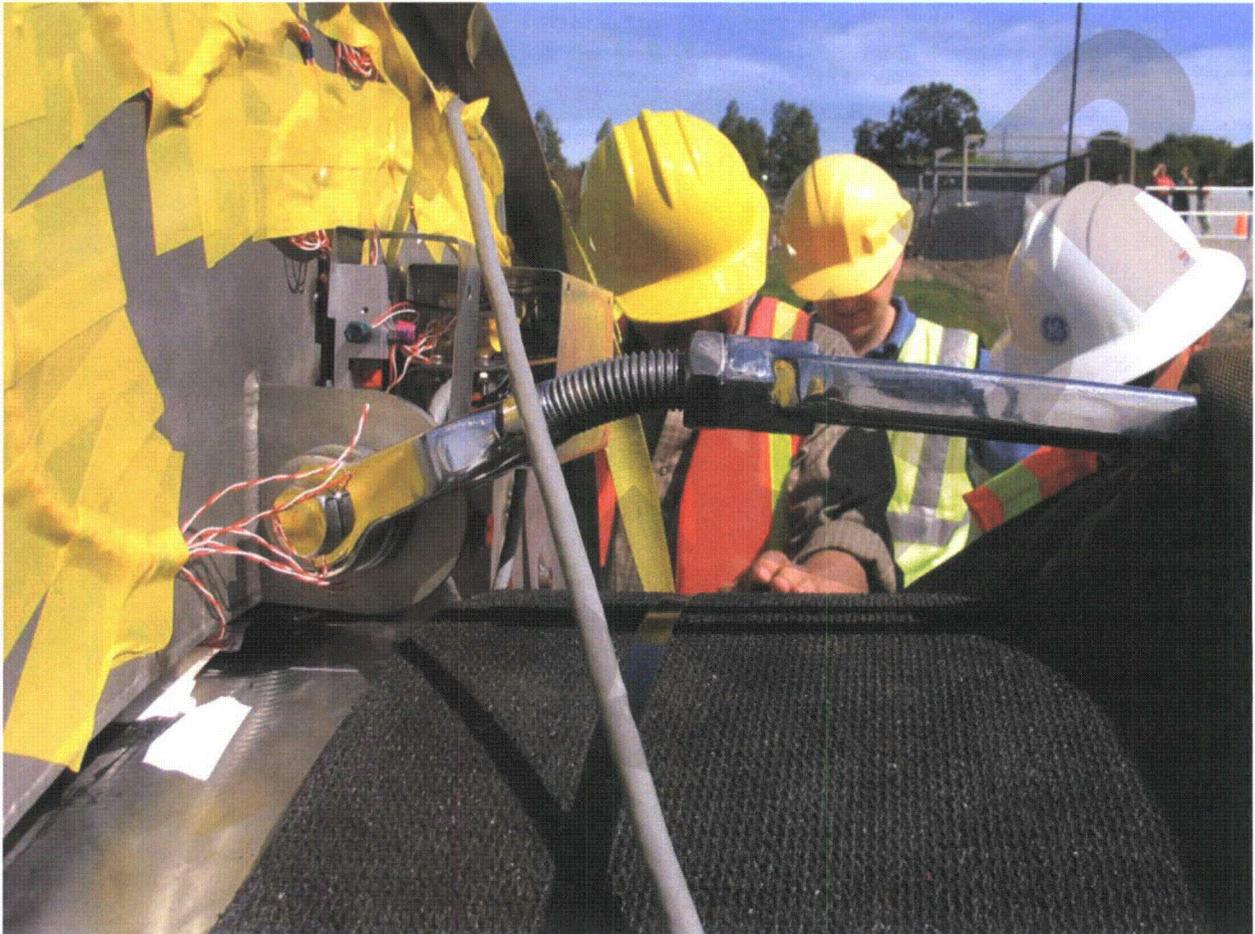
Figure 50 Uppermost turnbuckle after the slap-down drop.

drop used heavier clevis pins which did not break on impact. However the upper turnbuckles buckled which caused them to become shorter so there was still considerable relative rotation between the two impact limiters, as evident in the video frames. Figure 50 shows the uppermost turnbuckle following the drop.
