SUBJECT: INSPECTION REPORT NO. 70-1257/2009-202 AND NOTICE OF VIOLATION

Report No.: 70-1257/ 2009-202

Licensee: AREVA NP, Inc.

**AREVA Nuclear Power, Inc.
U.S. Nuclear Regulatory Commission
Inspection Report No. 70-1257/ 2009-202**

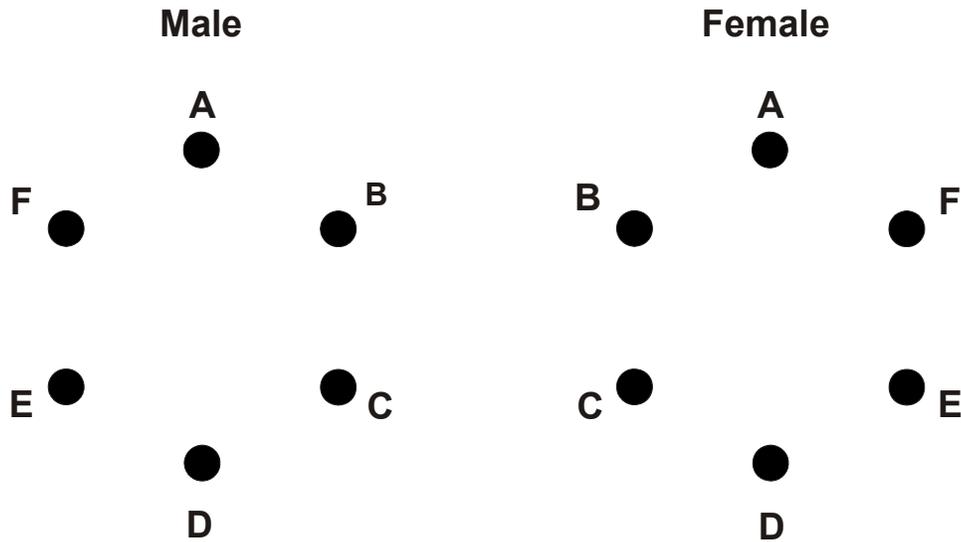
Figure 1
Six-Pin Connector Configuration

The inspectors reviewed a recent event at the facility which resulted from incorrect wiring of the criticality alarm system detector signal cables. During a recent source check of the criticality alarm system, the licensee discovered that the signal from two of three detectors in one of nine detector locations in the facility were non-functional. The licensee determined that the two malfunctioning detectors were not passing the alarm signal to the comparator for that location. Each detector had two three-wire cables, a power cable and a signal cable. To avoid confusing these cables, the licensee used a three-pin connectors for the power cables and six-pin connectors for the signal cable. The six-pin connector had mirror image male/female ends as shown in **Figure 1**. The licensee set up the six-pin signal cable with three wires and performed a continuity check before placing the cable in operation. The licensee determined that the two malfunctioning cables had been wired incorrectly and the continuity check was also performed incorrectly. As a result of the mis-wiring, the detectors could not pass either an alarm or a fault signal so that the entire three-detector unit was rendered inoperable. The inspectors reviewed criticality accident alarm system placement calculations to determine how coverage of the facility was affected. Final conclusions regarding the event, which was reported to the NRC as EN 45310, will be discussed in a Region II inspection report 70-1257/2009-006.

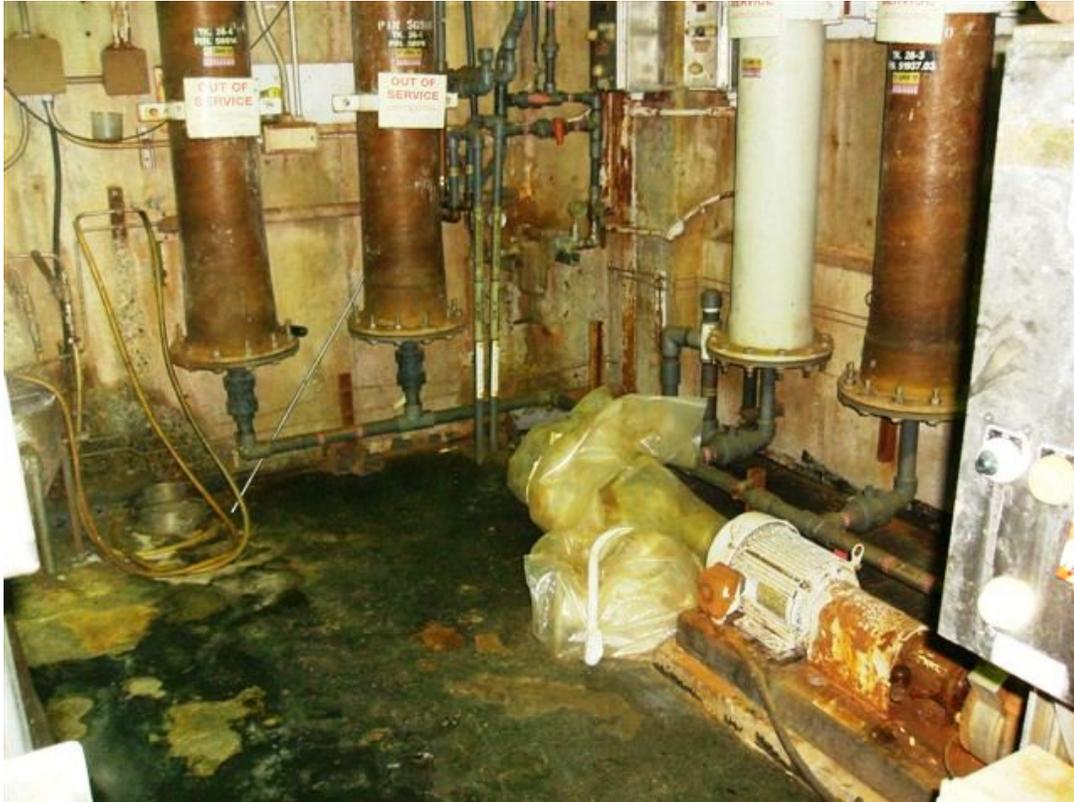
Contrary to the above, on and before June 24, 2008, the licensee failed to exclude unfavorable geometry containers from Room 102A. Specifically, two plastic bags with a volume greater than 5.5 gallons were found in the room in the open position.

The inspectors performed walkdowns of DCF, the Line #2 ADU conversion area, the UO₂ Building including scrap recovery processes, the BLEU facility, the BLEU powder storage area, and outside powder storage warehouses. During the plant walkdowns, the inspectors entered the UNH tank gallery, Room 102A. In Room 102A, the inspectors observed two large plastic trash bags filled with pump parts. The plastic bags are shown in **Figures 2 and 3**.

Figure 2
View Showing Bag Location in Room 102A

The licensee investigated and determined that the bags had been placed in the room by operators to allow a dismantled pump to decay briefly before being removed from the contaminated area. The licensee noted that the presence of the bags in Room 102A was an NCS infraction. The inspectors noted that posting NCSP-G01-007 prohibiting unfavorable geometry containers in Room 102A is a procedural requirement intended to implement IROFS 3503 in that area. The presence of open and unattended plastic bags larger than 5.5 gallons in Room 102A is **Violation (VIO) 70-1257/2009-202-02**.

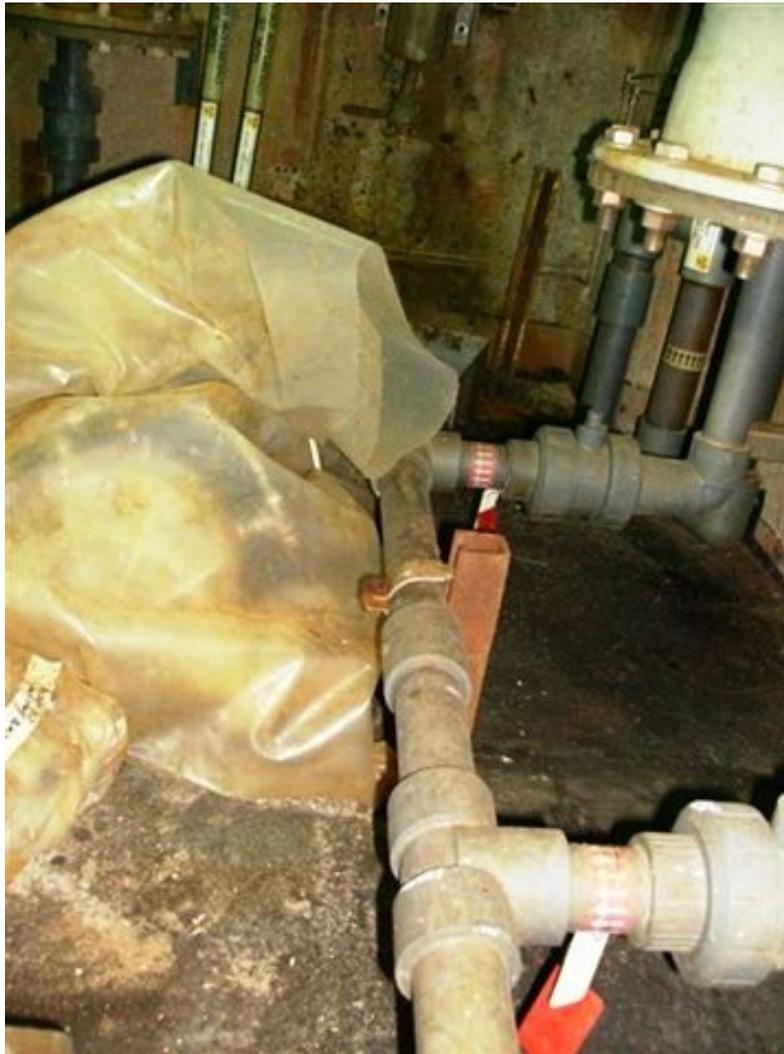
The inspectors noted that the door to Room 102A contained a criticality safety posting stating that “unfavorable geometry containers are not allowed in this room/area.” The inspectors reviewed the licensee glossary of terms and determined that the licensee had defined unfavorable geometry items as those that would retain fissile material that exceeds the following: a 3.6-inch depth, a 5.5-gallon volume, or a 7.7-inch diameter. The inspectors also noted that the licensee had defined an open container as any items which could hold liquid in the event of an accident or process upset. An example of an open container is described as “Plastic bag left in the open position.”

Figure 3
Close View Showing Openings and Proximity to Piping
