**MISSOURI
BASIN
POWER
PROJECT**

LARAMIE RIVER STATION

Basin Electric Power Cooperative
Laramie River Station
Unit 3 Feeder Deck Incident Report
NRC License #33-18224-01
David Cummings, RSO

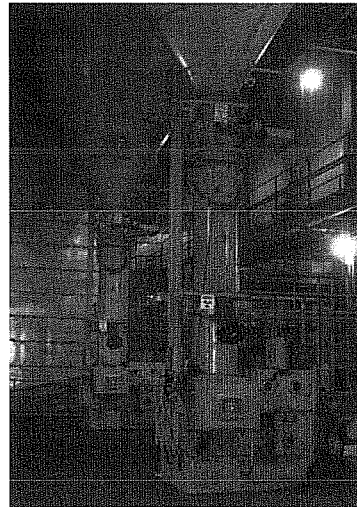
Figure 1. Typical SeCoal Assembly

SeCoal level controls are used to measure the flow of coal from storage bunkers located above the feeder deck to the pulverizers which reduce the size of the coal particles in preparation for their injection into the boiler. The SeCoal consists of two gauges, one mounted near the top and one near the bottom of the feeder chute (Figure 1). They are mounted on a common operational arm, which allows the gauge to be rotated up to 90 degrees from the operational position for two purposes: operators move the arm for local control of the feed, and instrument technicians for the purpose of instrument calibration and maintenance. The lower gauge is located approximately 10 feet above the floor, and the upper gauge about 20 feet above the floor. The SeCoal assembly was installed as a part of the original plant design in the late 1970's. The gauges were replaced in the early 1990's, with an original source of 50 mCi Cs137.

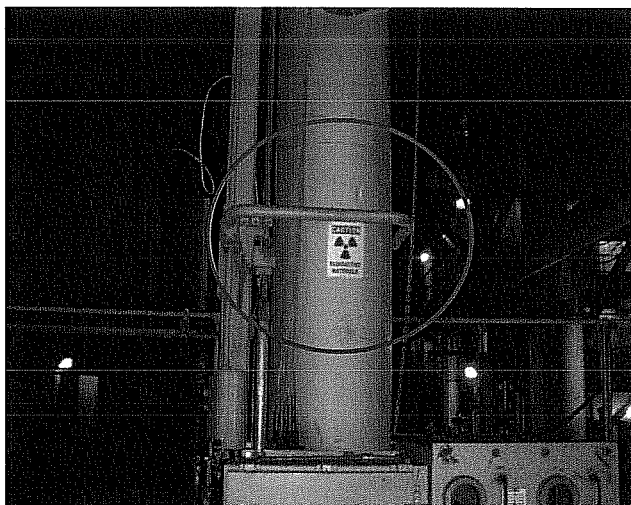
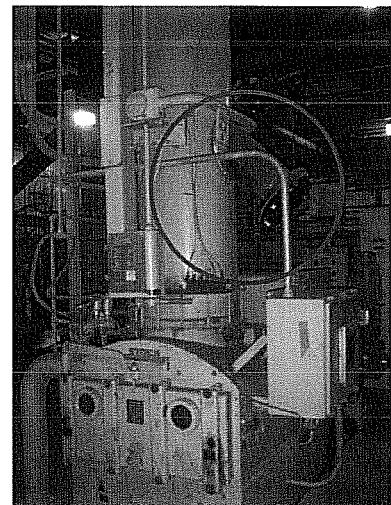
This work was ongoing from the beginning of September, and was nearly completed on September 18 when I became aware of the incident. The possibility of employees doing work in a position of exposure was observed by a Laboratory person, who stopped the work and made the proper notifications. Typically work done on and around the pulverizers is done with the SeCoal in the operational position, where the beam remains inside the chute and does not pose the risk of exposure to employees (Figure 2).

Figure 2. Lower SeCoal Assembly In Operational Position, Showing the area of the chute modification circled in RED, before and after modification. The gauge beam in this configuration is internal to the chute and this is the configuration in which work has been typically performed.
