License No. SUB-1452
Docket No. 040-08866
MLER-RI-89 -132

Licensee NUCLEAR METALS, INC.
Event Description damage to waste shipment
Event Date 5-25-89 *Report Date 8-1-89

We have completed our investigation of the incident involving our L.L.W. Shipment No. 0589-269. A copy of the report of investigation is enclosed and is also being forwarded to NRC Region II.

REPORT OF INVESTIGATION

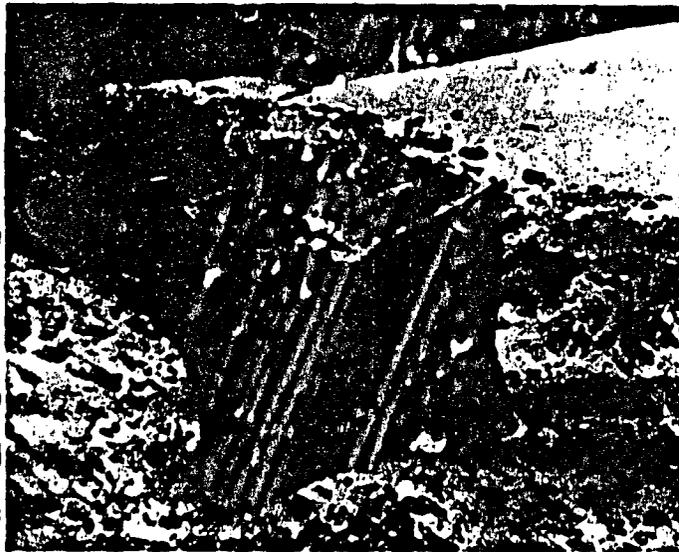
Photo 2: "F-54" box after exhumation on 31 May 1989.

Oxidation of uranium requires the presence of either atmospheric oxygen (air) or water. When it is supported by water, the oxygen from water molecules combines with uranium atoms, liberating hydrogen gas. Because of the high density of compacted uranium scrap, insufficient oxygen is available in entrained air to sustain combustion, and the compacted uranium scrap exhibits the same stability as a solid, massive piece of DU metal. This is due to the small interstitial or pore volume, the low density of air, and the fact that air is only 21% oxygen (by volume) at atmospheric pressure. On the other hand, if moisture were entrained in the same small void volume, about 3,500 times as much oxygen would be present. We conclude that the reaction observed involving Shipment No. 0589-269 resulted primarily from the briquetting of insufficiently dried turnings, which allowed the entrainment of moisture in one or more of the compacted scrap billets. Once the reaction got started, it was retarded by the lack of oxygen (which prevented a fire situation) but generated enough heat to propagate itself throughout the box and to adjacent boxes.

The primary cause of this incident is concluded to be moisture entrained in the pore structure of the compacted scrap billets.

A number of potential corrective actions are being explored at this time. On 22 June the D.U. scrap briquetting and compacting line was reviewed by Dr. Wolfgang Pietsch of CompactConsult, Inc., and additional recommendations were obtained. Measures now under consideration include: use of wider grate openings in the ring mill and a larger sieve mesh in the vibrating sifter to increase chip size and improve separation of smaller particles (lower unit surface area), replacement of the solvent degreaser with a centrifugal chip wringer to insure drier feed to the briquetting press, use of sodium silicate and hydrated lime as a binder in briquettes to enhance stability by forming water insoluble bonds between chips and filling briquette pore spaces (thereby excluding water from entrainment), and improvements to quality control procedures (e.g. moisture control, monitoring of feedstock, and periodic formal process reviews). The systematic evaluation of these alternatives will involve new equipment testing (and possibly acquisition) and may require significant reconfiguration of the processing line. As a result, the adoption of final corrective actions is not expected to be completed for eight to ten weeks. They will be reported separately at that time.
