INTERIM REPORT ON THERMOSTATIC VALVE FAILURE ON PALO VERDE EDG

Report No. 10CFR21-0098-INT
Rev. 0: 10/23/09

**INTERIM REPORT
10CFR21 REPORTING OF DEFECTS
AND NON-COMPLIANCE**

COMPONENT: Amot thermostatic valve element
P/N: 9760X

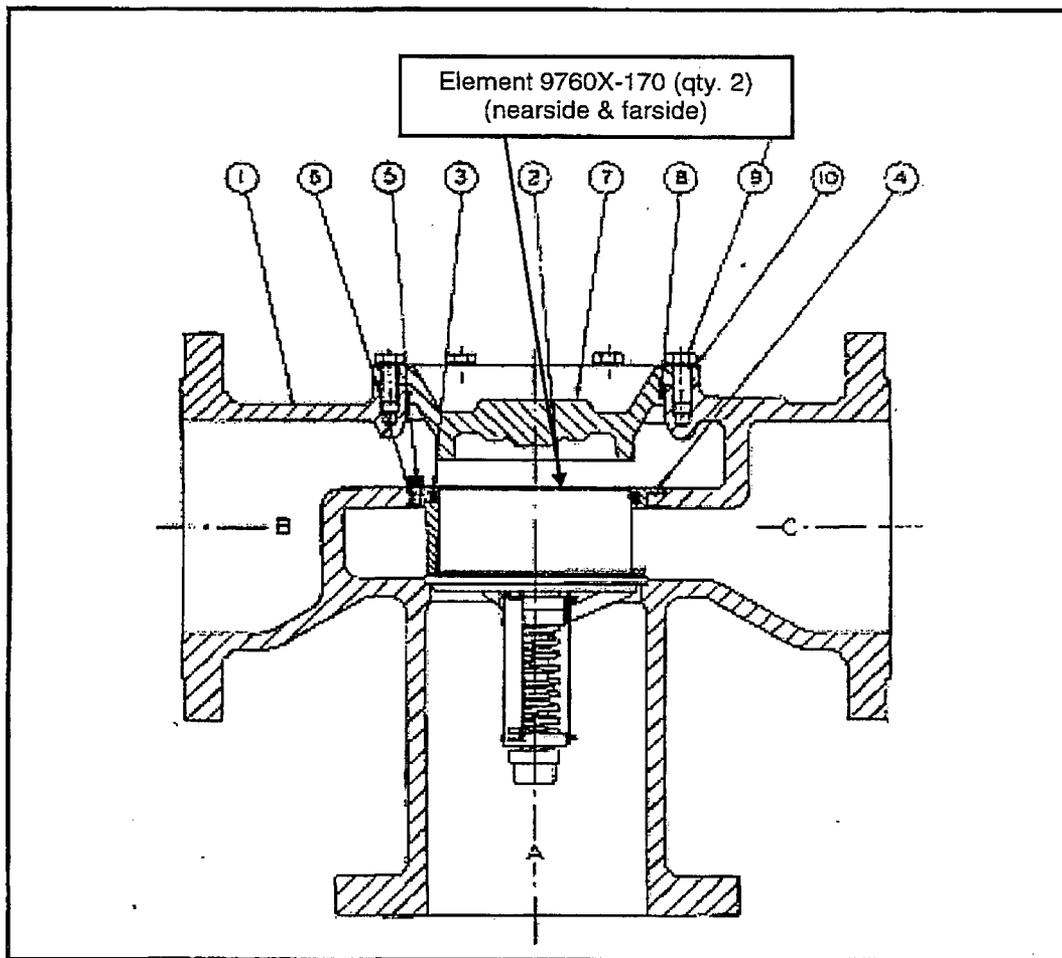
FIGURE 1: AMOT THERMOSTATIC VALVE

The Cooper Bessemer KSV-20T diesel engine uses one 6" thermostatic valve in the engine jacket water system and one in the engine lube oil system to regulate system temperatures during engine operation. The thermostatic valve is an Amot model 6HAS. Each valve uses 2 thermostatic elements, Amot type 9760X (Figure 1). The element being investigated for the Palo Verde application have a nominal temperature setting of 170°F and therefore the element part number is 9760X-170.

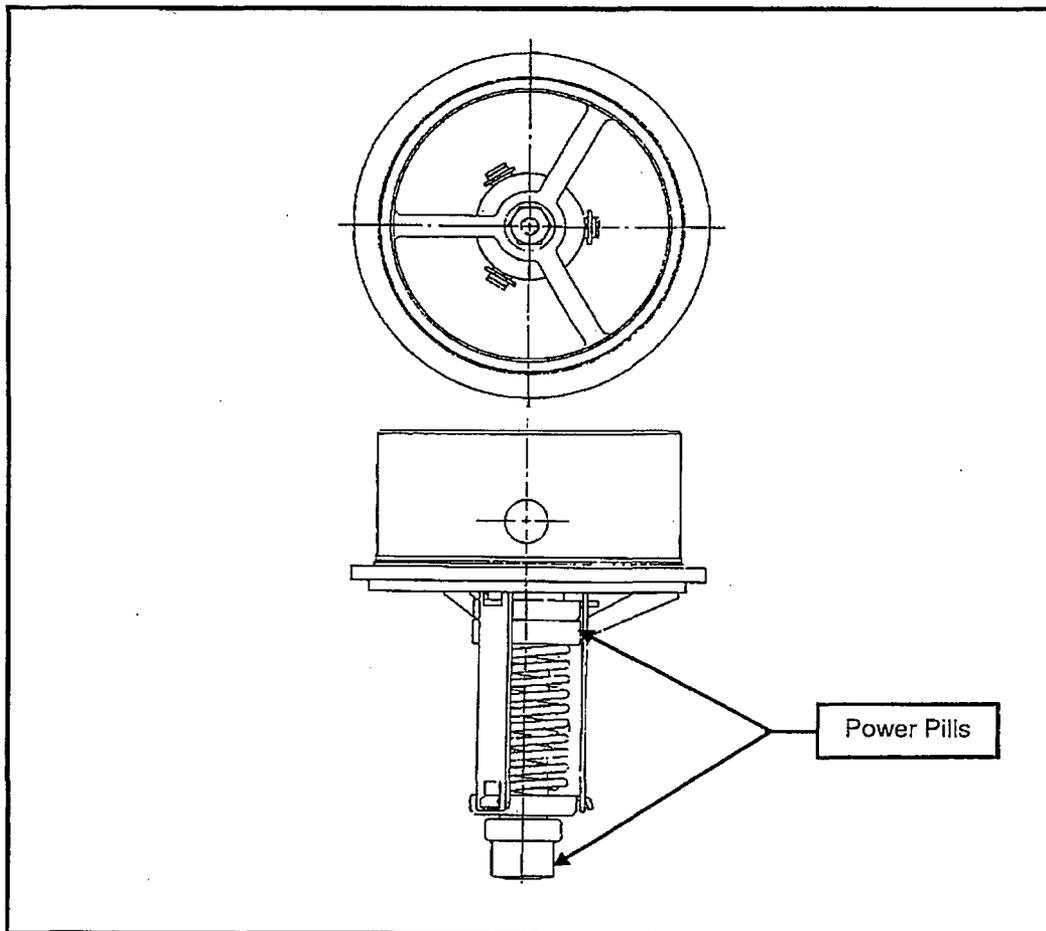
FIGURE 2 – VALVE ELEMENT 9760X

Each 9760X valve element contains two power pills (Figure 2). The power pills contain a temperature sensitive wax that expands with increasing temperature and provides the motive force to lift the element off of its seat.

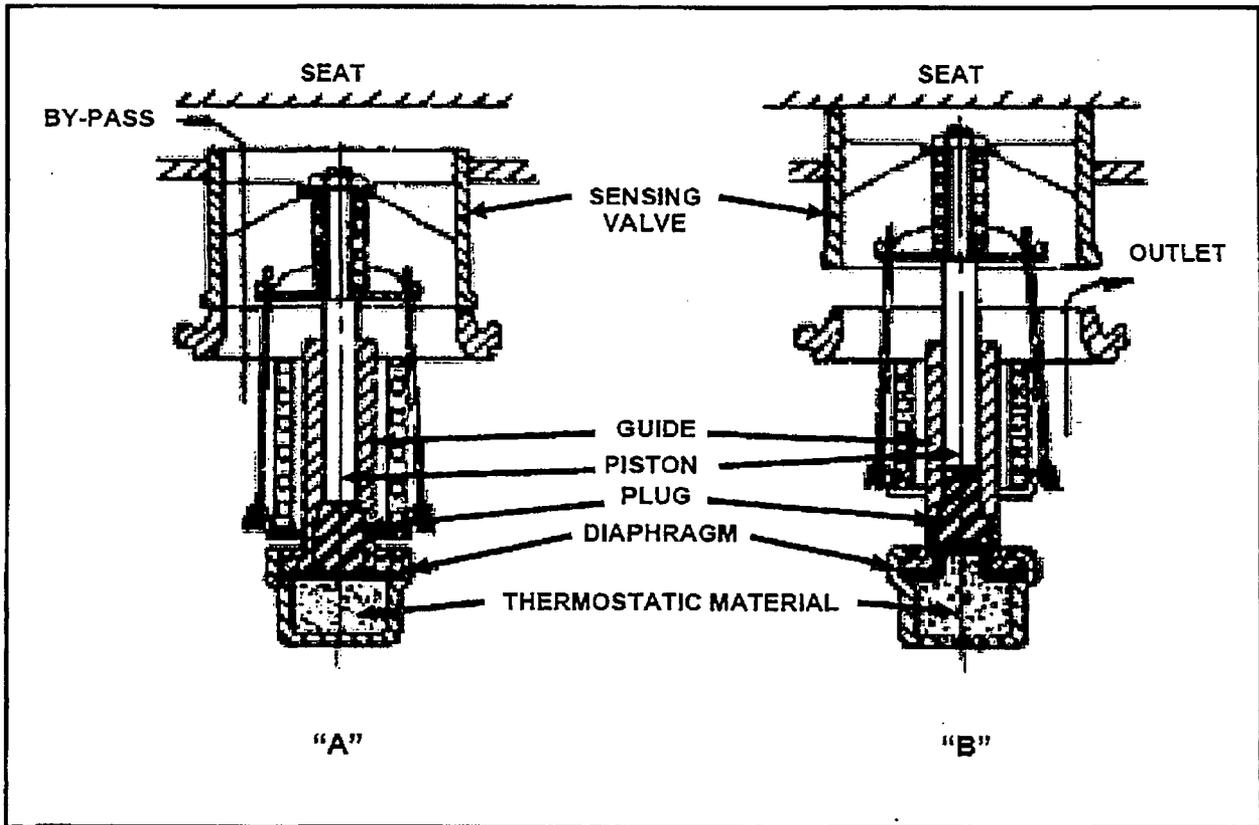
FIGURE 3 – ELEMENT OPERATION

Fig. 3 "A" shows an element assembly with the sliding valve in the cold position (the element shown only has one power pill, but the operating principal is the same as the two pill element). The fluid travels out the by-pass (Port B on the valve) as shown by the arrow.

Fig. 3 "B" shows the sliding valve moved up to the extended or warm position. The by-pass closes off as the sliding valve seats and the fluid is diverted to the outlet (Port C on the valve) as shown by the arrow. In actual operation, the sliding valve is normally in about the mid-position. When the wax material expands with rising temperature, the rubber plug is forced into a reduced diameter in the piston guide, which multiplies the movement of the piston by an extruding action.
