Subject: 10CFR21 Reporting of Defects and Non-Compliance -  
Engine Systems, Inc. Interim Report No. 10CFR21-0098-INT, Rev. 0

Amot Thermostatic Valve Element  
P/N: 9760X

**Report No. 10CFR21-0098-INT**

**INTERIM REPORT  
10CFR21 REPORTING OF DEFECTS  
AND NON-COMPLIANCE**

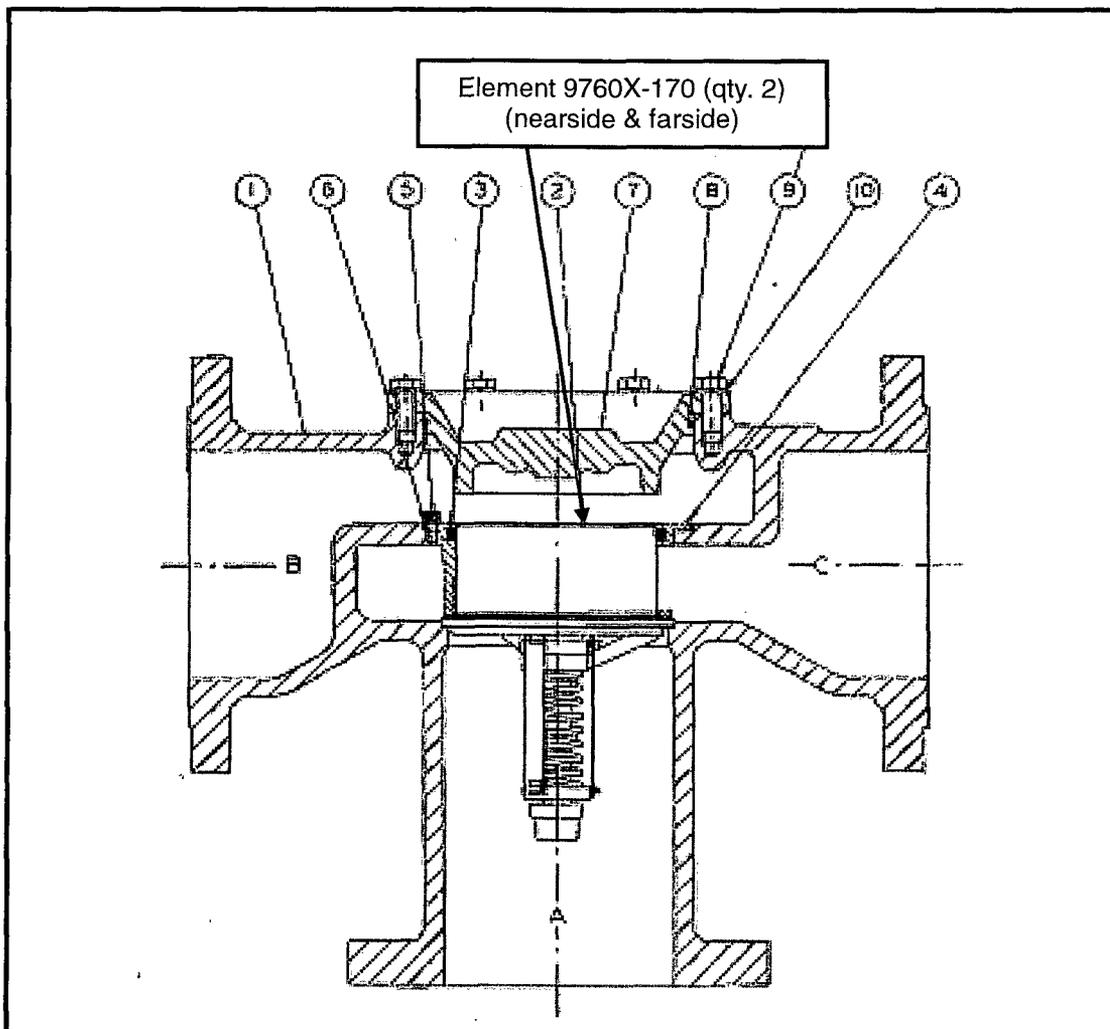
**FIGURE 1: AMOT THERMOSTATIC VALVE**

The Cooper Bessemer KSV-20T diesel engine uses one 6" thermostatic valve in the engine jacket water system and one in the engine lube oil system to regulate system temperatures during engine operation. The thermostatic valve is an Amot model 6HAS. Each valve uses 2 thermostatic elements, Amot type 9760X (Figure 1). The element being investigated for the Palo Verde application have a nominal temperature setting of 170°F and therefore the element part number is 9760X-170.

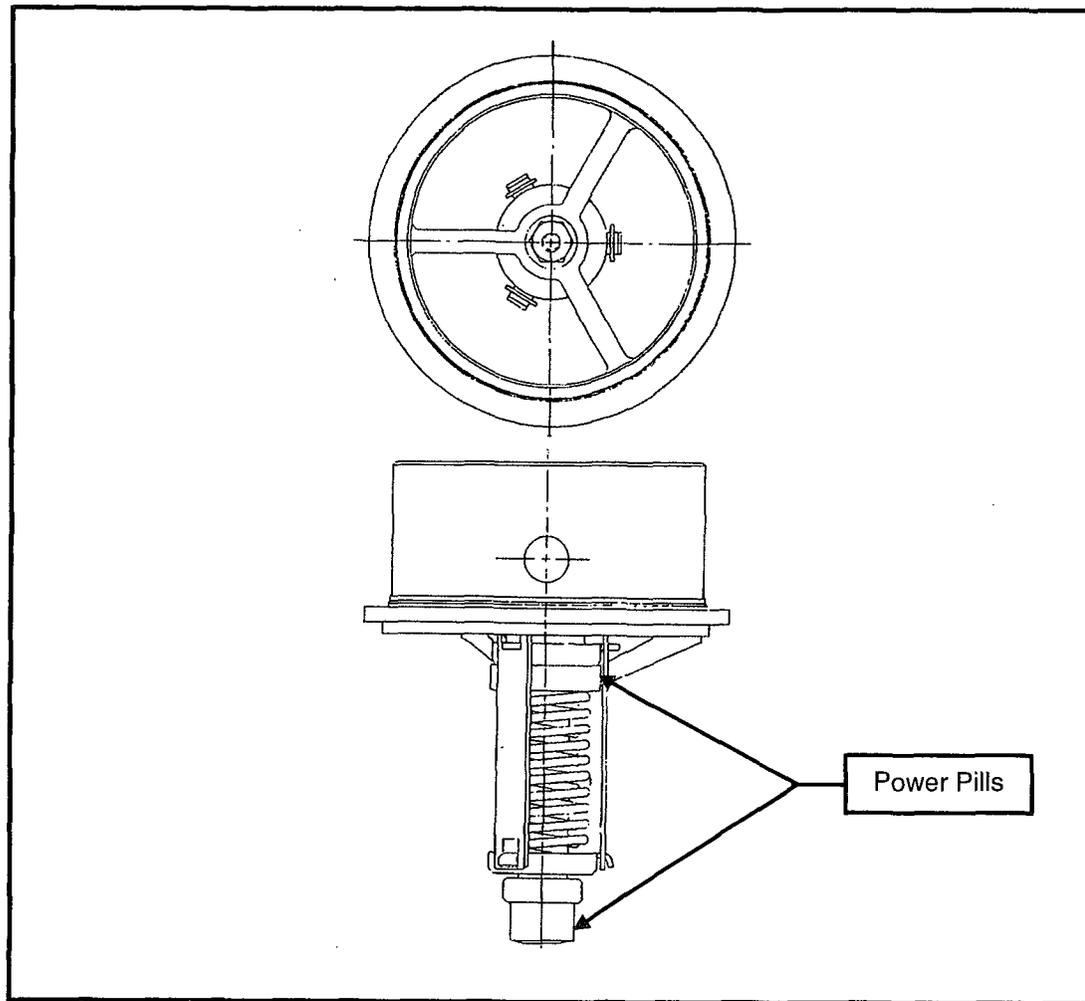
**FIGURE 2 – VALVE ELEMENT 9760X**

Each 9760X valve element contains two power pills (Figure 2). The power pills contain a temperature sensitive wax that expands with increasing temperature and provides the motive force to lift the element off of its seat.

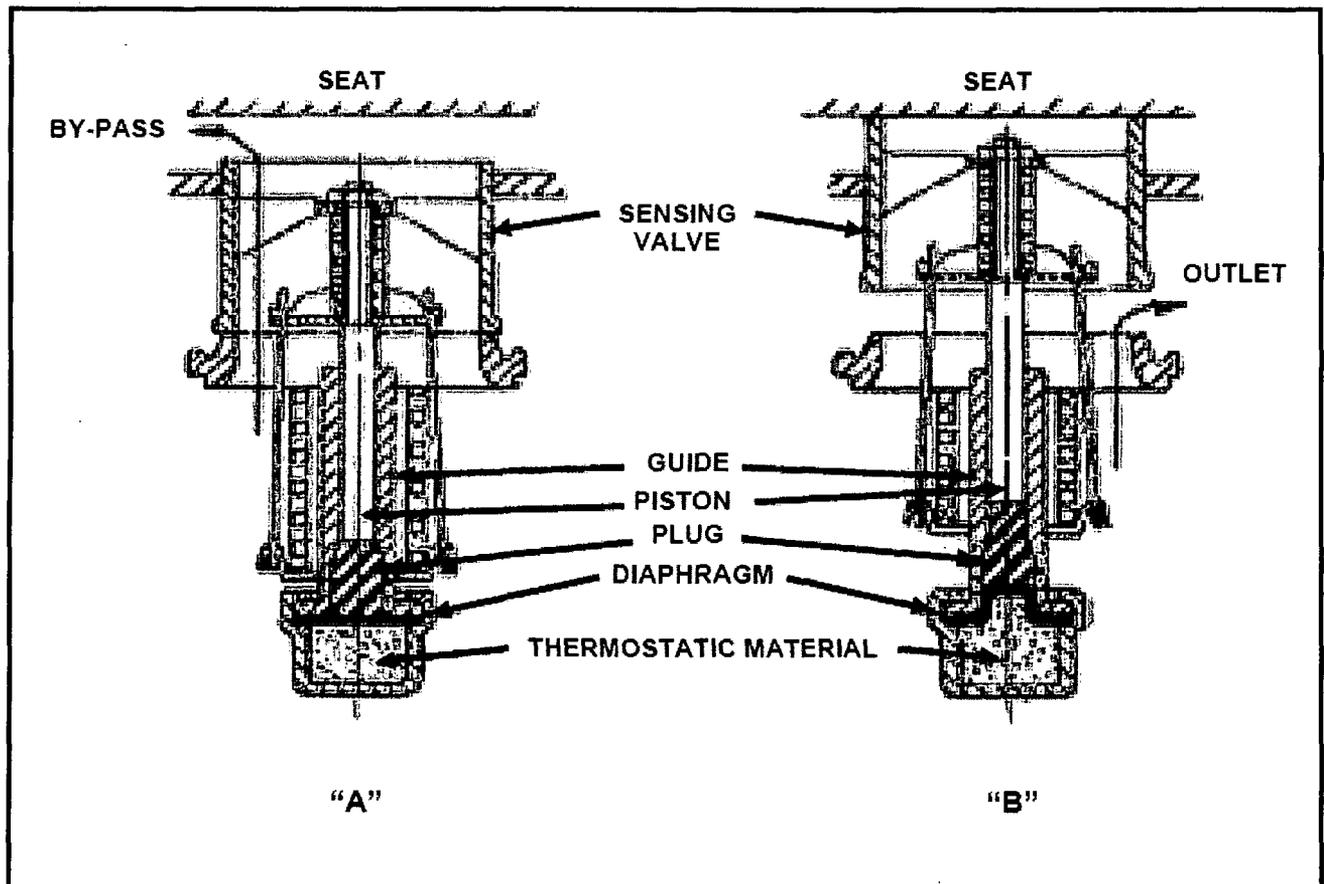
**FIGURE 3 – ELEMENT OPERATION**

Fig. 3 "A" shows an element assembly with the sliding valve in the cold position (the element shown only has one power pill, but the operating principal is the same as the two pill element). The fluid travels out the by-pass (Port B on the valve) as shown by the arrow.

Fig. 3 "B" shows the sliding valve moved up to the extended or warm position. The by-pass closes off as the sliding valve seats and the fluid is diverted to the outlet (Port C on the valve) as shown by the arrow. In actual operation, the sliding valve is normally in about the mid-position. When the wax material expands with rising temperature, the rubber plug is forced into a reduced diameter in the piston guide, which multiplies the movement of the piston by an extruding action.
