Unit 1 Cook Nuclear Plant Turbine Event Status Report

***Nuclear Regulatory Commission
Presentation
November 2, 2009***

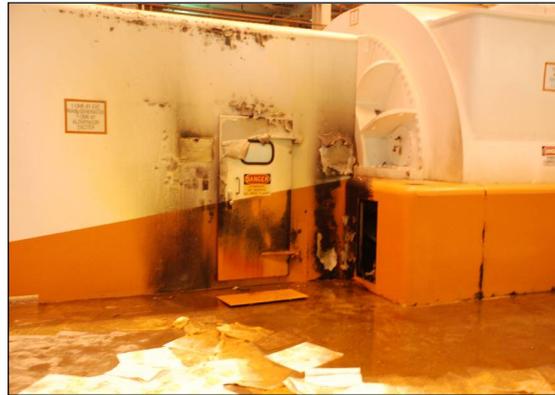
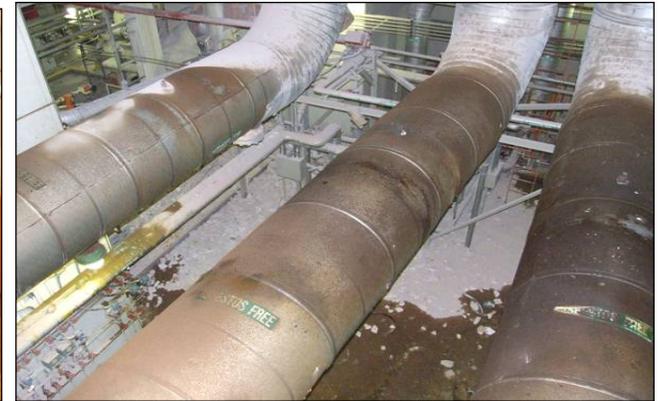
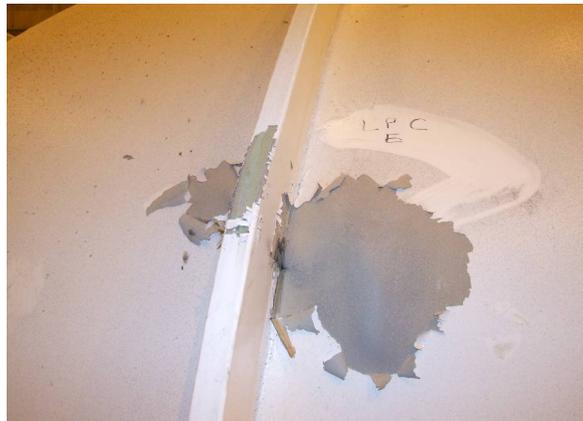
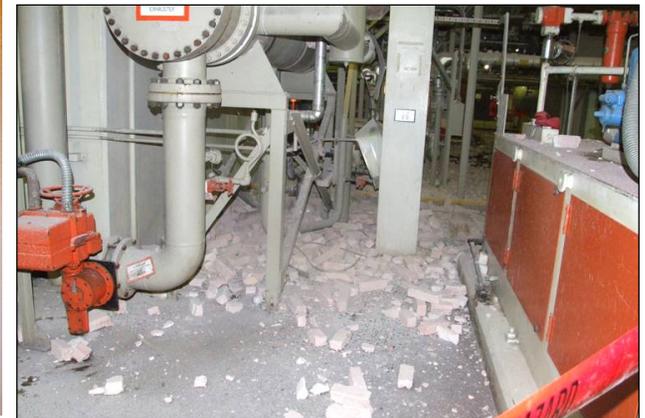
- Fire damage to main generator/exciter housing
- Turbine damage
- Piping insulation damage
- Visible concrete damage around turbine
- Oil spills
- Damaged hangers and supports on various pipe systems

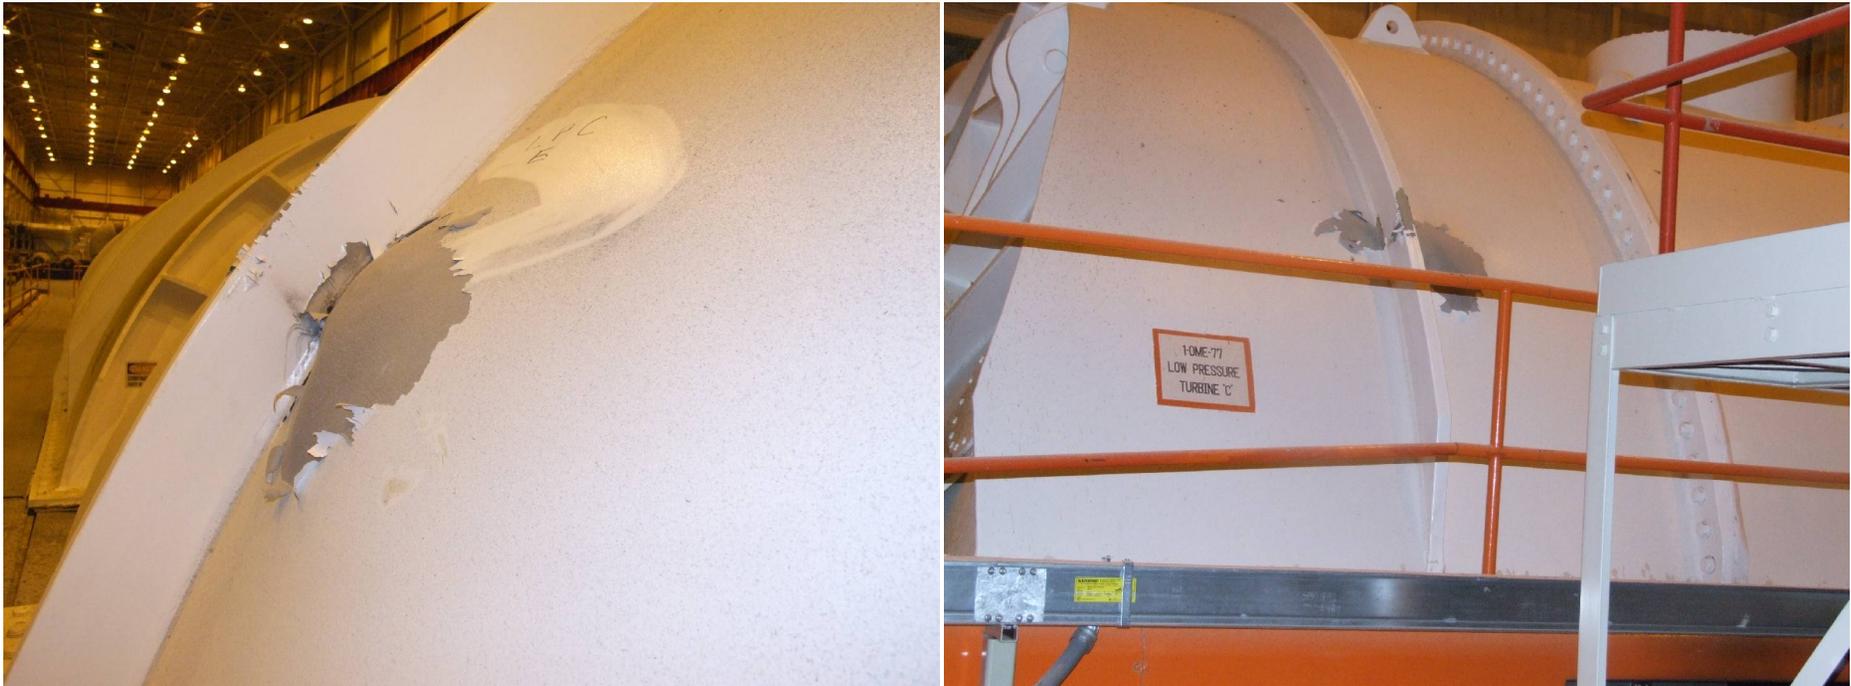
- LP turbine exhaust hoods
 - LP turbine exhaust hoods display evidence of blade impact
 - All blades were contained within turbine hoods
 - Bearing housings were displaced

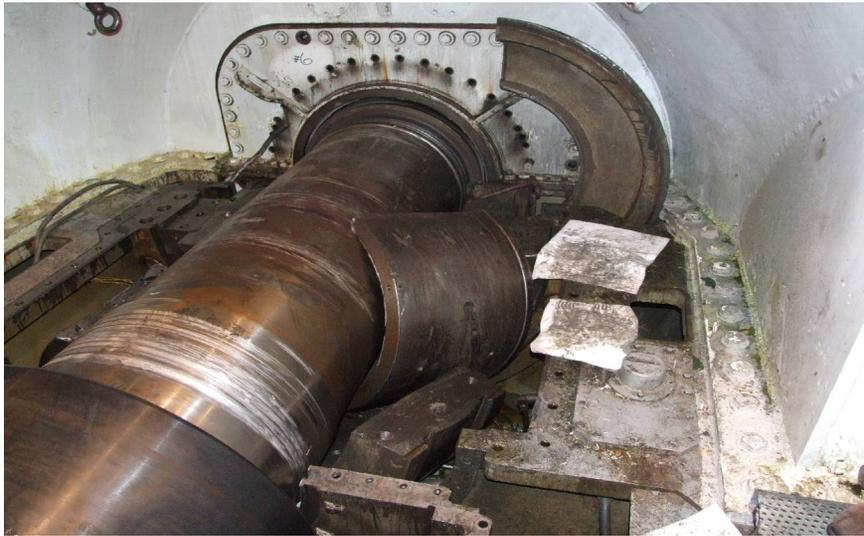
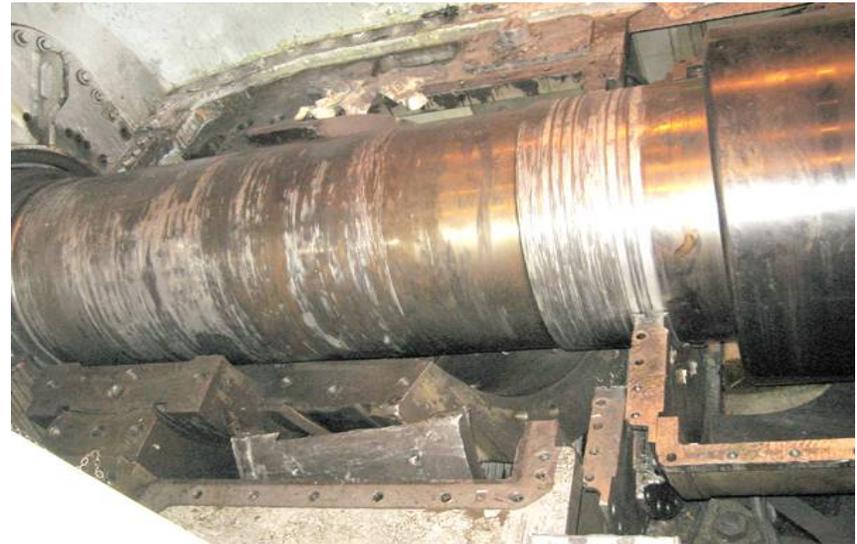
- Turbine shafts
 - No coast down or turning gear operation
 - Significant shaft scoring
 - Bearing damage evident at all 12 main bearing locations

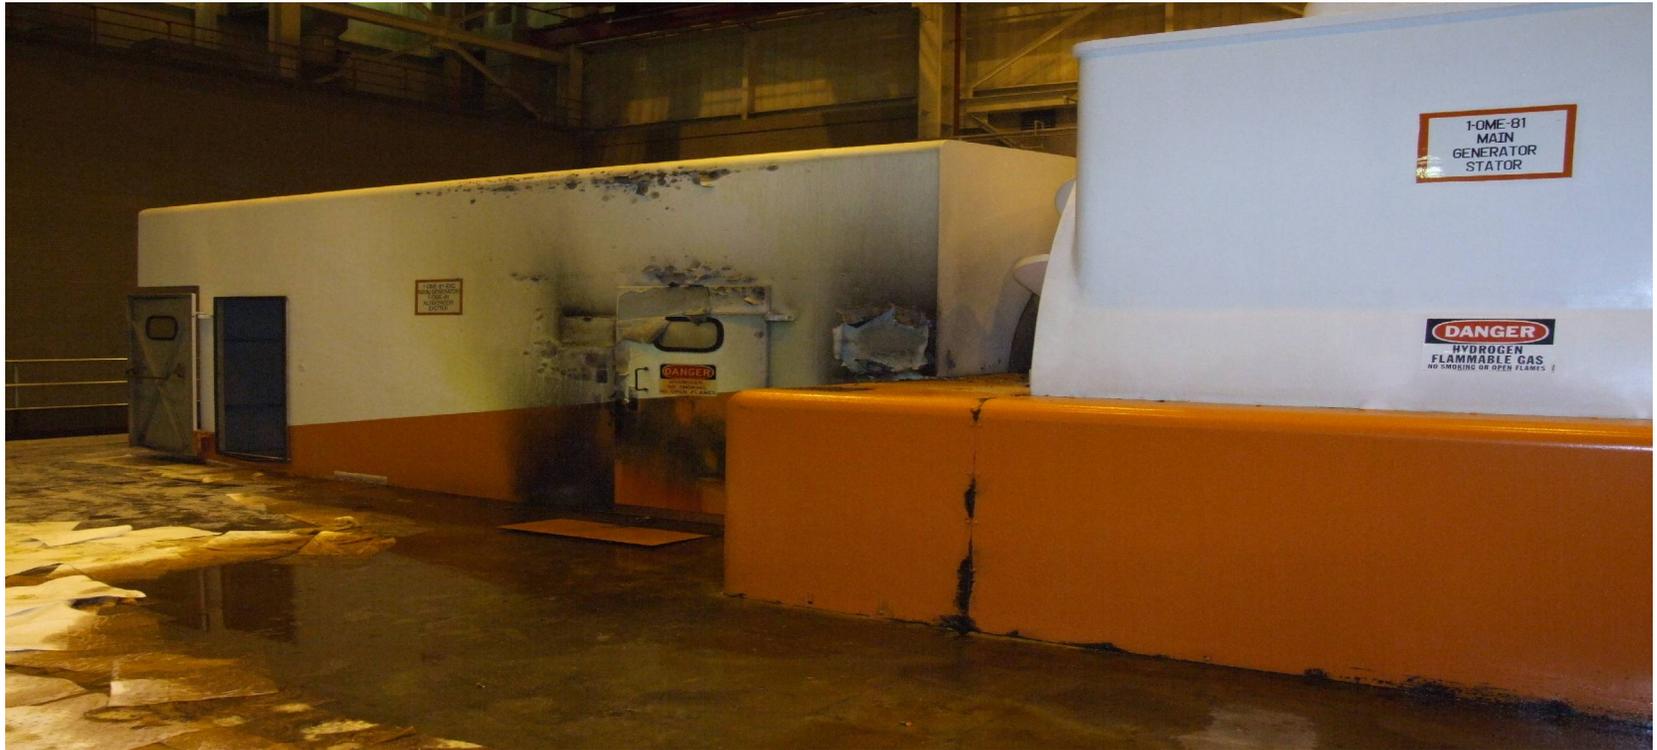
- Fire due to failure of generator hydrogen seal
- Fire brigade responded and extinguished fire within 23 minutes
- Excellent local fire department assistance

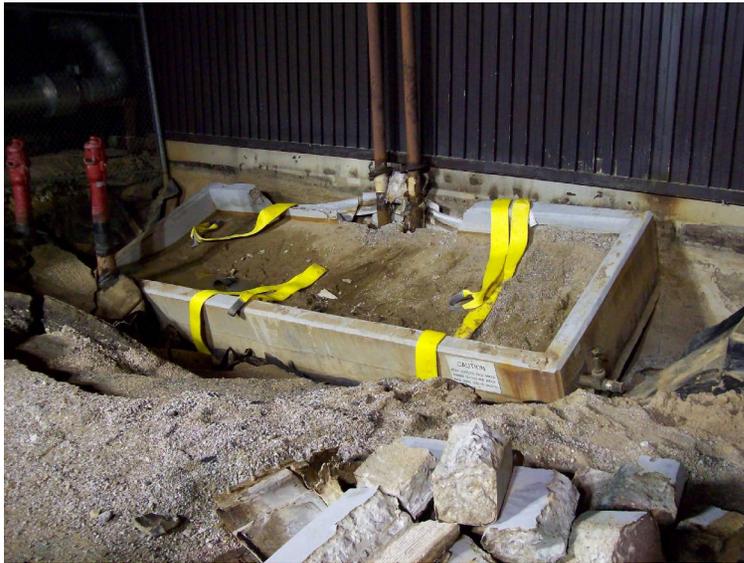
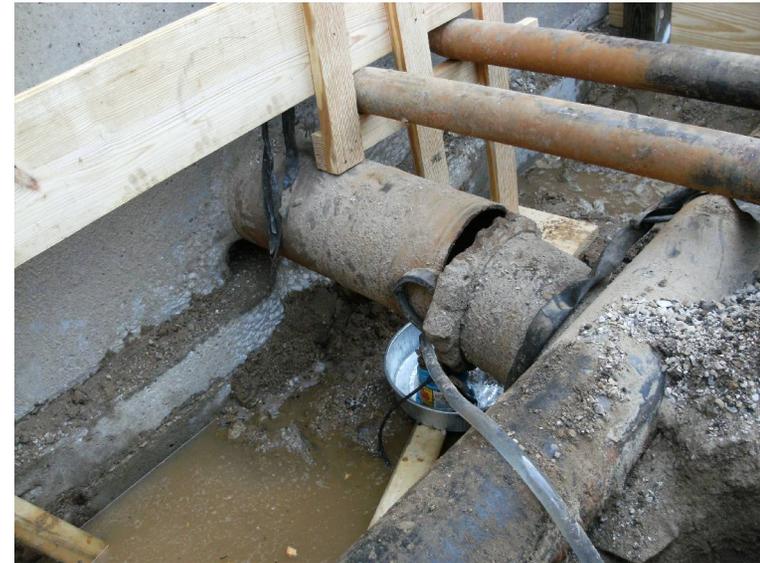
- The Fire Water System experienced complications including a breach of the piping on the West side of the plant, draining of the South Fire Water Tank and failure of the East Diesel Fire Pump.
- The NRC sent a fire protection inspector to the site on September 21, 2008, to launch a Special Inspection Team (SIT).
- The on-site NRC resident inspectors and SIT inspectors monitored activities associated with full restoration of the site-wide fire protection system and conducted an investigation into the causes of both the turbine failure and the fire suppression system failure.
- A number of enhancements were identified and entered into the Corrective Action Program.

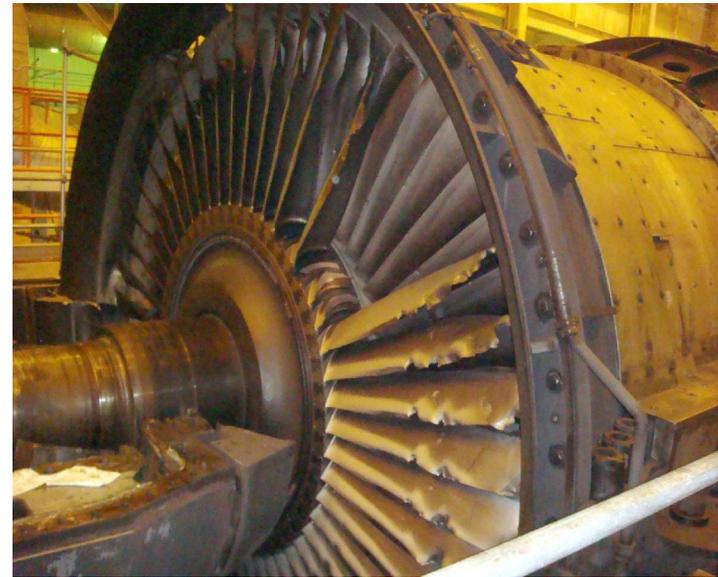
- Blade #40 on LP turbine B, turbine side (LP B TS) is liberated due to high cycle fatigue
- Blade #56 on LP B TS also exhibited high cycle fatigue and is liberated during the event
- Blade #189 on LP turbine C TS also exhibited high cycle fatigue and is liberated during the event
- Blades #29 and #64 on LP B TS fracture in overload during the event
- The loss of 5 L-0 blades creates a severe unbalance condition on the rotor

- The high vibration of the unbalanced turbine causes extensive damage to connected systems.

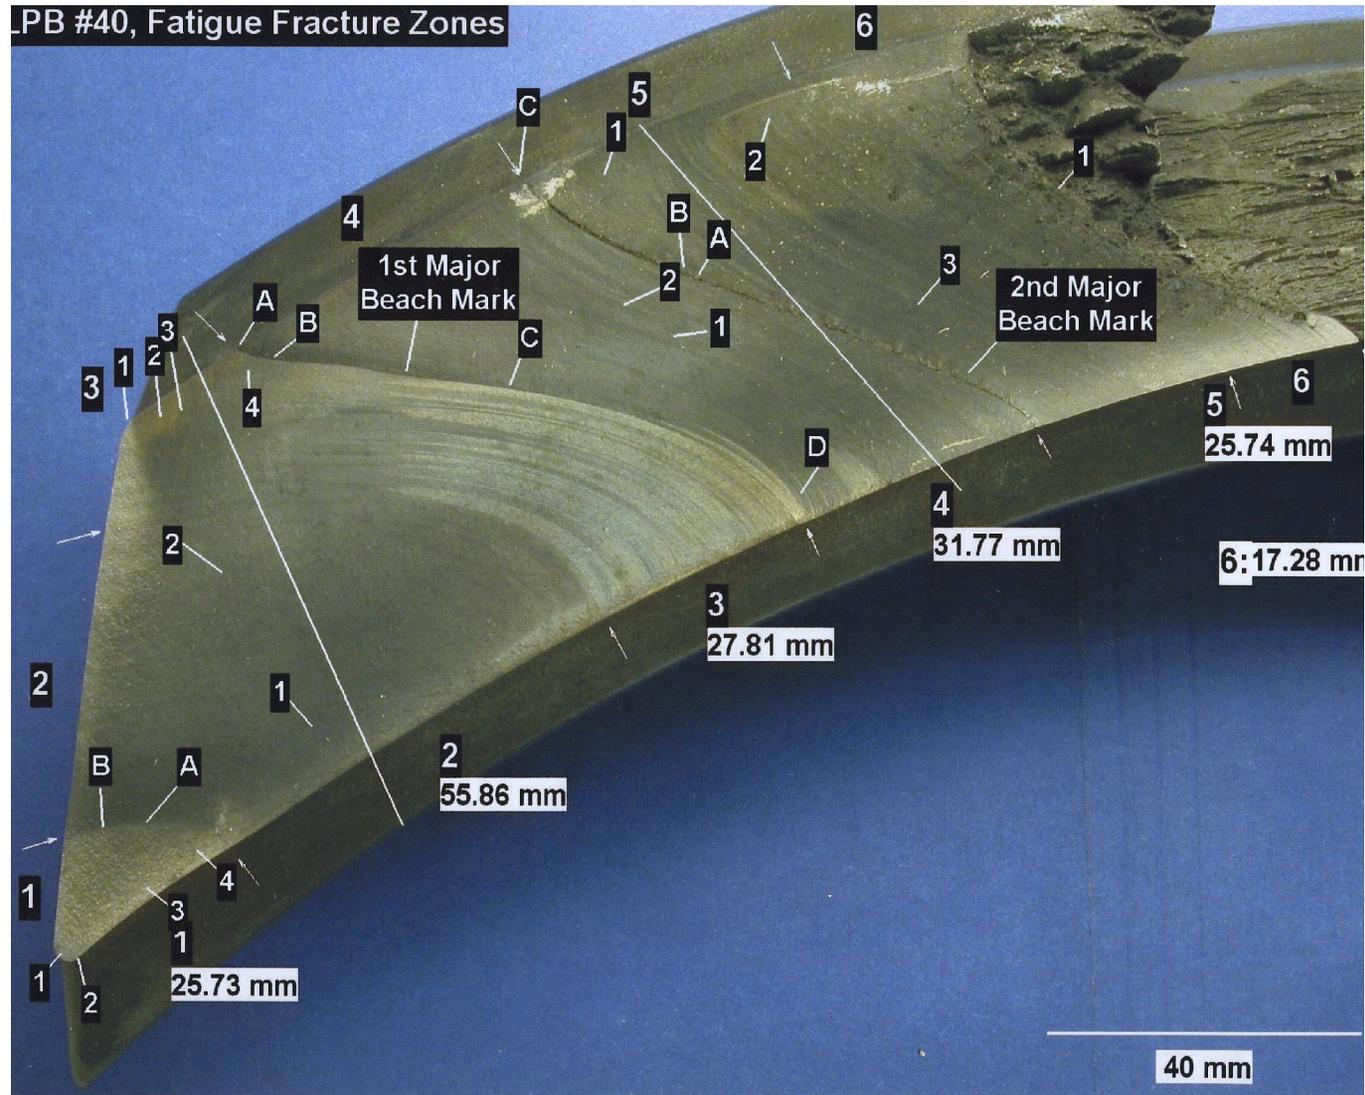
LPB Blade #40 Fracture Surface Distinctive Zones and Beach Marks

A Blade-Rotor System Design Which Failed to Provide Adequate Stress Margin in at Least Three L-0 Blades

- Blade vibrations
- Indications of non-uniform loading in root engagement
- Normal electrical grid variations correlate to fracture beach marks

- Interim repaired LP turbines without L-0 blades
- Replace LP turbines with proven design in 2011
- Design to be validated by a third party review
- Additional turbine monitoring instrumentation

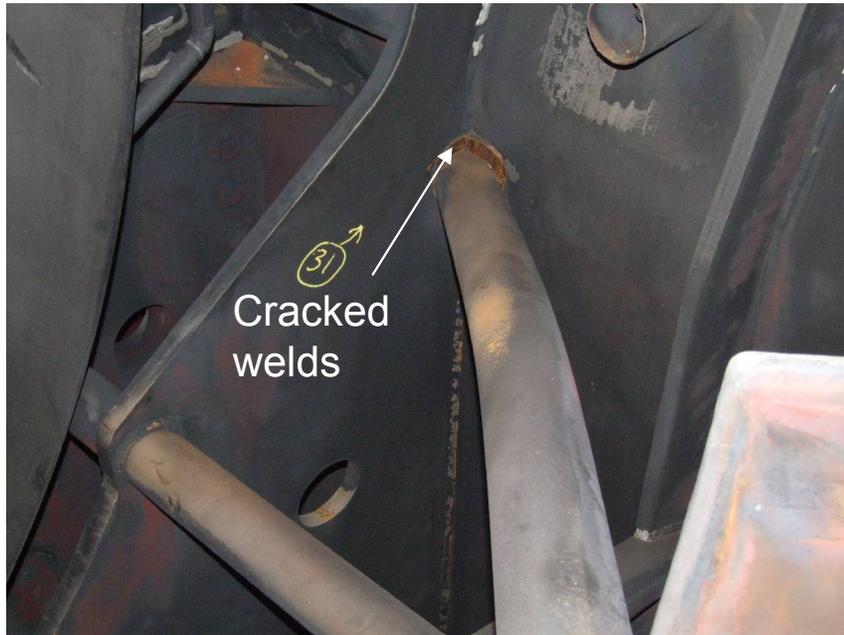
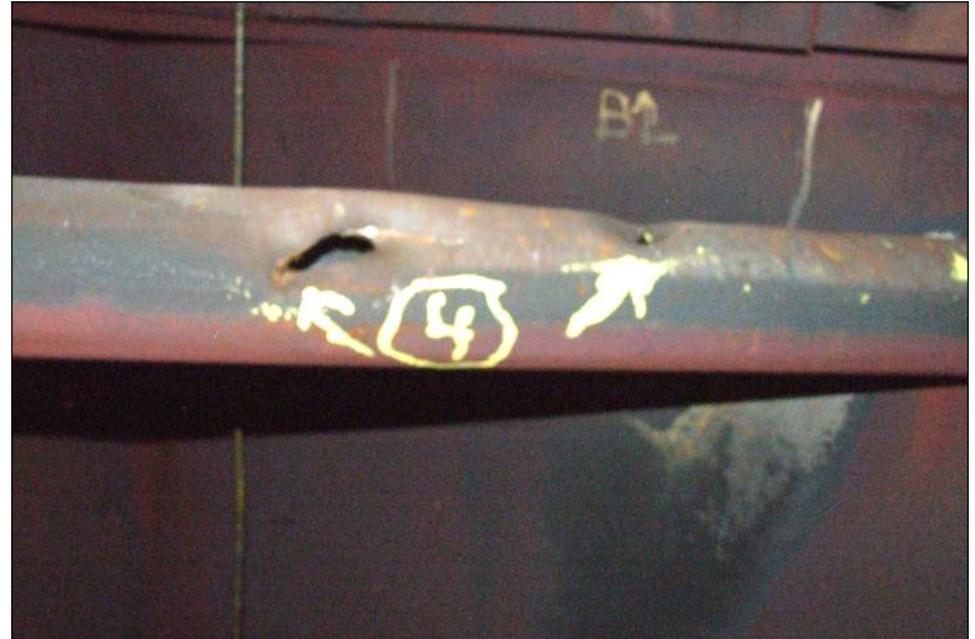
Initial Inspection of LEHs

- Structural supports and struts damaged
 - Grout cracking and foundation bolts damaged
 - Cone extension have moved
-
- LEHs required extensive repairs and are now complete

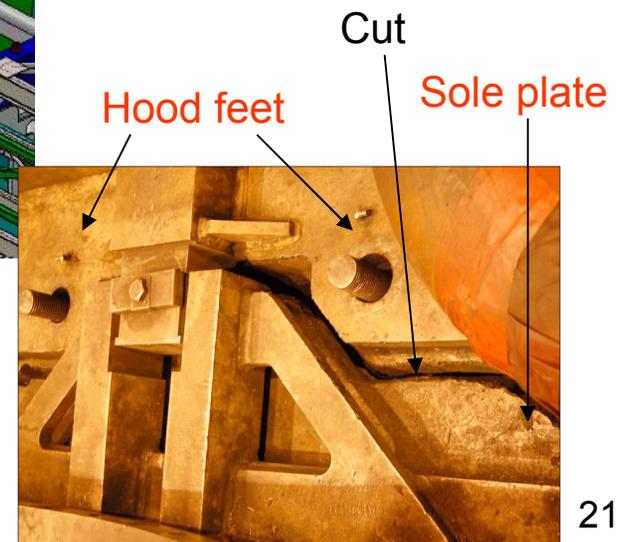
- Sole plates between hoods were welded, due to event, to bottom of LEH feet. Had to be cut without effecting hood supports.

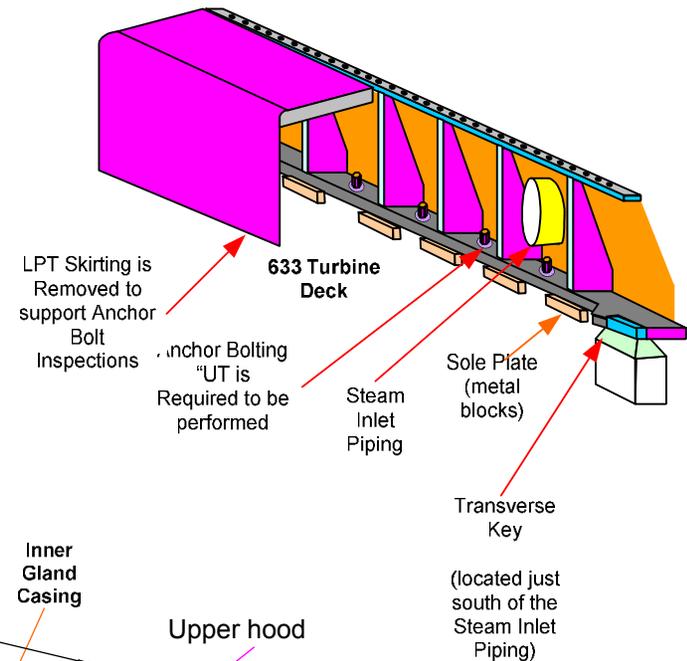
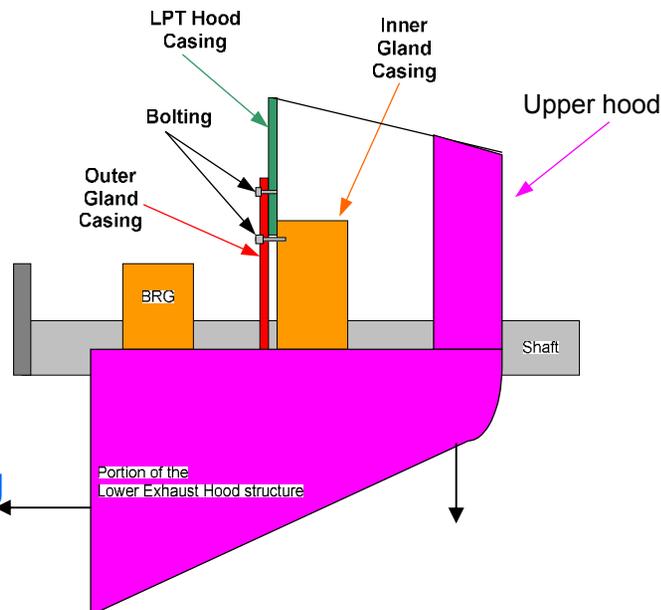
Inspection after Lift

- Sole plates welded to bottom of LEH feet causing damage to feet, requires machining
- Cone extensions have pushed vertical wall on north and south ends
- Large number of welds inside the cones had to be repair and stressed relieved.

- 1) Number of welds
- 2) Lift hoods additional 2' for machining
- 3) Machining feet and verticals
