**Flow Control Division**

**Subject:** USNRC 10CFR Part 21 Notification

**Ref:** Flowserve Size  $\frac{3}{4}$  Figure 848Y Disk/Disk Nut Separation  
LaSalle Station  
Exelon PowerLabs, LLC Project Number: LAS-62808  
Flowserve Complaint Report 4914  
Flowserve Evaluation Report No. 10 CFR 21-50

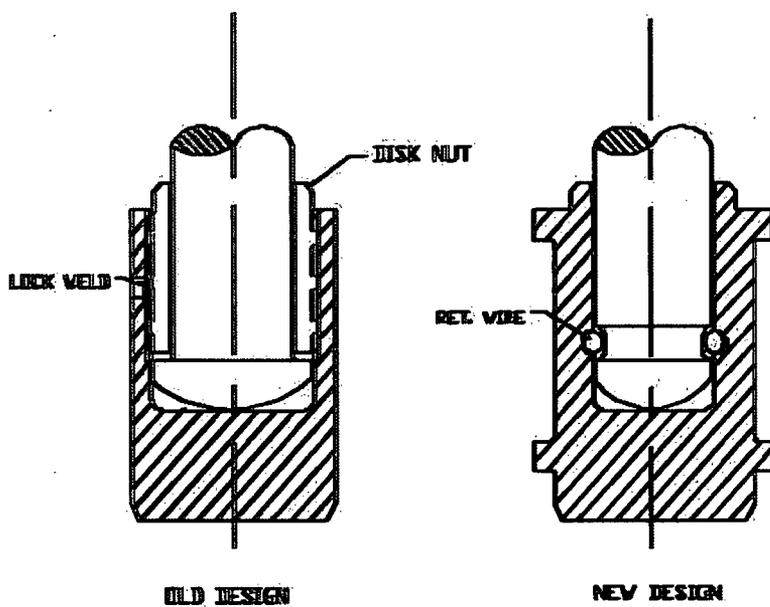
**Figure 1 Stem/Disk Assemblies for Old Design and New Design Figure 848 / A848 Valves.**

Figure 1 provides an illustration of the stem/disk assembly in the Size  $\frac{3}{4}$  Figure 848 valve. The **"Old Design"** is typical of the valve that is the subject of this discussion. The valve stem has a collar on the very end. After the stem is inserted into the disk, the disk nut is threaded into the disk to retain the stem. A lock weld is then created to prevent the disk nut from unthreading out of the disk.

In about 1990, the design was changed to that shown as the **"New Design"** in Figure 1. The disk nut was eliminated, and the disk retained on the end of the valve stem using a piece of wire inserted into a groove located half in the valve stem and half in the disk.

For the case of the **"Old Design"** valve at LaSalle, once the disk nut has unthreaded out of the disk, the stem and the disk are no longer connected. The valve will then operate as a stop-check valve. The valve will open in response to normal forward flow, and close in response to normal reverse flow.

Because the disk nut is a solid piece assembled around the valve stem, the disk nut cannot fall off of the valve stem and become a loose part in the piping system.

After unthreading from the disk, the disk nut will sit on top of the disk. The valve will be able to open only partially, because the disk nut will interfere with the ability of the valve to open fully. The amount that the valve can open will depend on the size of the valve. For the Size ¾ valve at LaSalle, the disk would be able to open less than 1/8 of an inch. The amount that other valve sizes would be able to open is different, but all would be reduced.

The valves affected are Size 2 and smaller Edward Figure 848 valves manufactured by Rockwell International at the Sulphur Springs, Texas, and the Raleigh, North Carolina, manufacturing facilities prior to 1991. These valves may be tagged "Rockwell", "Rockwell Edward" or "Edward". The valves affected have the "**Old Design**" stem/disk assembly shown in Figure 1.

Valves with Figure Number **A848** incorporate the "**New Design**" stem/disk connection and are not affected.

Based on the above, the Nuclear Industry needs to be notified concerning the potential defect, and encouraged to inspect the operation of their valves, especially if they have a safety-related function in the plant that may be adversely affected.
