Event # 45477

PART 21 REPORT - POTENTIAL FAILURE OF BONNET VALVE

Subject: USNRC 10CFR Part 21 Notification

Ref: Flowserve Size $\frac{3}{4}$ Figure 848Y Disk/Disk Nut Separation
LaSalle Station
Exelon PowerLabs, LLC Project Number: LAS-62808
Flowserve Complaint Report 4914
Flowserve Evaluation Report No. 10 CFR 21-50

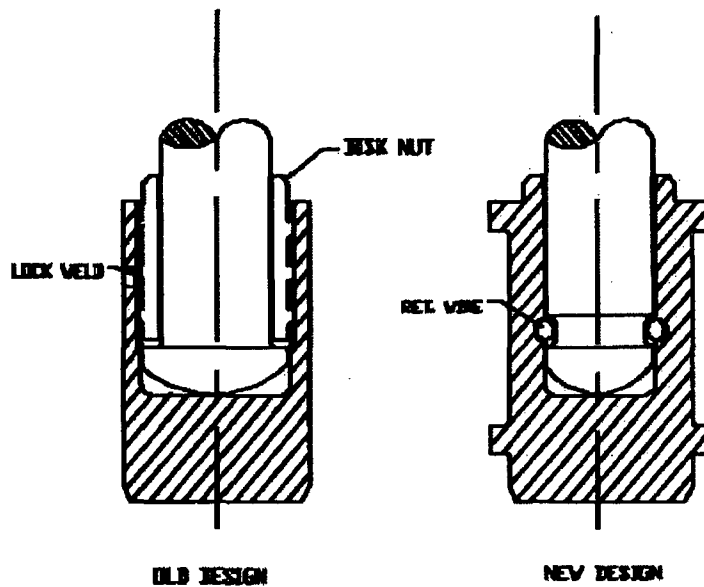
Figure 1 Stem/Disk Assemblies for Old Design and New Design Figure 848 / A848 Valves.

Figure 1 provides an illustration of the stem/disk assembly in the Size $\frac{3}{4}$ Figure 848 valve. The **"Old Design"** is typical of the valve that is the subject of this discussion. The valve stem has a collar on the very end. After the stem is inserted into the disk, the disk nut is threaded into the disk to retain the stem. A lock weld is then created to prevent the disk nut from unthreading out of the disk.

In about 1990, the design was changed to that shown as the **"New Design"** in Figure 1. The disk nut was eliminated, and the disk retained on the end of the valve stem using a piece of wire inserted into a groove located half in the valve stem and half in the disk.

For the case of the **"Old Design"** valve at LaSalle, once the disk nut has unthreaded out of the disk, the stem and the disk are no longer connected. The valve will then operate as a stop-check valve. The valve will open in response to normal forward flow, and close in response to normal reverse flow.

Because the disk nut is a solid piece assembled around the valve stem, the disk nut cannot fall off of the valve stem and become a loose part in the piping system.

After unthreading from the disk, the disk nut will sit on top of the disk. The valve will be able to open only partially, because the disk nut will interfere with the ability of the valve to open fully. The amount that the valve can open will depend on the size of the valve. For the Size $\frac{3}{4}$ valve at LaSalle, the disk would be able to open less than $\frac{1}{8}$ of an inch. The amount that other valve sizes would be able to open is different, but all would be reduced.

The valves affected are Size 2 and smaller Edward Figure 848 valves manufactured by Rockwell International at the Sulphur Springs, Texas, and the Raleigh, North Carolina, manufacturing facilities prior to 1991. These valves may be tagged "Rockwell", "Rockwell Edward" or "Edward". The valves affected have the "**Old Design**" stem/disk assembly shown in Figure 1.

Based on the above, the Nuclear Industry needs to be notified concerning the potential defect, and encouraged to inspect the operation of their valves, especially if they have a safety-related function in the plant that may be adversely affected.

Valves with Figure Number **A848** incorporate the "**New Design**" stem/disk connection and are not affected.
