SUBJECT: BEAVER VALLEY POWER STATION, UNIT NO. 2 (BVPS-2) - SUMMARY OF  
CONFERENCE CALL REGARDING THE SPRING 2008 STEAM GENERATOR  
TUBE INSERVICE INSPECTION RESULTS (TAC NO. ME2216)

## SUMMARY OF CONFERENCE CALL

### REGARDING THE SPRING 2008 STEAM GENERATOR TUBE INSPECTION RESULTS

#### BEAVER VALLEY POWER STATION, UNIT NO. 2

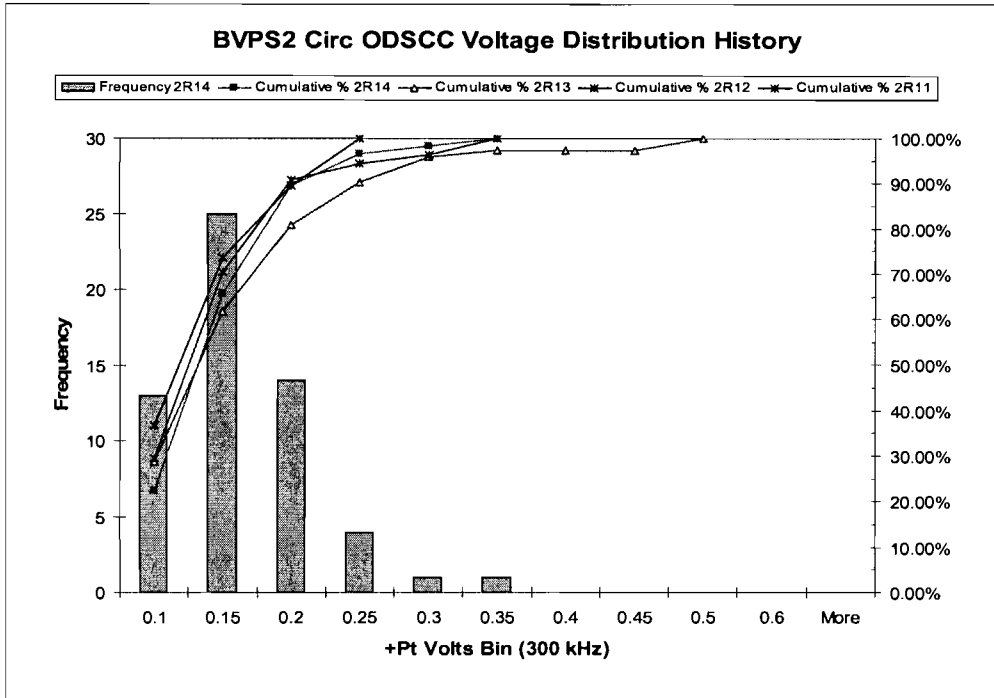
The following figures compare several flaw parameters for the 2R14 and 2R13 outages. The conclusion is that there is no apparent difference in the flaw signals between these two inspections. At 2R13, a top of tubesheet ASCA cleaning process was applied. This reduced the deposit influence at the top of tubesheet and resulted in reduced noise conditions. The 2R14 eddy current data is judged to include a reduced noise level compared to prior outages. The observations that flaw parameters are consistent between 2R13 and 2R14 suggests that the ODSCC aggressiveness condition may have been slightly reduced for Cycle 14 compared to Cycle 13 as the improved noise condition would be expected to result in "larger" flaws at 2R14. The number of tubes affected by SCC at the hot leg top of tubesheet is slightly reduced for 2R14 compared to 2R13.

Long term trending of circ ODSCC +Pt amplitudes shows essentially no change over multiple outages. Therefore it can be concluded that the slight temperature increase associated with uprating has had no discernable effect upon SCC signal amplitude @ 2R14.

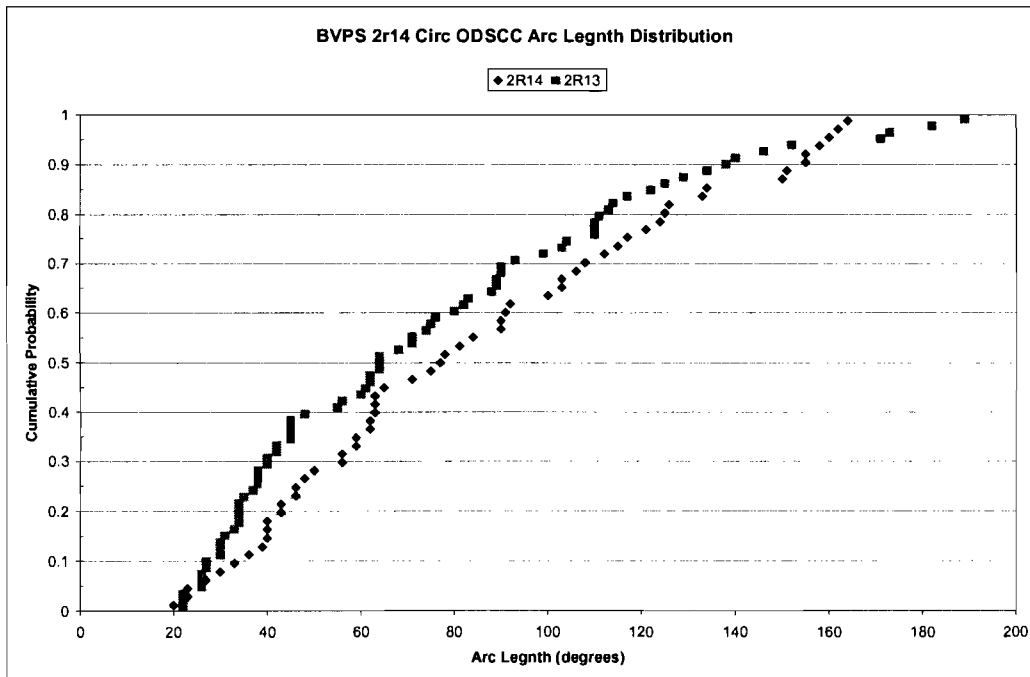
Circ ODSCC arc length distribution for 2R14 is bounded by 2R13 data:
