CROW BUTTE RESOURCES, INC.

**CROW BUTTE MINE
DAWES COUNTY, NEBRASKA**

2009 POND INSPECTION REPORT

By: David V. Coe, PE
Nebraska Registration No. E - 4295

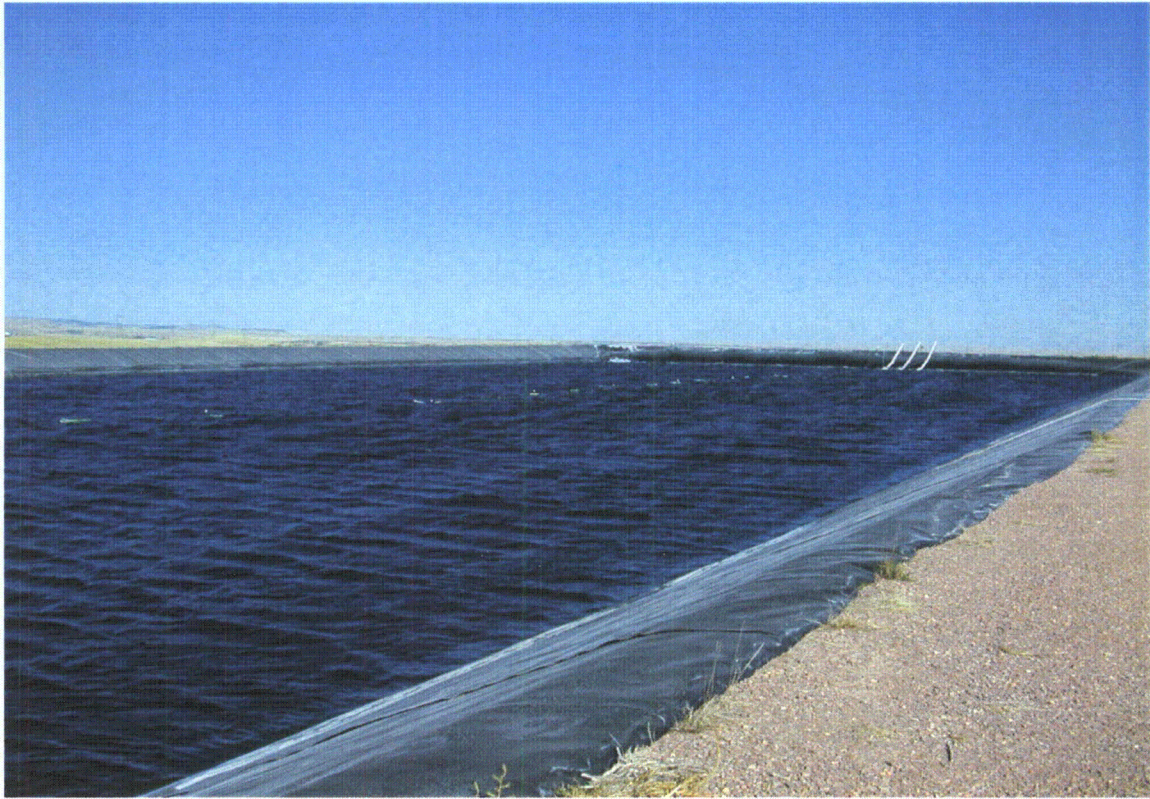
#1 Northwest view of evaporation pond #1, date: 09/29/09

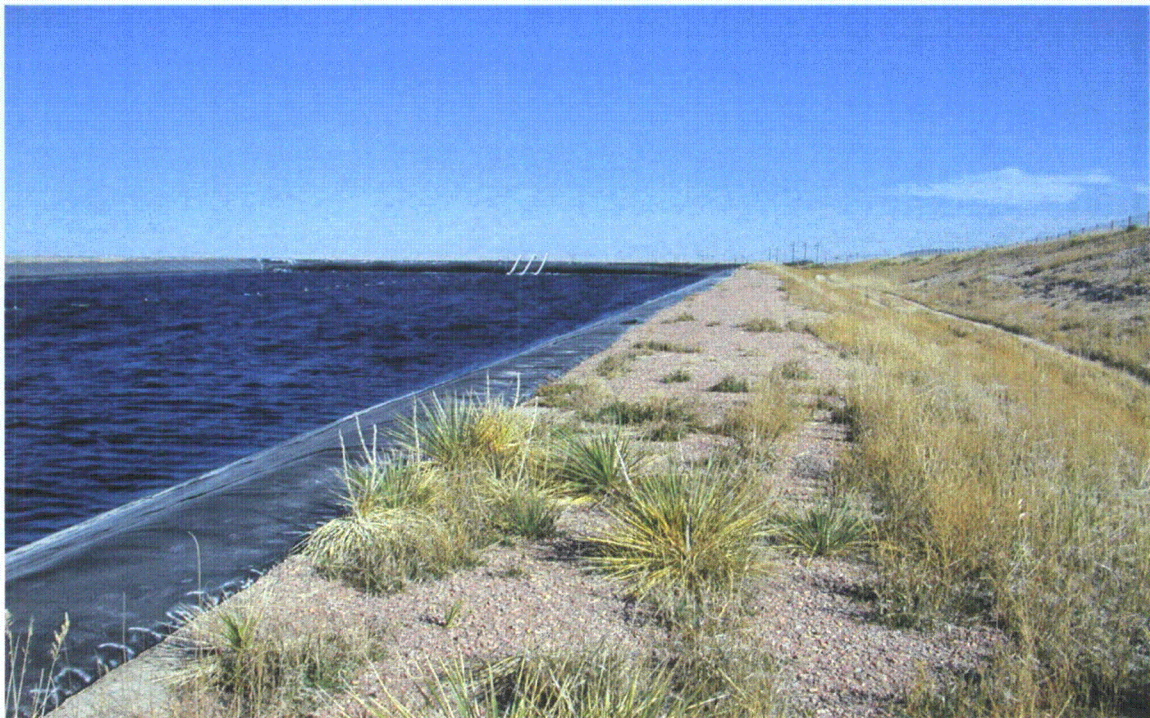
#2 Northwest view of pond #1. Date: 09/29/09

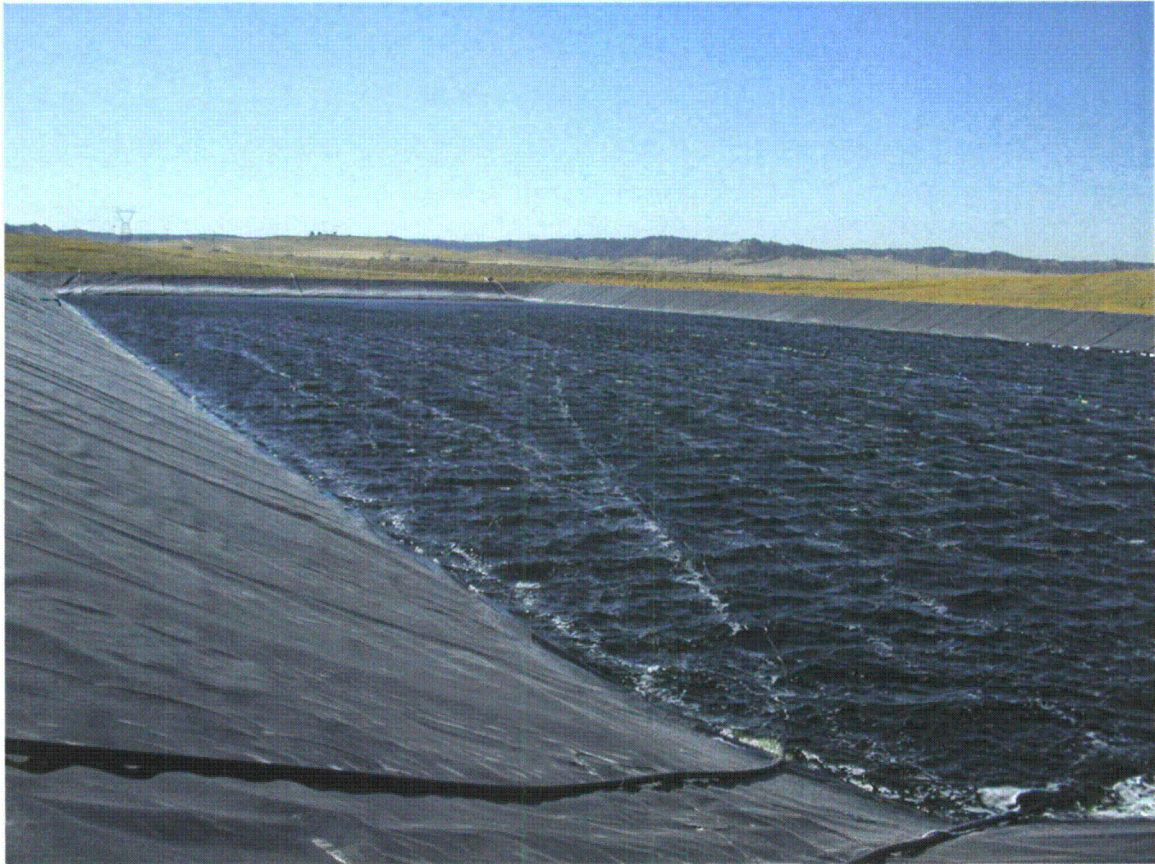
One could observe the white salt build-up of about 3 feet in width around the pond liner. This deposit was directly above the water line of pond #3. This salt deposit on pond #3 was more prevalent on this pond than pond #1 or pond #4. The NRC inspection recommended investigation of the potential harmful reaction on the pond liner resulting from the salty deposit.

#3 Northeast view of pond #3. Date: 09/29/09

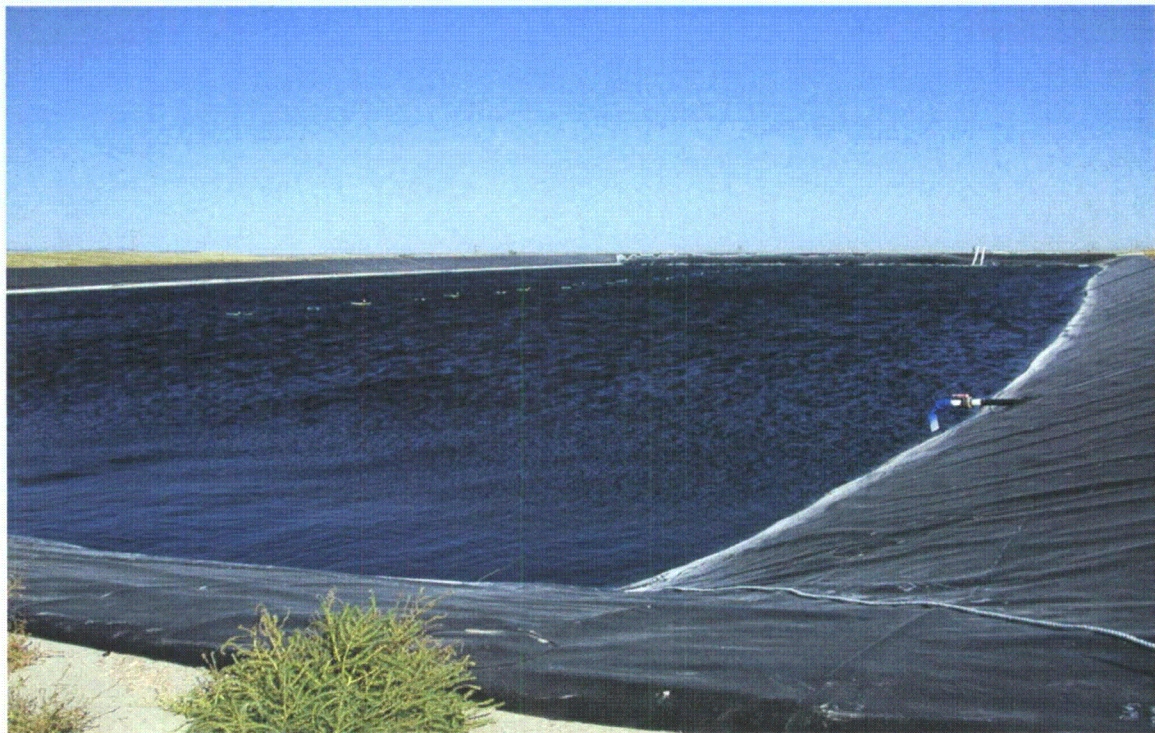
I then inspected the embankment of pond #4. The pond depth of #4 was 5.7 feet leaving about 9.3 feet of additional storage. Walt indicated they are still having problems with leaking in Pond #4 when they raise the level of the pond beyond the 7 or 8 foot elevation. At this present time they are cleaning the water between the two pond liners. They have not been charging pond #4 from the plant operation water.

#4 Northwest view of pond #4. Date: 09/29/09

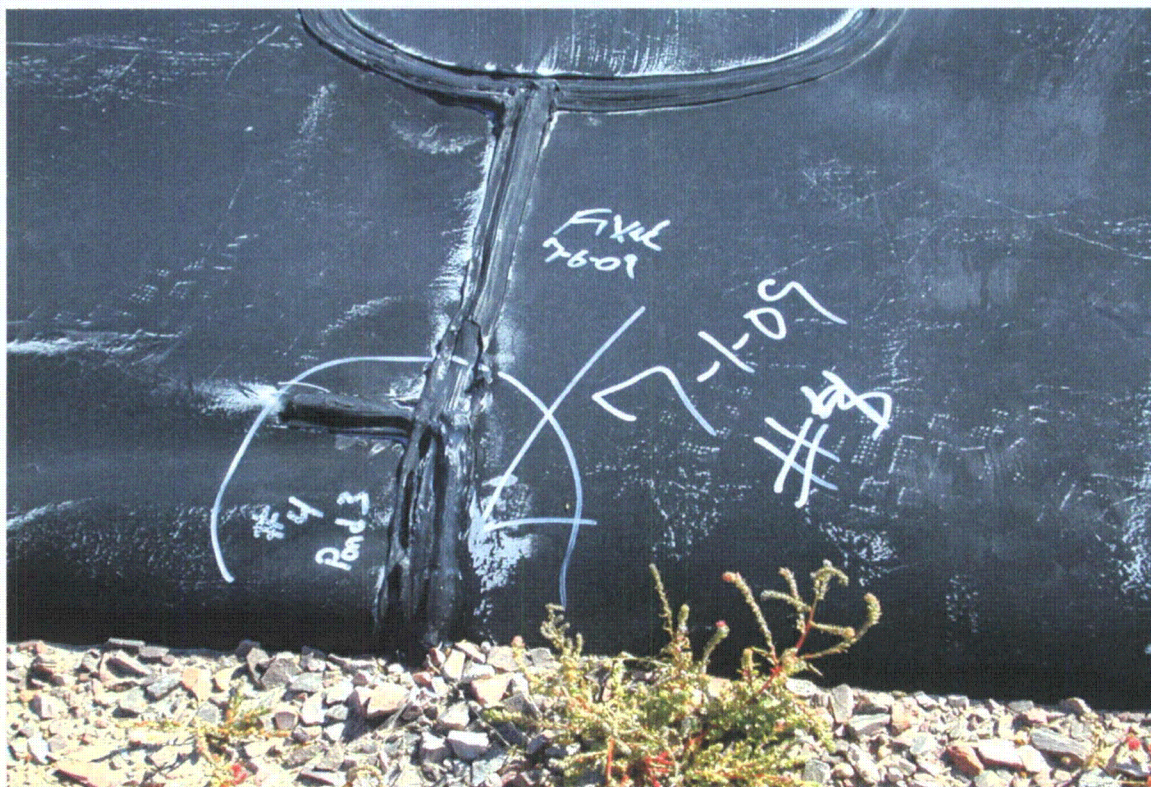
There were several patches to the pond liner material along the top portion of all the ponds. Walt indicated they were installing the patches themselves in lieu of hiring a firm from the Denver area. Significant pond liner damage is repaired via contract with a firm regularly involved in pond liner repair.

#5 liner repair on Pond #4, Date: 09/29/09

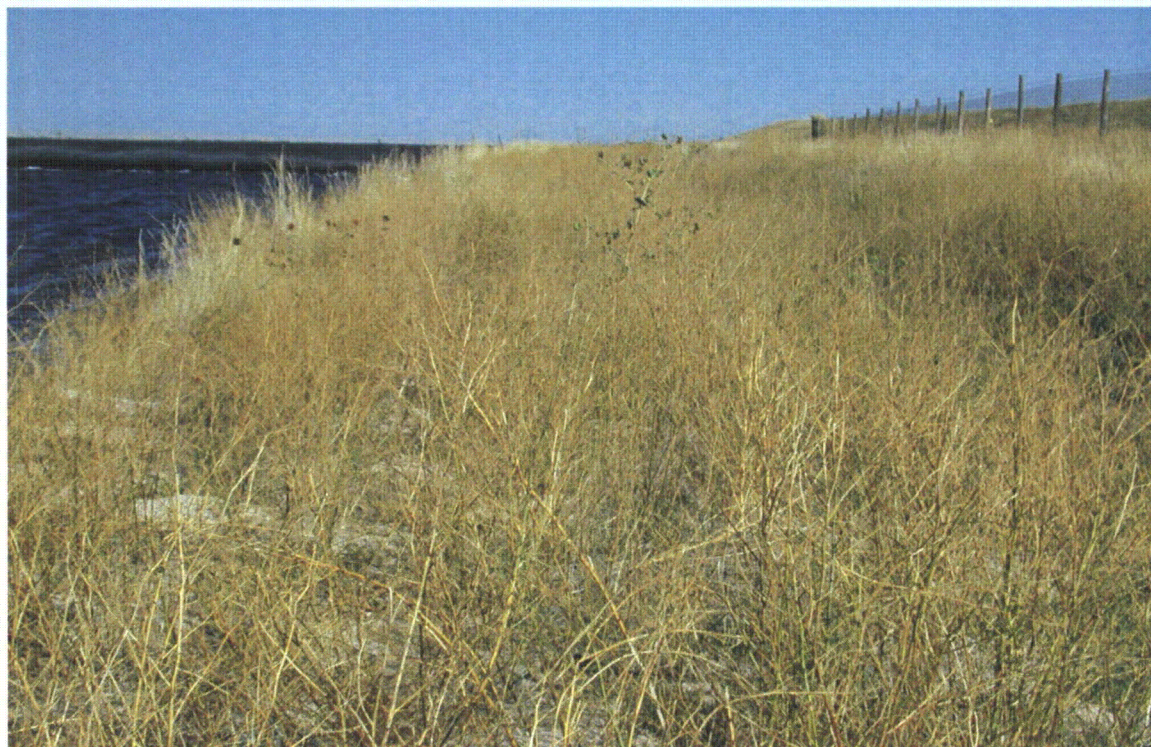
#6 View of vegetation & toe of slope of pond #4, looking to the north. Date: 09/29/09

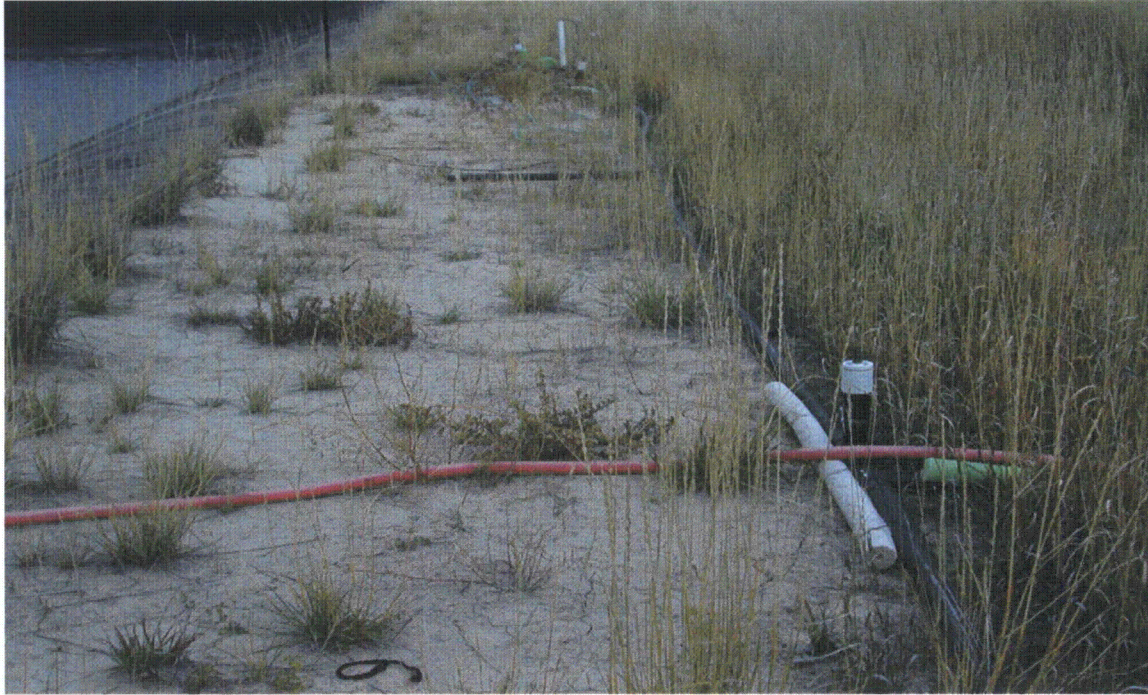
There was also a small section of pond #4, east berm, with barren soil and no vegetation. About the only way to correct this section is to add some decent top soil to the barren soil and seed the area.

#7 East embankment of pond #4, example of poor soil condition & very little vegetative growth. 09/29/09

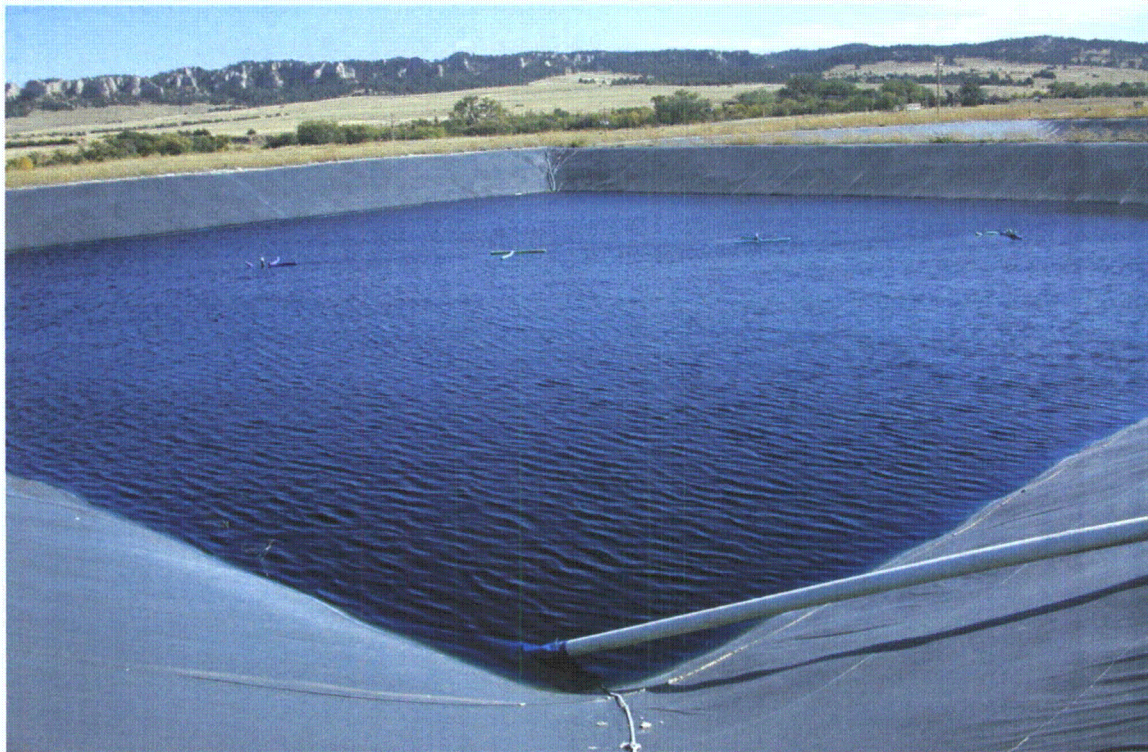
#8 Northeast views of R&D ponds. Cell #1 (west pond) in foreground. Date: 09/29/09

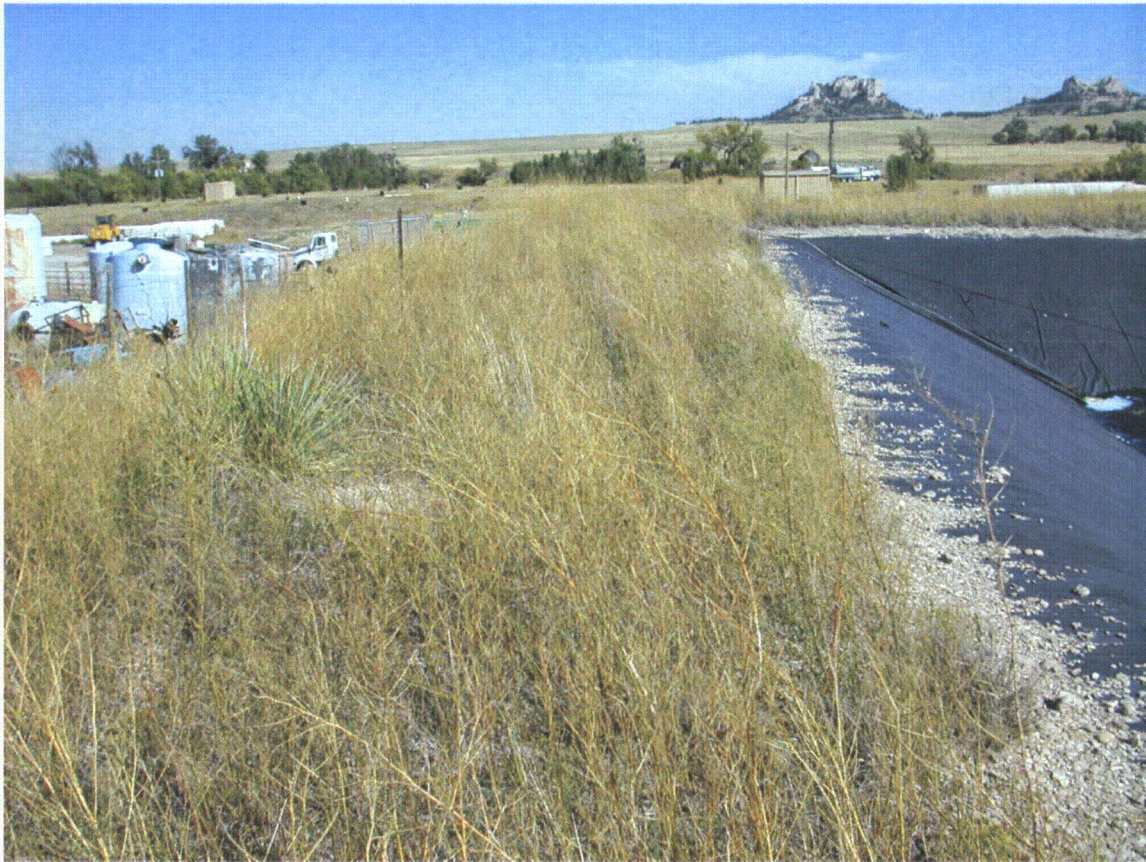
The R & D ponds have excellent vegetative cover. The safety of the R & D ponds is sound.

#9 West view of south embankment of R & D ponds, good vegetation: Date: 09/29/09

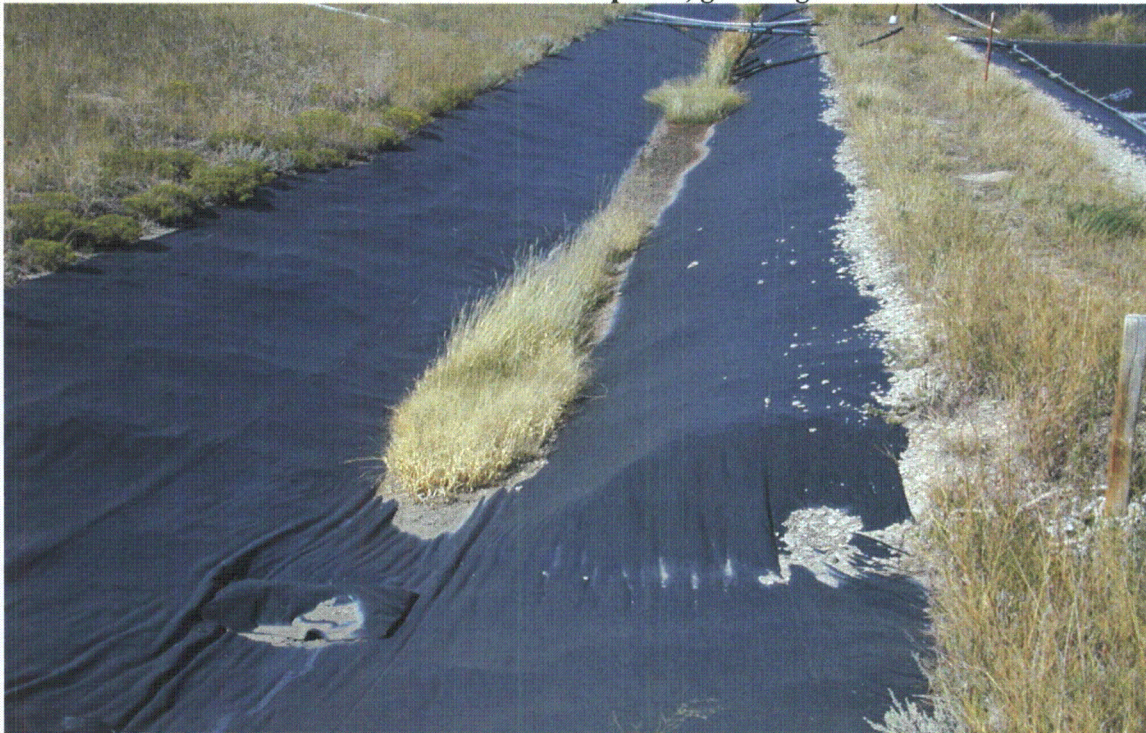
There has been no change in the cutoff dike. The dike still has a good growth of vegetation in the bottom of the channel. There was no standing water in the bottom of the cutoff dike.

**Photo #10 View of diversion ditch on the south side of the R & D ponds
Photo taken 09/29/09**

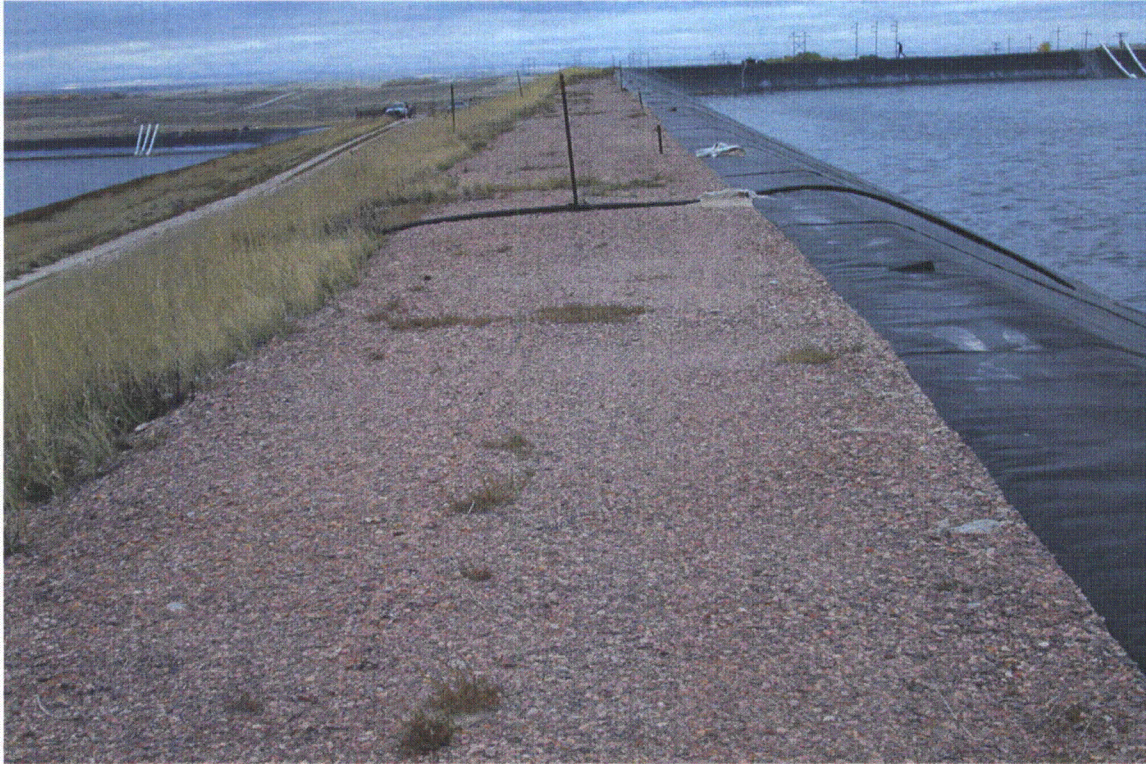
On the west berm of pond #1 there is vegetation mixed with a limestone gravel surface. The vegetation showed improvement over last year and it was well established on the limestone surface. The vegetation mixed in with the gravel surfacing does not have any detrimental affect on the safety of the pond embankment. It would be nice to have all the berm tops of the ponds gravel surfaced with limestone base course material. The vegetation along outside slope of the pond is good and well established. I did not see any evidence of a longitudinal cracking along the embankment of pond number 1. The gopher control is currently accomplished by hand and Crow Butte employees. They manually inject poison in the holes of the gophers. I did notice one dead gopher. The gopher activity seemed to be more prevalent this year as compared to the last few inspections.

#11 North view of west embankment & berm of pond #1, good protection against erosion of berm & protection of area adjacent to pond liner. 10/20/08

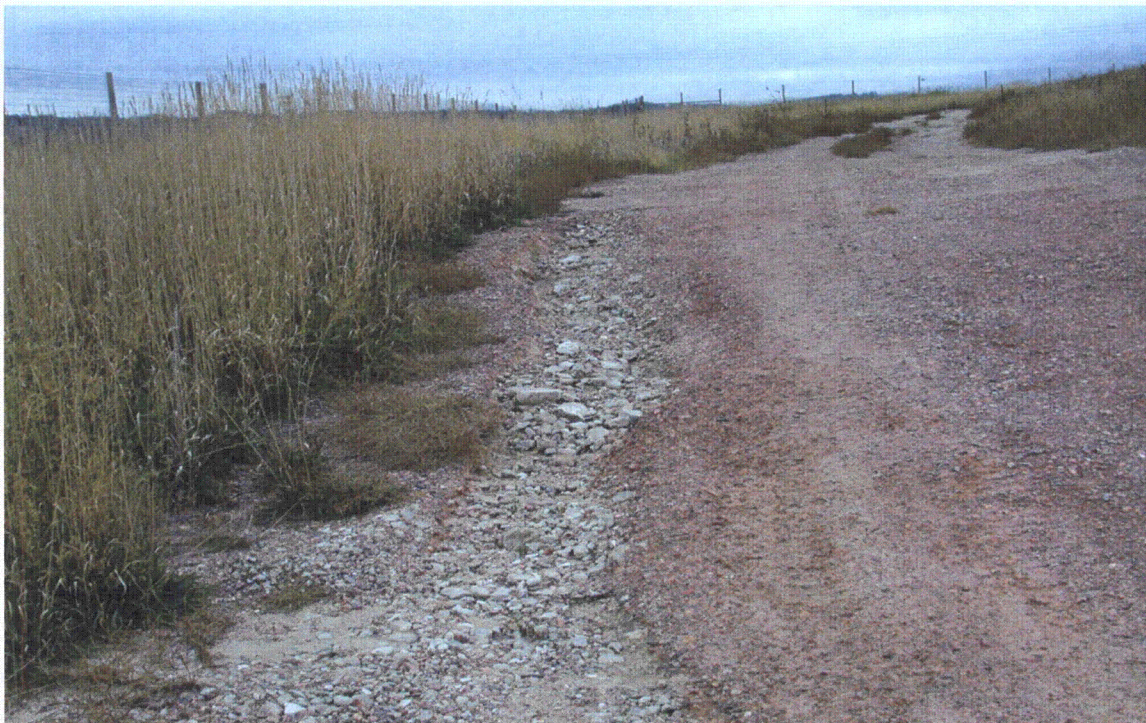
#12 North toe of pond #1 & access road showing erosion ditch on north side. 09/29/09

Walt and I discussed some grading work that is planned for the north east area of Pond #1. Walt would like me to stake an even grade for about 500 feet of drainage along the toe of the slope on pond #1. This could be improved by re-grading. To obtain an even grade might require some additional borrow dirt to be hauled into the pond area. There was some erosion along the access road to pond #1 on the north. The erosion was about 6" deep and on the north edge of the access road. Grading a crown on the road; then directing the surface runoff to the vegetation directly on the north side of the access road could reduce this erosion. Walt will call me sometime in October for slope staking the surface of the planned grading.
