SUBJECT: SUMMARY OF REGULATORY CONFERENCE WITH AMEREN UE REGARDING CALLAWAY PLANT

Topics discussed during the meeting included the significance, cause, and corrective action associated with an apparent violation involving the inoperability of the turbine driven auxiliary feedwater pump. The apparent violation is discussed in NRC Inspection Report 05000483/2009009 (ADAMS ML092730656). Members of the public present at the meeting were allowed to ask questions and comment on the proceedings.

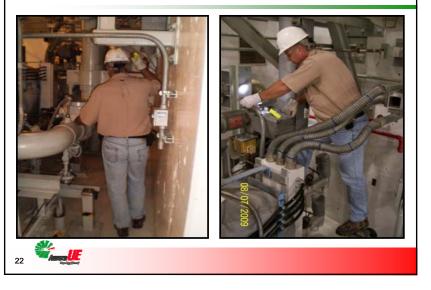
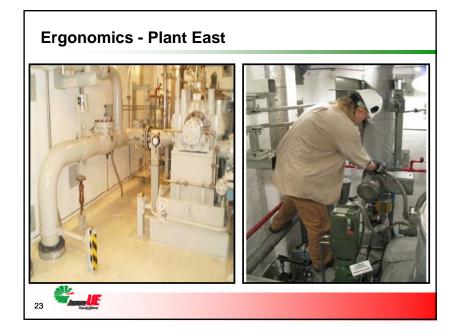
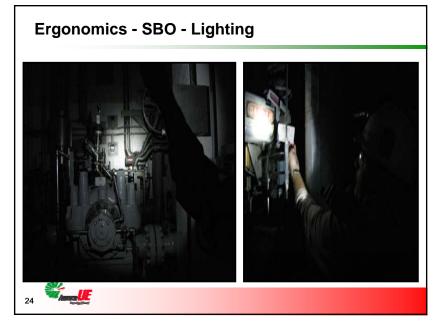
Ergonomics - Plant West

- Room temperature averages 90 -110 deg F
- No Emergency Lighting in the room only Emergency Lighting was in the hallway
- Trip throttle valve accessibility

- Approved use of a more effective high temperature grease for the trip throttle valve
- Correct valve stem lubrication type and preventive maintenance frequency for other important motor operated valves are being verified
- Installed emergency lighting in TDAFP room
- Installed an access platform for the trip throttle valve
- Adequate emergency lighting, access, and tooling to support other critical operator recovery actions are being verified

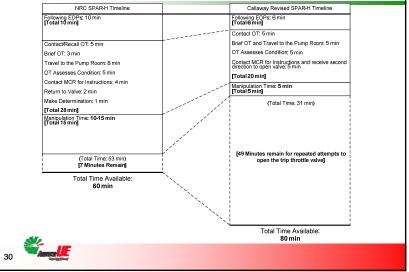
Available Time - Timeline Comparison

- Time to S/G dryout (before core damage)
 S/G dryout is conservatively determined to be 80 minutes
- Time for the crew/operator to diagnose the fail-to-start condition
 - o Control Room diagnosis performed within 6 minutes
- Time available to act and manually start the TDAFP
 - Communication and transit (10)
 - Contact and brief
 - Transit
 - Assess and manipulate (15)
 - Assess and communicate
 - Manipulation
- Time available for repeat actions
