Waterford 3 RF16 Steam Generator Tube Inspection Discussion Points

The following discussion points have been prepared by the NRR Staff to facilitate the conference call to discuss the results of the Waterford 3 Refueling Outage 16 (Fall 2009) steam generator tube inspection. This conference call has been scheduled for Friday, November 13, 2009 at 1:00 PM CST/2:00 PM EST prior to completions of the inspections and repairs.

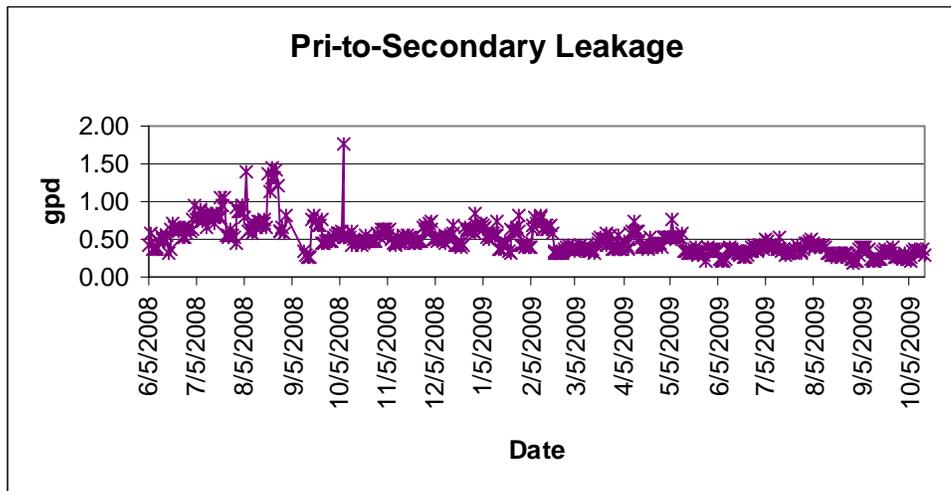
Primary to secondary Leakage has remained below 2 gpd for the entire cycle.
Primary to secondary leakage has remained less than 1 gpd for the last 12 months.
