Steam Generator Batwing Inspections

Fall 2009 Refuel 16 Outage

Preliminary Results

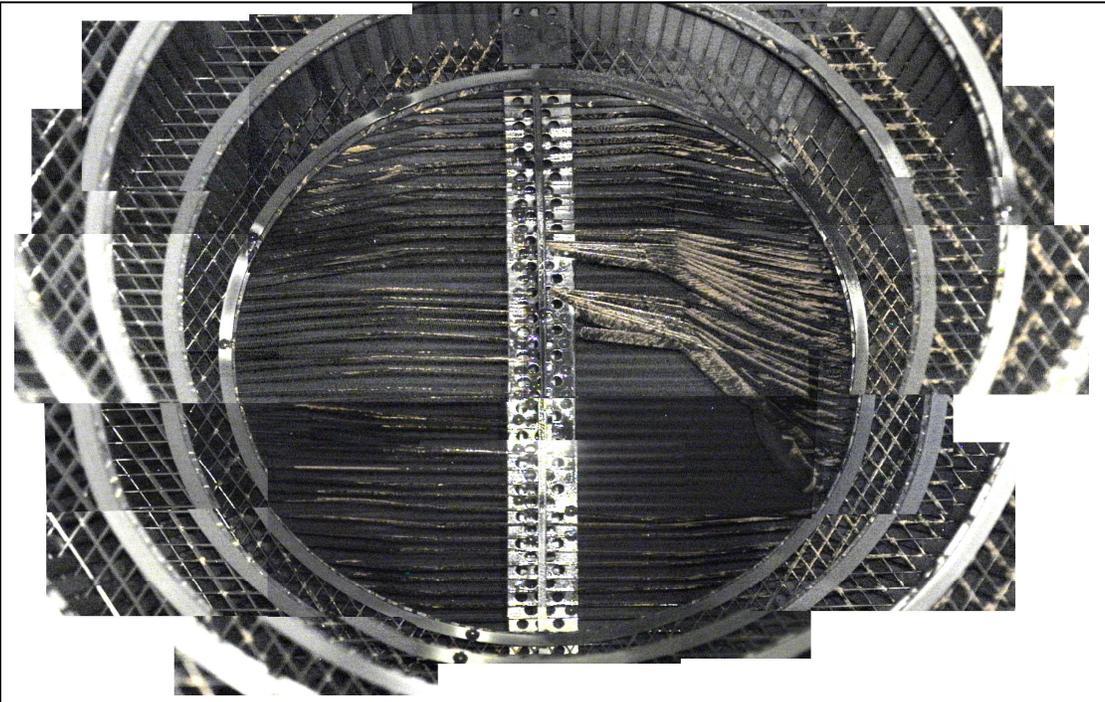
Figure 1a: RF16 SG-1 Composite

- The bottom-up visual inspection of stay cavity region area of interest was performed. No gross tube deformation was indicated and no unexpected batwing degradation was found. The progression of the batwing condition is following the progression observed in SG-2, excepting that the extent of damage is much less. 18 batwings were identified broken at center notch versus 8 in RF15. One batwing had bent over and was above the other displaced batwings, which is also similar to but bounded by the conditions observed in SG-2. No missing batwing pieces had formed. All batwings met the acceptance criteria of less than 36" segments formed, with no concerns identified.
- The composite bottom-up video inspection was parsed and compiled to form a composite view. The composite view from RF16 and RF15 are provided as figures 1a and 1b, respectively.

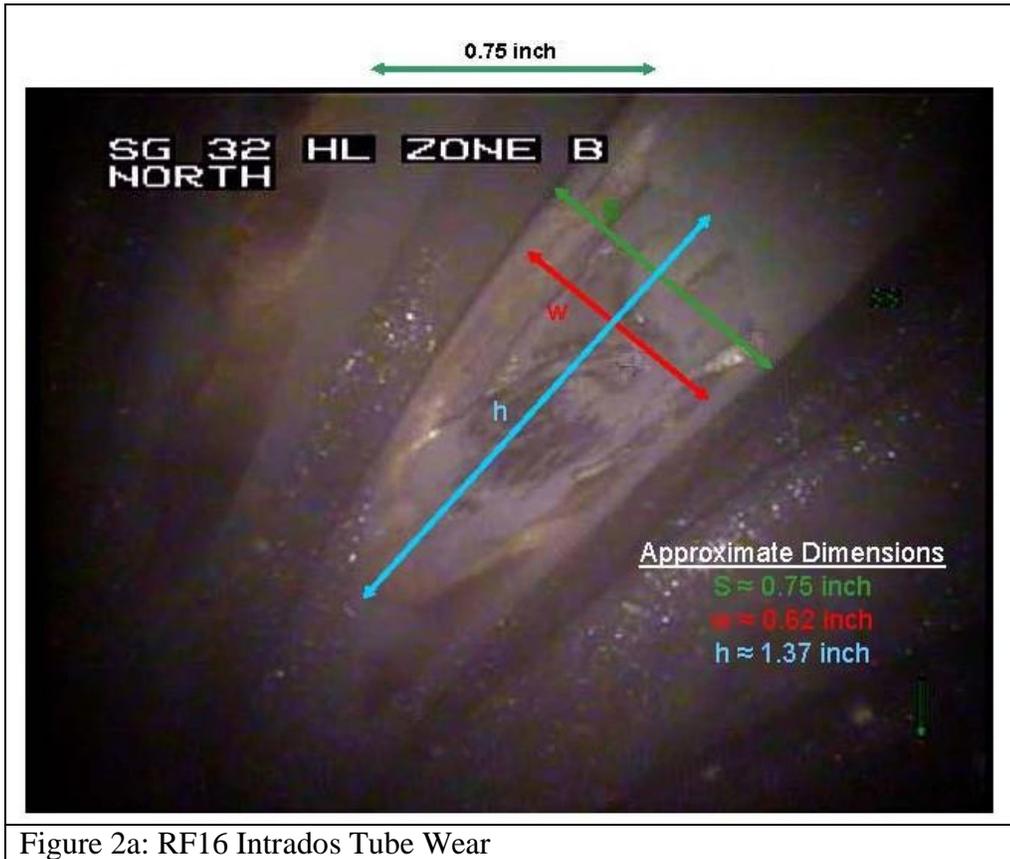
Figure 2a: RF16 Intrados Tube Wear

- The batwing to tube interface around the stay cavity region area of interest was visually inspected. The stabilized tubes were intact with no gross deformation or severe damage indicated. Although the batwing damage had progressed, this was expected and the batwing to tube interface condition had not noticeably changed from the previous inspections. The intrados tube wear that had been previously observed was examined in detail. The wear models predicted the stabilized tubes adjacent to the stay cavity region could have through-tube wear, and established gross tube damage criteria that would characterize unexpected or unacceptable wear. The gross tube damage was defined as irregular tube spacing, tube dislocation, through-wall wear greater than 180 degrees of the tube circumference or, if stabilized, the stabilizer is visibly scalloped, gouged or torn such that the structural integrity of the stabilizer fence around the stay cavity boundary may not be able to restrain the forces generated. During the mid-cycle outage and RF15 outage, one cold leg tube had what appeared to be a teardrop-shaped wear scar (approximately 1 1/2 inches long by 3/8 inch wide) on the intrados tube wall at or near the C103 tube. This wear scar had progressed, and is now about 25% through tube wear, with two strands of the stabilizer having visible wear. Figures 2a and 2b are of this wear. All tubes met the

acceptance criteria of less than 33% through tube wear, and observed stabilizer wear was analyzed and confirmed to be acceptable with at least 30% of the stabilizer remaining at the end of the cycle 17.

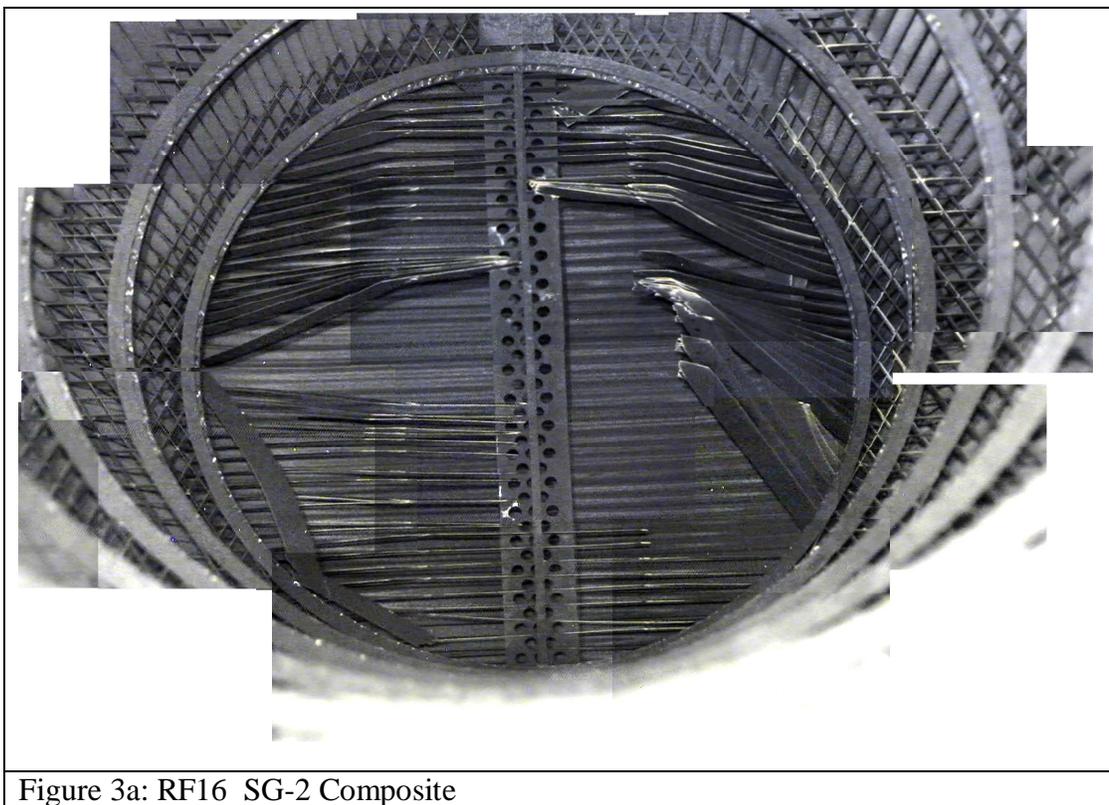
Figure 3a: RF16 SG-2 Composite

- The bottom-up visual inspection of stay cavity region area of interest was performed. No gross tube deformation was indicated and no unexpected batwing degradation was found. 25 batwings were identified broken at center notch, 18 of which had separated half horizontal bar segments of about 6.5 inches in length versus 4 in RF15. Otherwise, the general batwing condition remained similar to the conditions previously observed in SG-2. 5 loose batwing segments were located. Previous analyses accept worst case wear from the loose batwing segments and all loose batwing segments met the acceptance criteria of less than 36". No other concerns were identified.
- The composite bottom-up video inspection was parsed and compiled to form a composite view. The composite view from RF16 and RF15 are provided as figures 3a and 3b, respectively.
