# Crystal River Unit #3 *Containment Delamination Update*

November 20<sup>th</sup> 2009

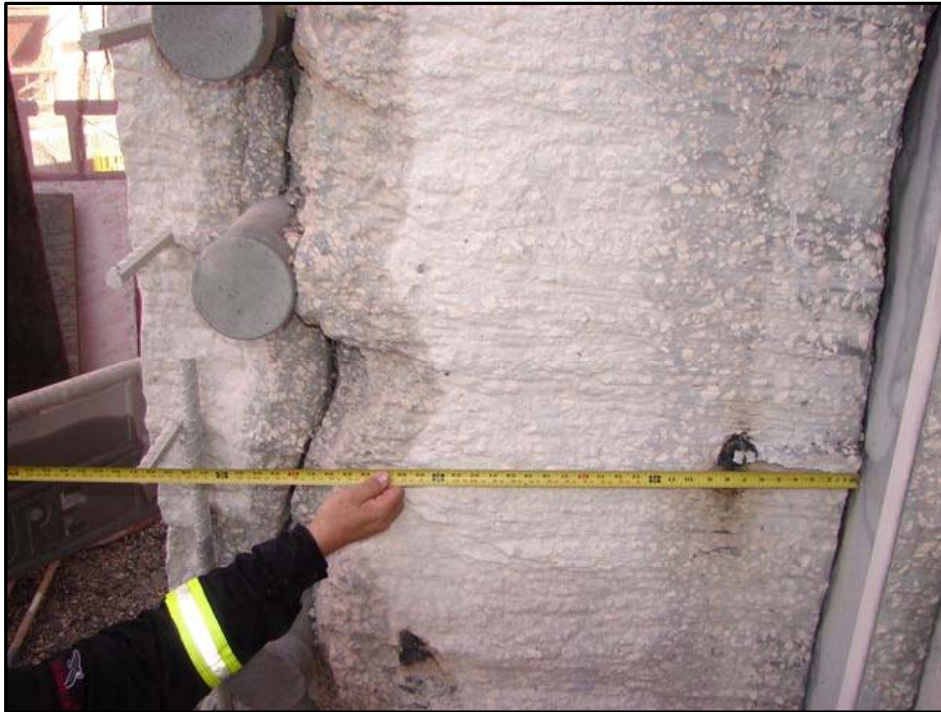
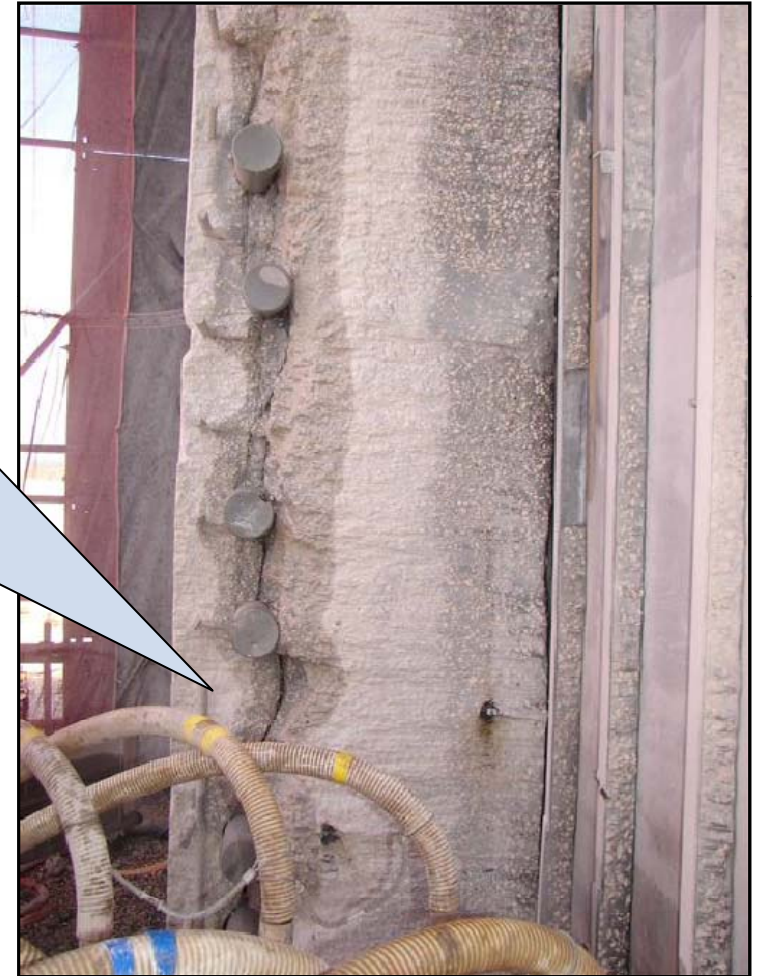
# Delamination Close-up

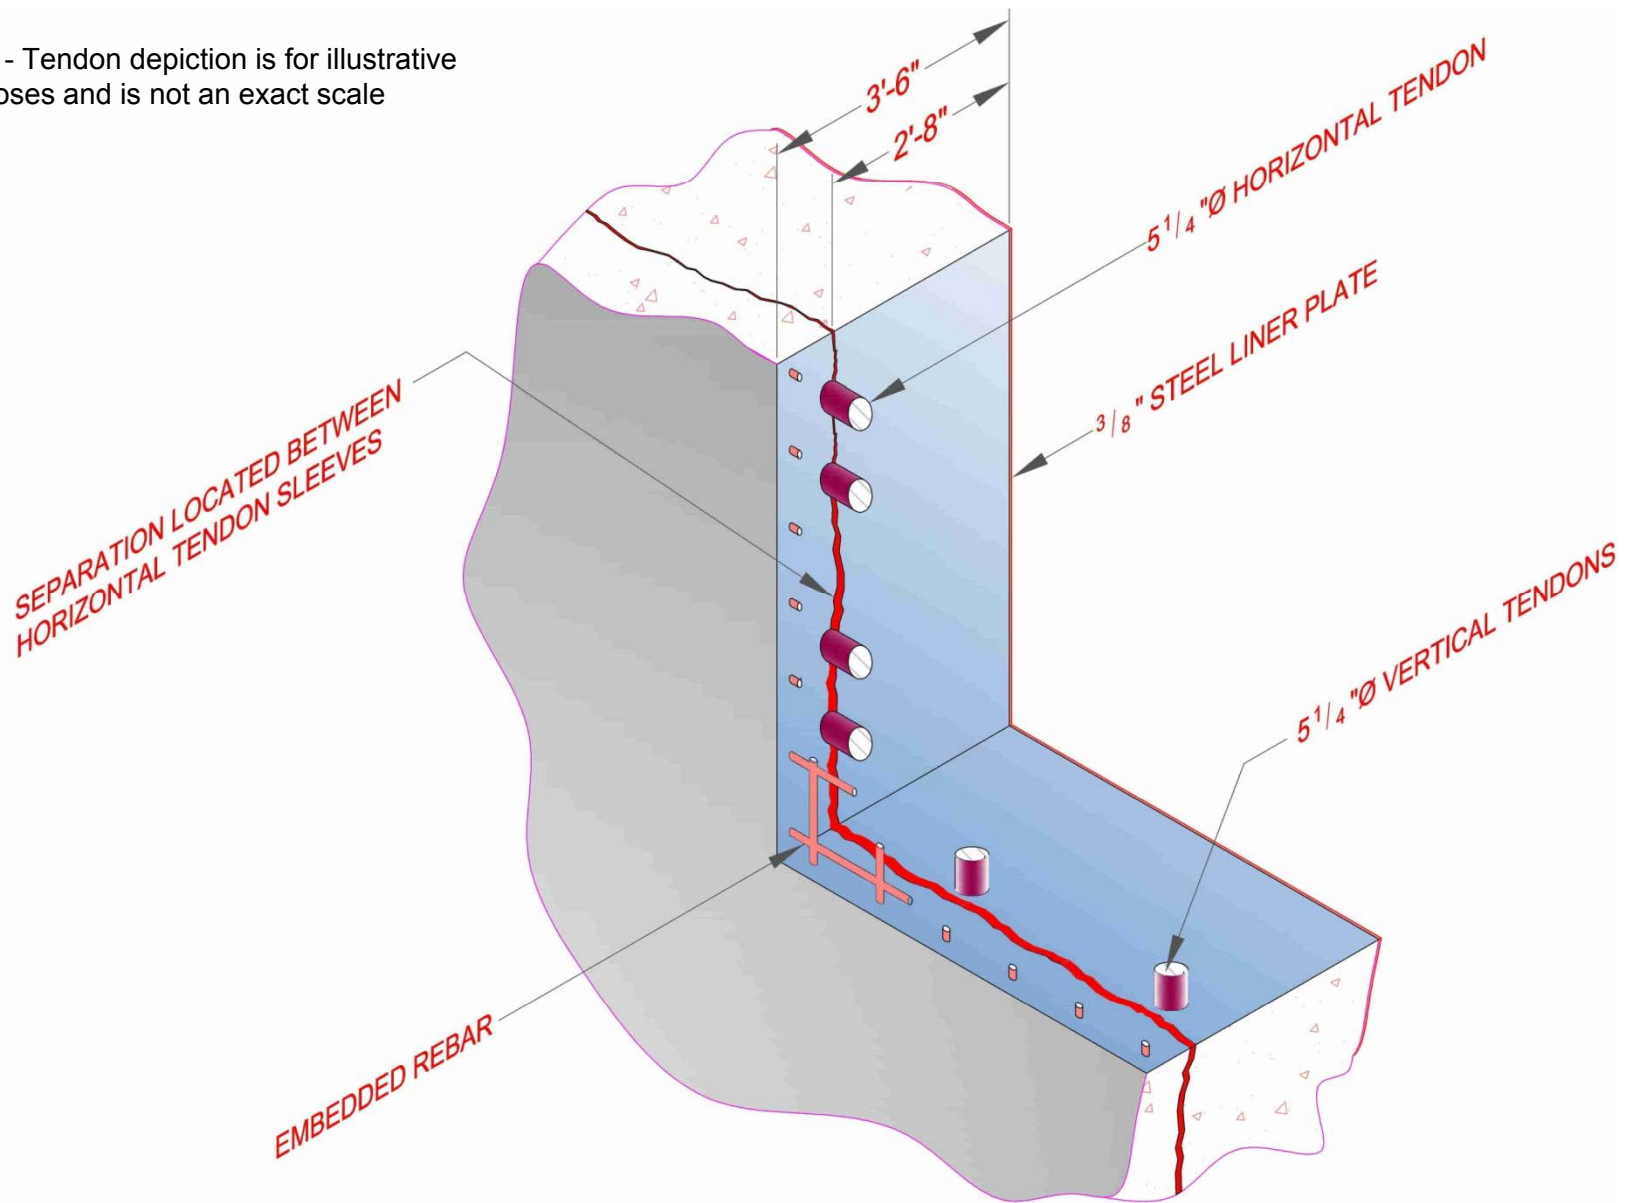
# Location of the Delamination

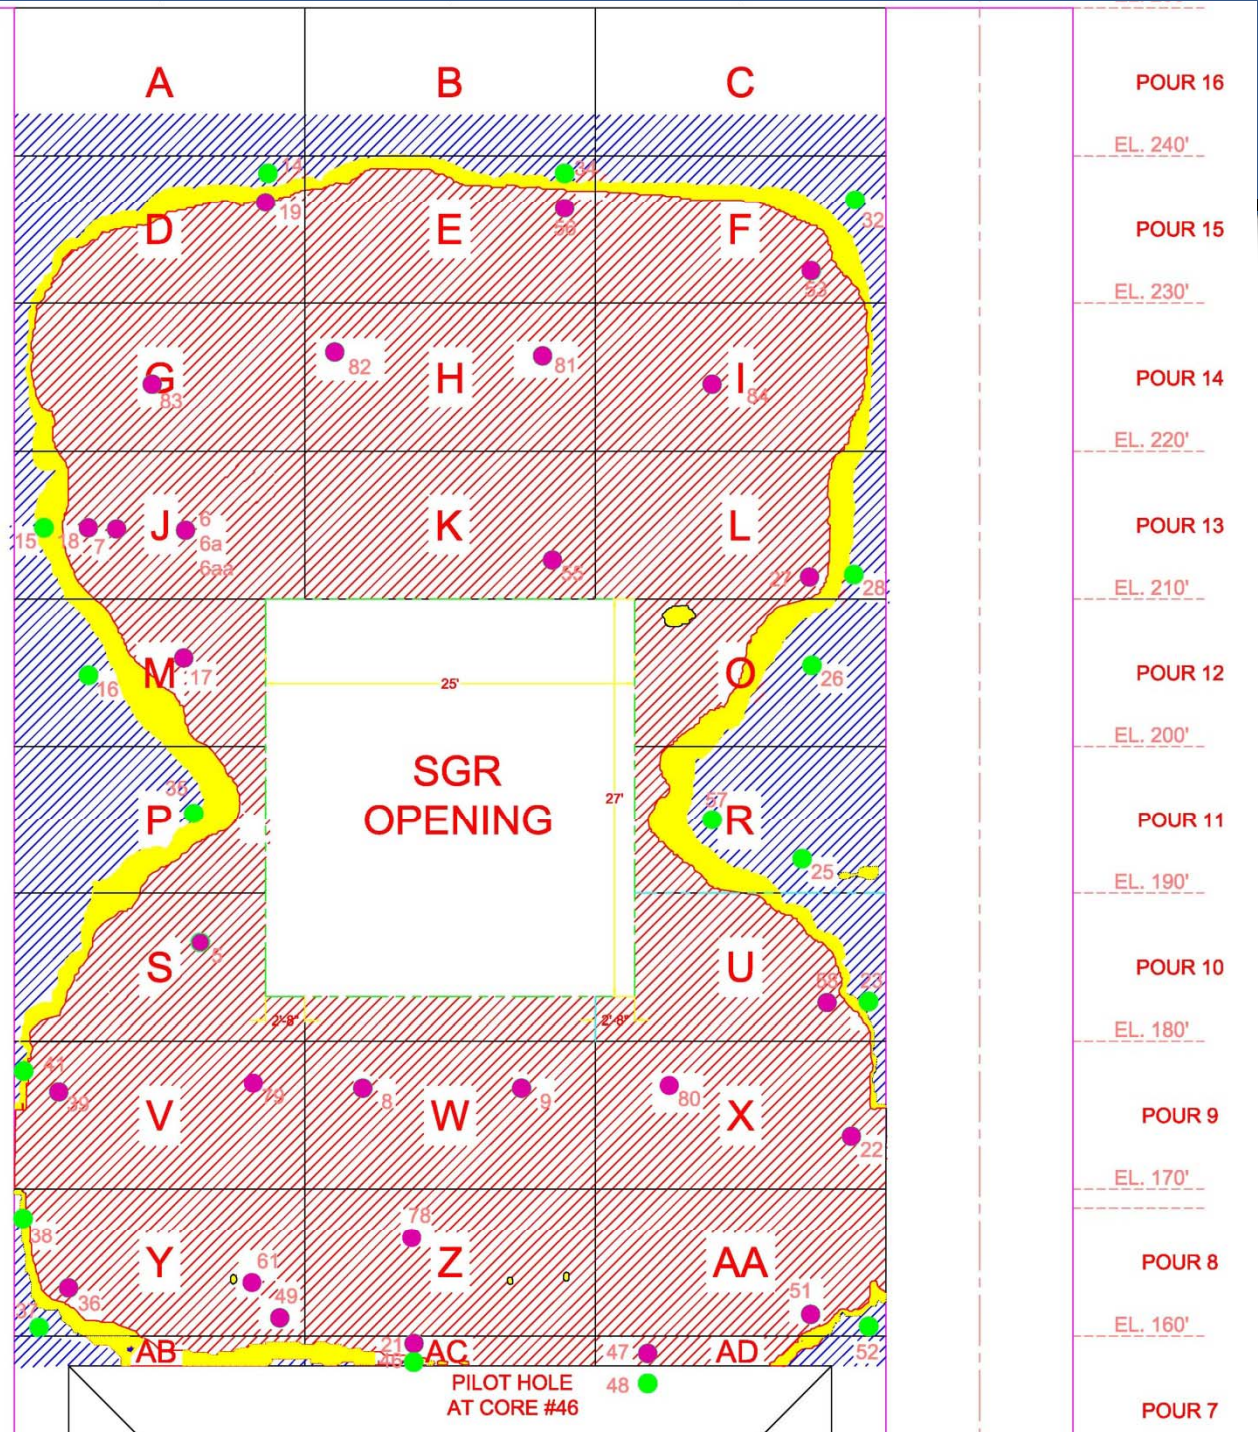
**Conclusion** – Delamination has only been observed in core bore hole(s) boroscopic exams in the buttress 3-4 span, as accurately predicted by IR

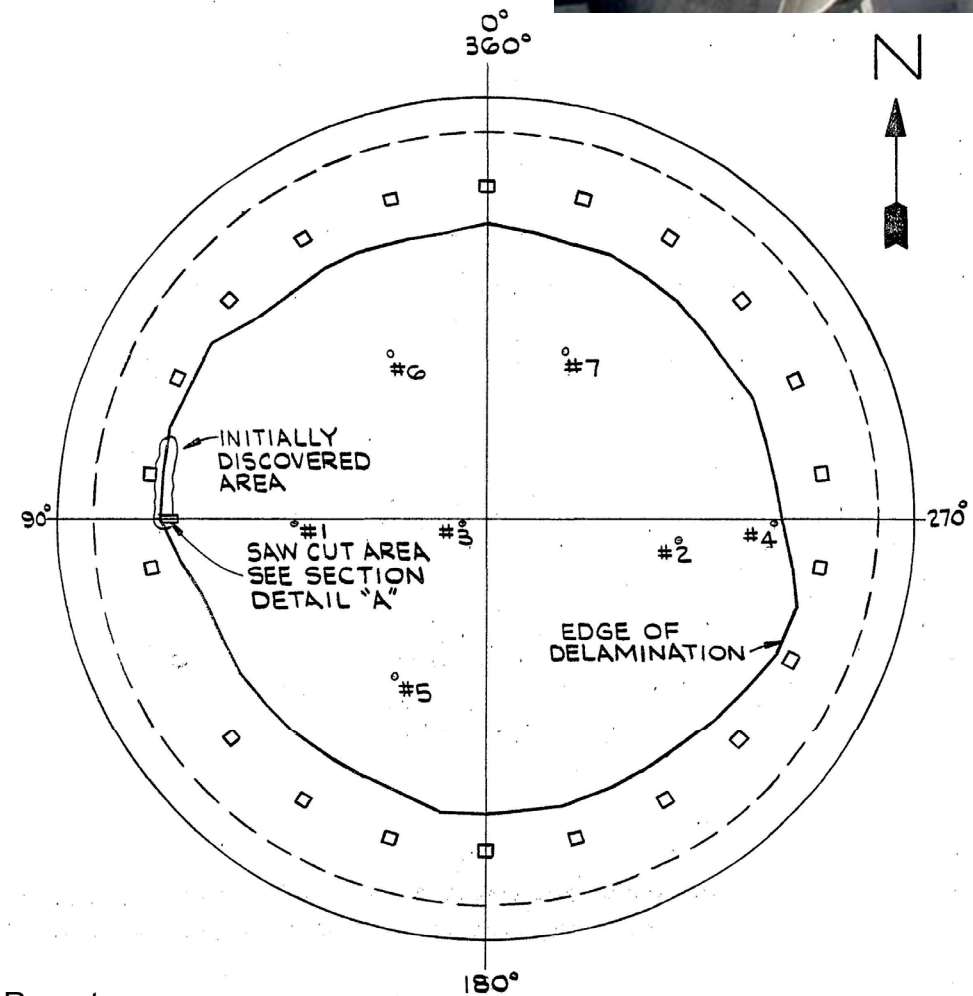
- Compression - tension interaction failure occurred
- Contributing Effects
  - ◆ Radial tension due to pre-stressing
  - ◆ Thermal effects
  - ◆ Tendon alignment
  - ◆ Stress concentrations
  - ◆ Shrinkage
- Combined with biaxial compressive stresses and lower than normal<sup>(2)</sup> direct tensile strength of concrete
