Flow Control Division

Subject: USNRC 10CFR Part 21 Notification (Log No. 2009-24-00 / Event No. / Accession No. ML093140090) **Revised Notification**

Ref: Flowserve Size 3/4 Figure 848Y Disk/Disk Nut Separation
LaSalle Station
Exelon PowerLabs, LLC Project Number: LAS-62808
Flowserve Complaint Report 4914
Flowserve Evaluation Report No. 10 CFR 21-50

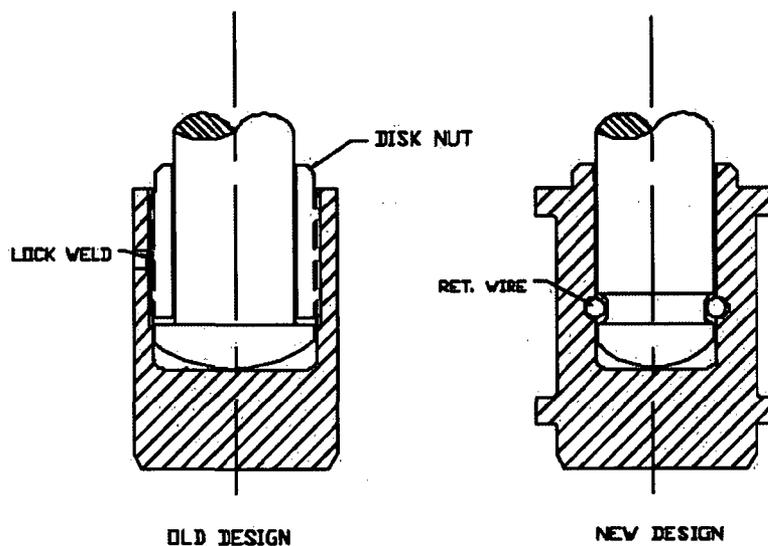
Figure 1 Stem/Disk Assemblies for Old Design and New Design.

The subject valve was in service at the time of disassembly. The disassembly revealed that the disk nut, which captures the valve stem in the valve main disk, had separated from the main disk.

Figure 1 provides an illustration of the stem/disk assembly. The **"Old Design"** is typical of the valve that is the subject of this discussion. The valve stem has a collar on the very end. After the stem is inserted into the disk, the disk nut is threaded into the disk to retain the stem. A lock weld is then created to prevent the disk nut from unthreading out of the disk.

In about 1990, the design was changed to that shown as the **"New Design"** in Figure 1. The disk nut was eliminated, and the disk retained on the end of the valve stem using a piece of wire inserted into a groove located half in the valve stem and half in the disk.

For the case of the **"Old Design"** valve at LaSalle, once the disk nut has unthreaded out of the disk, the stem and the disk are no longer connected. The valve will then operate as a stop-check valve. The valve will open in response to normal forward flow, and close in response to normal reverse flow.

After unthreading from the disk, the disk nut will sit on top of the disk. The valve will be able to open only partially, because the disk nut will interfere with the ability of the valve to open fully. The amount that the valve can open will depend on the size of the valve. For the Size 3/4 valve at LaSalle, the disk would be able to open less than 1/8 of an inch. The amount that other valve sizes would be able to open is different, but all would be reduced.

The valves affected are Size 2 and smaller Edward Figure 848, 849, 828 and 829 valves manufactured by Rockwell International at the Sulphur Springs, Texas, and the Raleigh, North Carolina, manufacturing facilities prior to 1991. These valves may be tagged "Rockwell", "Rockwell Edward" or "Edward". The valves affected have the "**Old Design**" stem/disk assembly shown in Figure 1.

Valves with Figure Number **A848 / A849 / A828 / A829** incorporate the "**New Design**" stem/disk connection and are not affected.

Based on the above, the Nuclear Industry needs to be notified concerning the potential defect, and encouraged to inspect the operation of their valves, especially if they have a safety-related function in the plant that may be adversely affected.
