#### INTERIM REPORT ON THERMOSTATIC VALVE FAILURE ON PALO VERDE EDG

**Report No. 10CFR21-0098**  
Rev. 0: 12/01/09

**10CFR21 REPORTING OF DEFECTS  
AND NON-COMPLIANCE**

COMPONENT: Amot thermostatic valve element  
P/N: 9760X

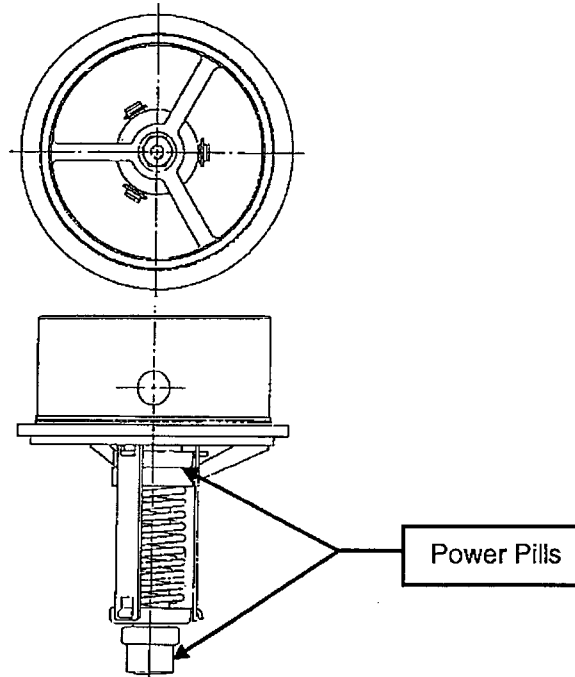
**FIGURE 2: VALVE ELEMENT 9760X**

The Palo Verde failure analysis determined that one of two elements within the valve was defective. The element failure was attributed to wax leakage past the diaphragm seal on one of two power pills within the element. Evidence of mechanical binding of the piston is believed to have caused the wax leakage. If the piston was jammed, the expanding wax could have over-pressurized the diaphragm seal leading to wax leakage. The failure analysis noted the following to support piston binding:

- The piston was initially difficult to remove from its guide tube.
- A gouge was observed on the piston surface.
- The rubber plug within the power pill exhibited brass machining chip debris.

- The primary cause of the failure is believed to be the gouge found in the pill stem. The gouge could have occurred during the conversion process as the stem is removed and handled at that time.

The 9760X element contains two power pills (Figure 2). The power pills contain a temperature sensitive wax that expands with increasing temperature and provides the motive force to lift the element off of its seat.

- As a precaution, Amot has made changes to their conversion process for this pill. The drilling fixture was modified to eliminate the possibility of chips entering the pill during the machining operation. This change was made effective 10/22/09.

The element failure at Palo Verde is considered to be an isolated incident related to a gouge in the pill stem. Thus, there is no recommended corrective action for users of the Amot 9760X element.
