## POWER AUTHORITY OF THE STATE OF NEW YORK

Subject: Indian Point 3 Nuclear Power Plant

Docket No. 50-286

Steam Generator Tube Leak

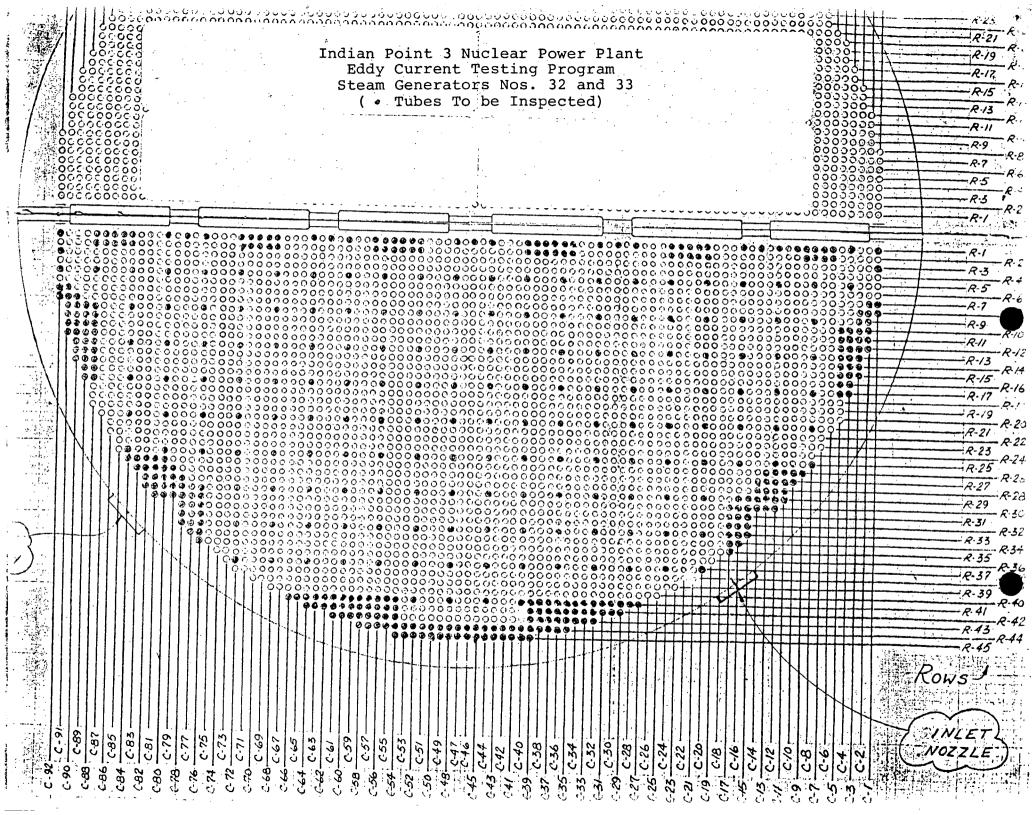
The Authority will perform inspection of tubes at the hardspot regions between the support plate flow slots. These additional inspections (five tubes) are indicated on the attached map of the Westinghouse Model 44 steam generator.

As discussed during the above mentioned phone conversation, the Authority has reoriented the tubes to be inspected in the interior of the steam generator (i.e.; on a column basis versus row basis) to permit easier identification by the operator of the tubes to be inspected. This reorientation is indicated on the attached map. There is no change in the number of tubes to be inspected.

The Authority will gauge the tubes in the Indian Point 3 Steam Generators Nos. 32 and 33 using 720, 650, 610 and 540 mil eddy current probes. Tubes will be plugged if the 540 mil probe fails to traverse the tube. The Authority is considering gauging of tubes adjacent to those where extensive denting has occurred. The extent of the additional gauging to be performed will be decided by the Authority depending upon the general condition of the steam generator as determined by this inspection.
