**Report No. 10CFR21-0098**

**10CFR21 REPORTING OF DEFECTS  
AND NON-COMPLIANCE**

COMPONENT: Amot thermostatic valve element  
P/N: 9760X

SYSTEM: Emergency Diesel Generator – lube oil & jacket water system

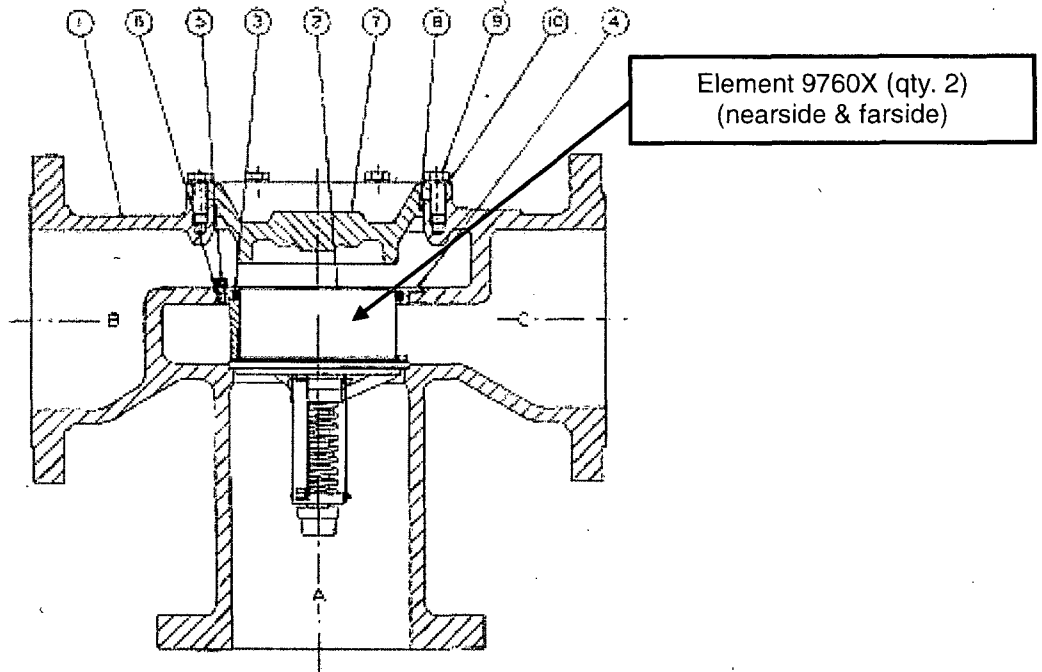
**FIGURE 1: AMOT THERMOSTATIC VALVE**

The Amot type 9760X elements are used in the Amot type "H" thermostatic valve. These valves are used in some Cooper-Bessemer KSV diesel engine jacket water and/or lube oil systems to maintain proper system temperatures during engine operation. A very limited number of EMD diesel engines also use the type "H" valve in the jacket water system.

Each valve uses 2 thermostatic elements, Amot type 9760X (item 2 in Figure 1). The element being investigated for the Palo Verde application has a nominal temperature setting of 160°F and therefore the element part number is 9760X-160.

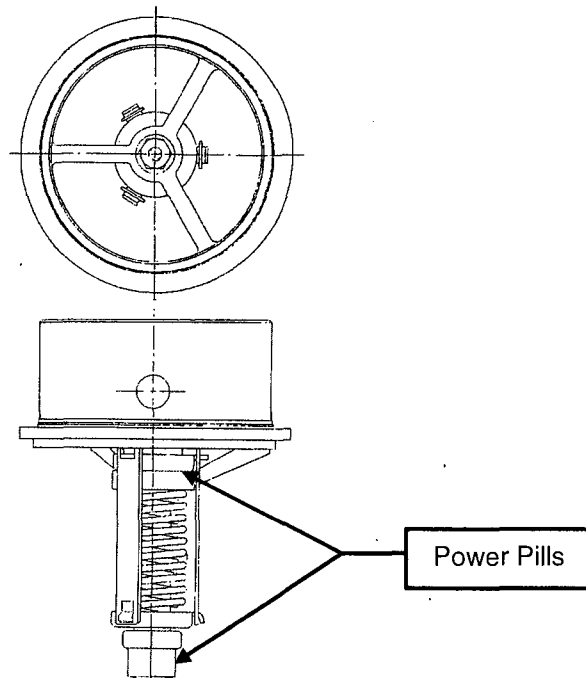
**FIGURE 2: VALVE ELEMENT 9760X**

The Palo Verde failure analysis determined that one of two elements within the valve was defective. The element failure was attributed to wax leakage past the diaphragm seal on one of two power pills within the element. Evidence of mechanical binding of the piston is believed to have caused the wax leakage. If the piston was jammed, the expanding wax could have over-pressurized the diaphragm seal leading to wax leakage. The failure analysis noted the following to support piston binding:

- The piston was initially difficult to remove from its guide tube.
- A gouge was observed on the piston surface.
- The rubber plug within the power pill exhibited brass machining chip debris.

- The primary cause of the failure is believed to be the gouge found in the pill stem. The gouge could have occurred during the conversion process as the stem is removed and handled at that time.

The 9760X element contains two power pills (Figure 2). The power pills contain a temperature sensitive wax that expands with increasing temperature and provides the motive force to lift the element off of its seat.

- As a precaution, Amot has made changes to their conversion process for this pill. The drilling fixture was modified to eliminate the possibility of chips entering the pill during the machining operation. This change was made effective 10/22/09.

The element failure at Palo Verde is considered to be an isolated incident related to a gouge in the pill stem. Thus, there is no recommended corrective action for users of the Amot 9760X element.

The evaluation also indicated a weakness in Amot's manufacturing process for the element pill which introduced machining debris. While not believed to be the cause of the Palo Verde element failure, machining debris within the element pill is undesirable and increases the potential for failure in the future. Users with thermostatic valves containing Amot P/N 9760X elements should be aware of this issue so that they can monitor their systems for any indications of thermostat element problems.
