**New York Power
Authority**

Subject: Indian Point 3 Nuclear Power Plant
Docket No. 50-286
1982/1983 Steam Generator Tube Inspection and
Repair Program

1982 STEAM GENERATOR E.C.T. SUMMARY

REPORT OF ACTUAL SLEEVE CONDITIONS

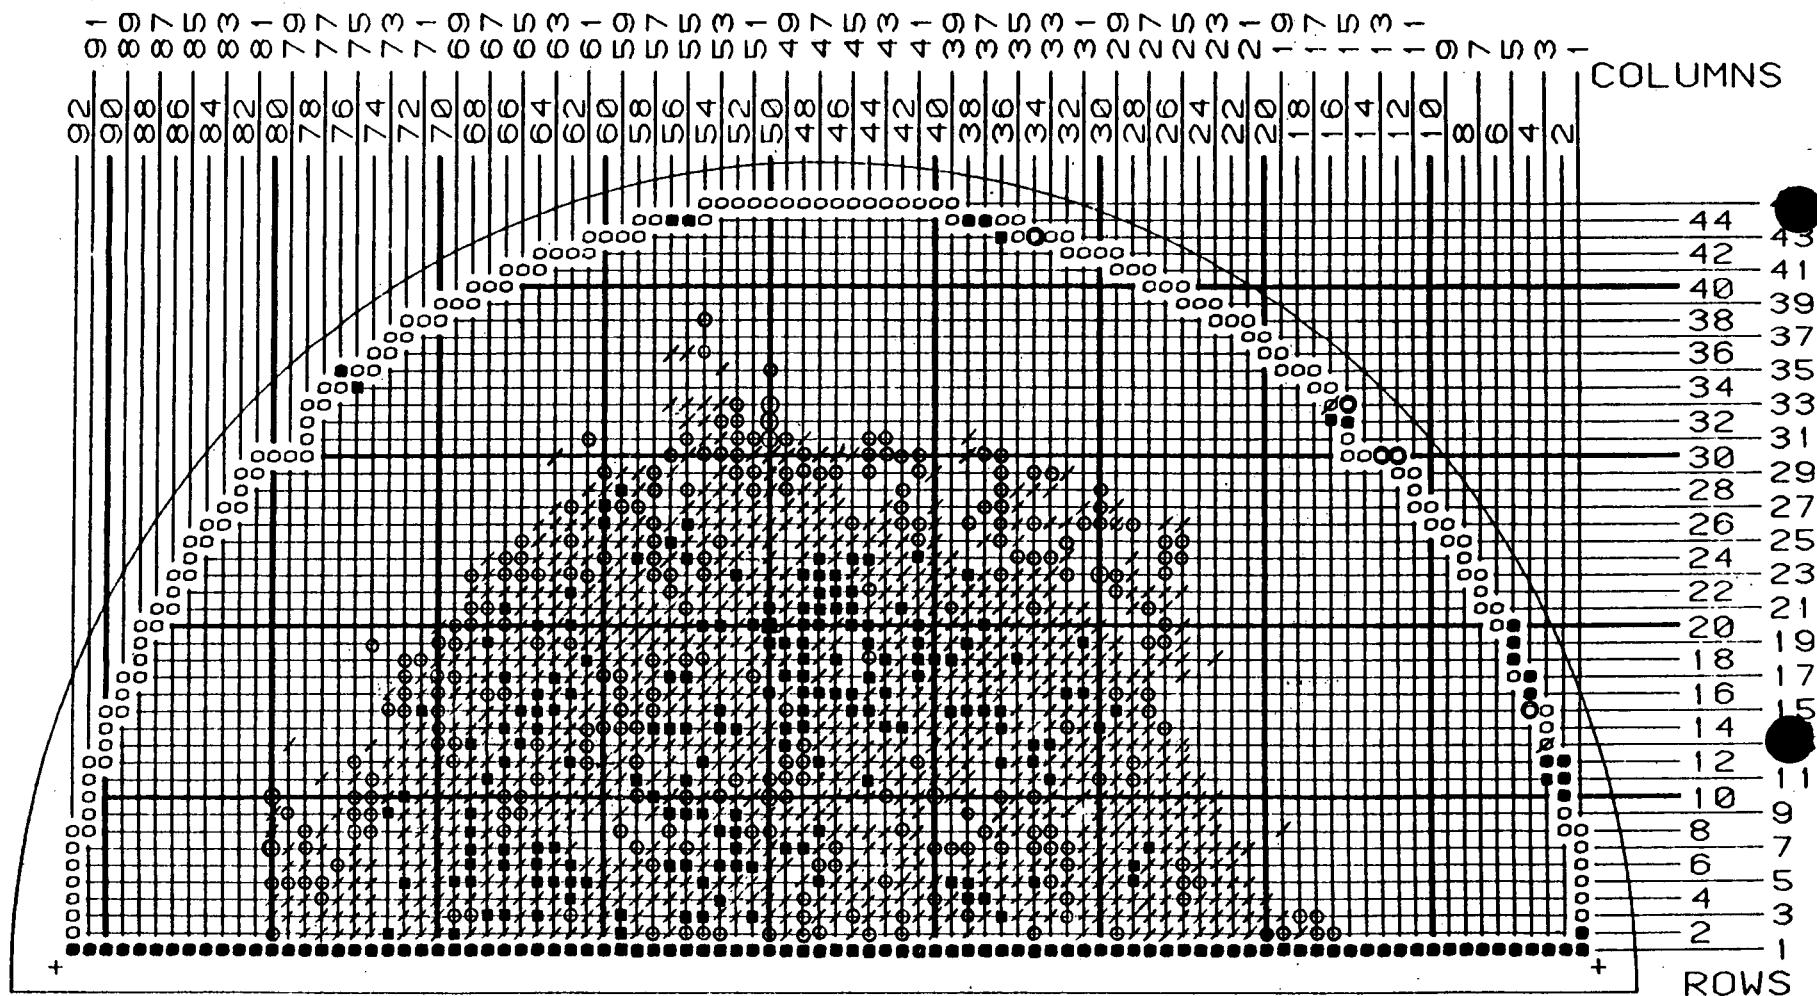
TUBESHEET MAP - 31 OUTLET

* = $\geq 50\%$ (848)

⊕ = $< 50\%$ (274)

■ = PREVIOUSLY PLUGGED TUBES (285)

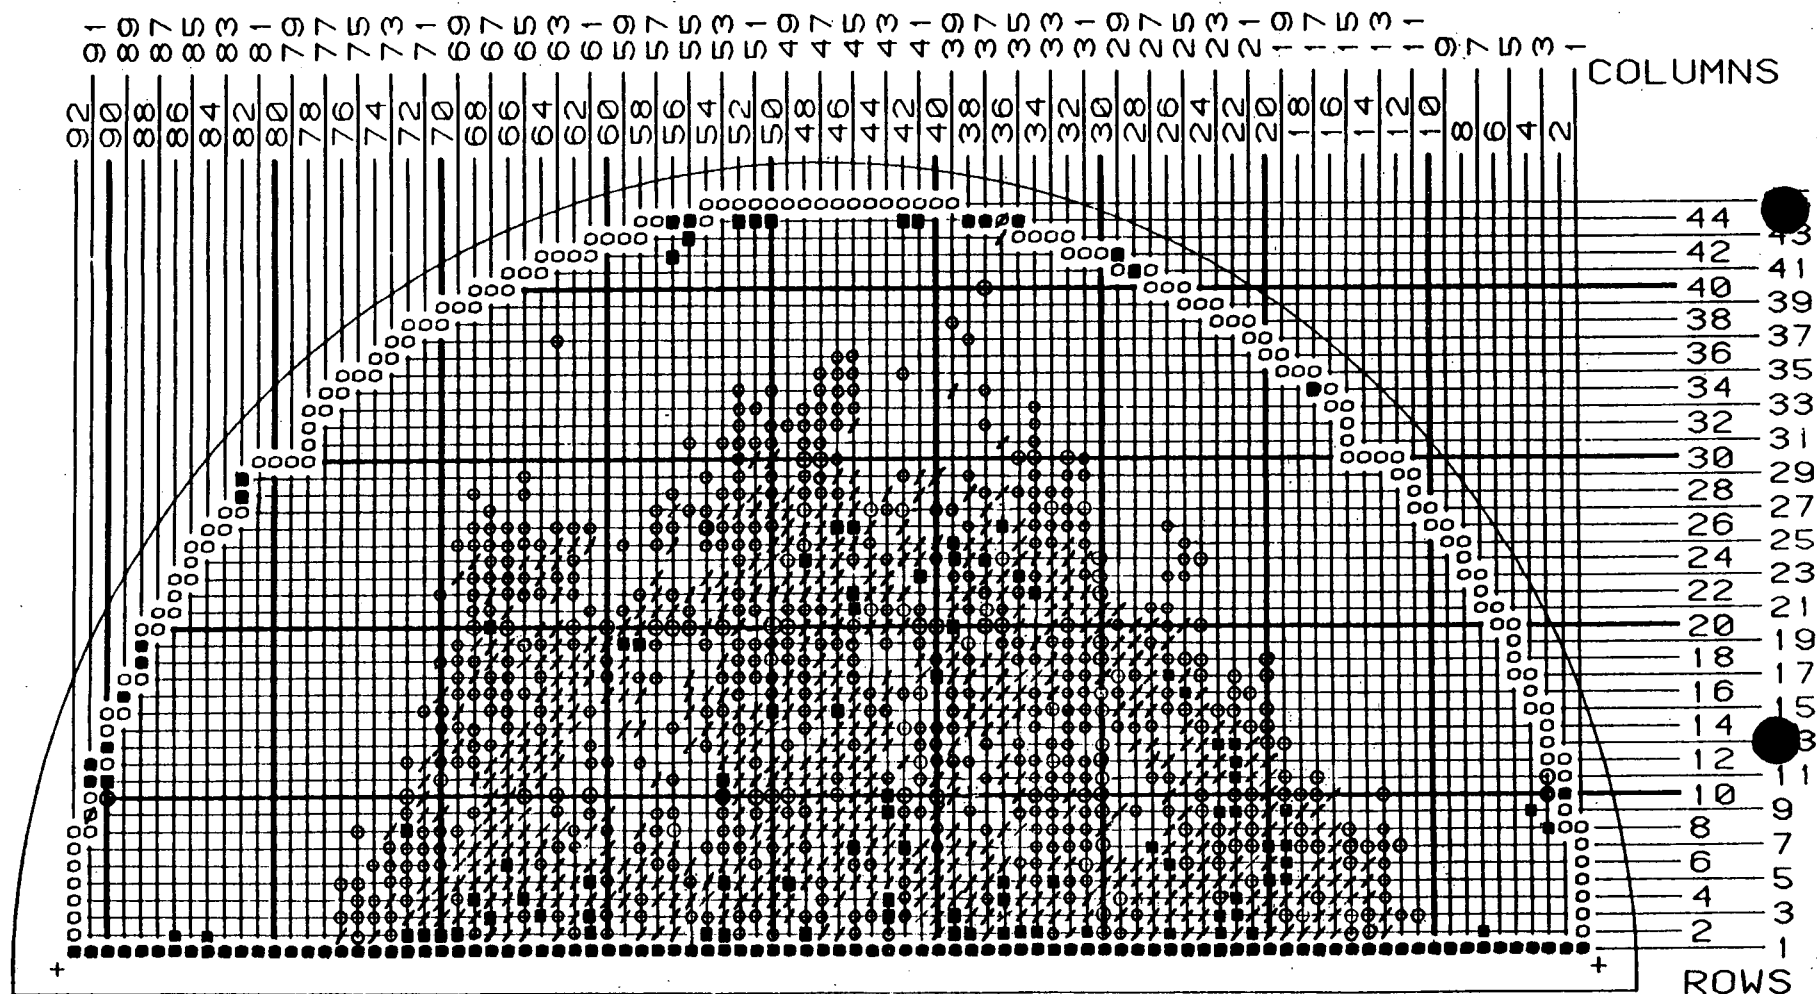
TUBESHEET MAP - 32 OUTLET

✱ = ≥ 50% (583)

⊙ = < 50% (553)

■ = PREVIOUSLY PLUGGED TUBES (198)

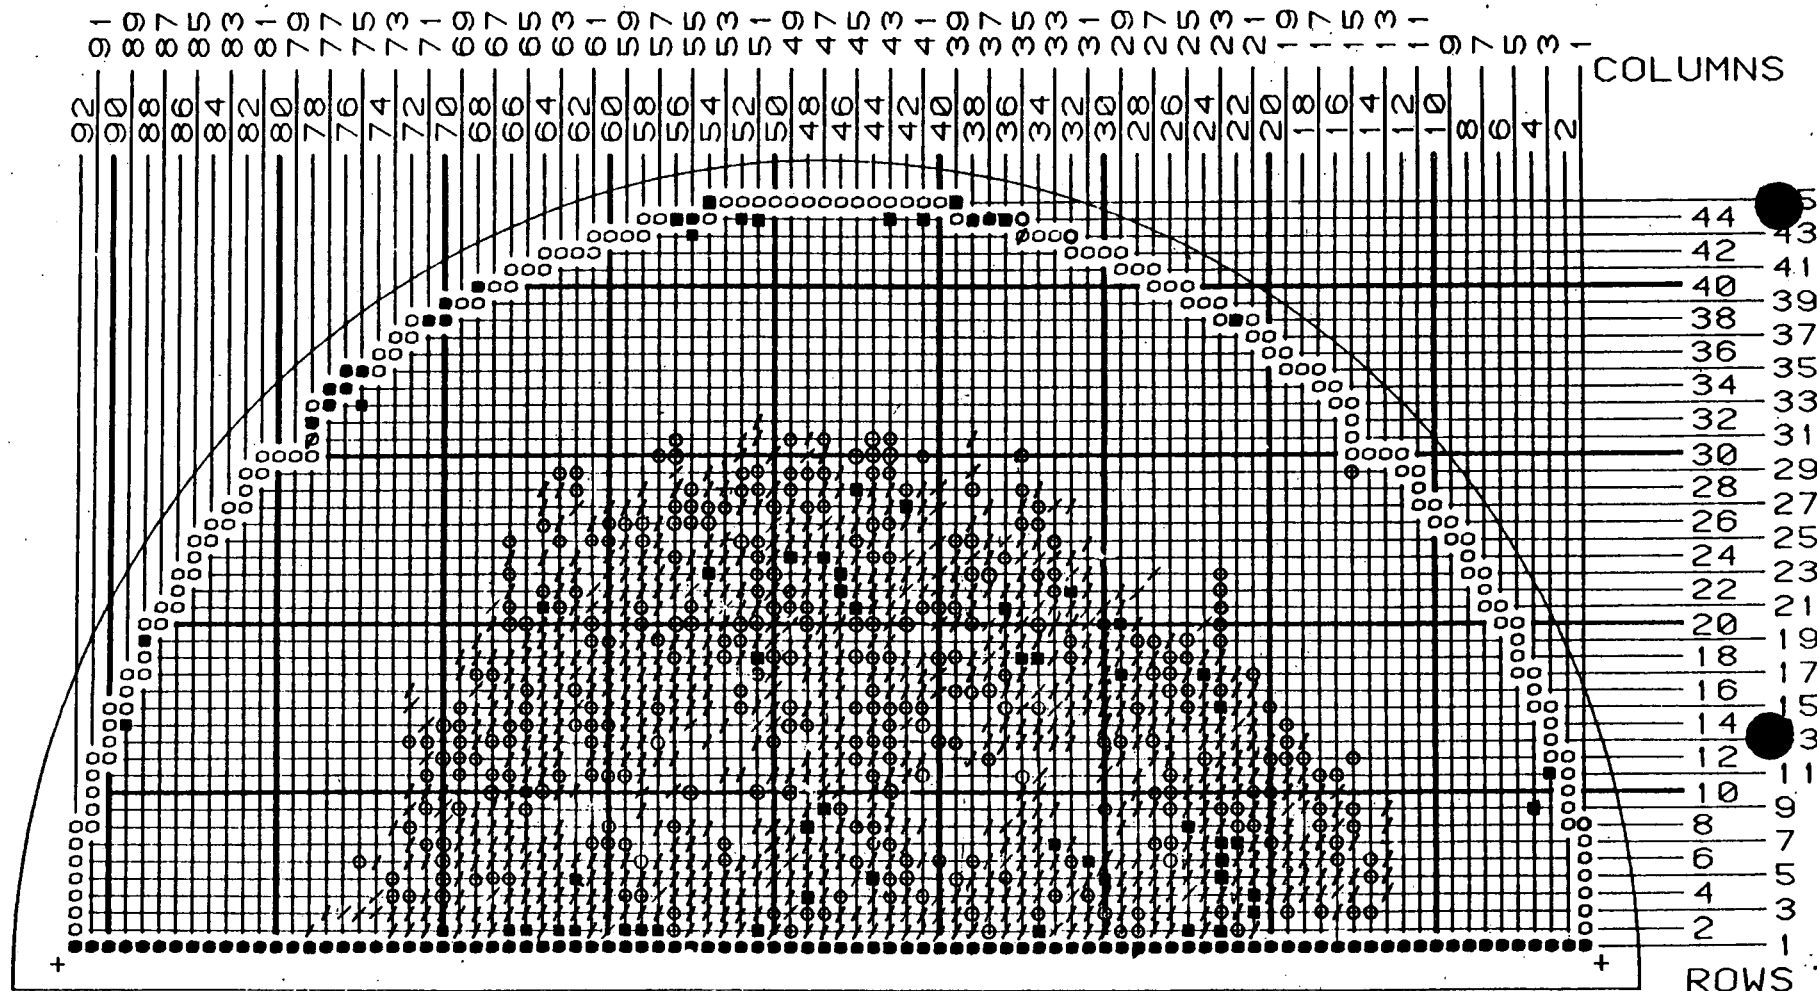
TUBESHEET MAP - 33 OUTLET

* = $\geq 50\%$ (770)

⊕ = $< 50\%$ (310)

■ = PREVIOUSLY PLUGGED TUBES (167)

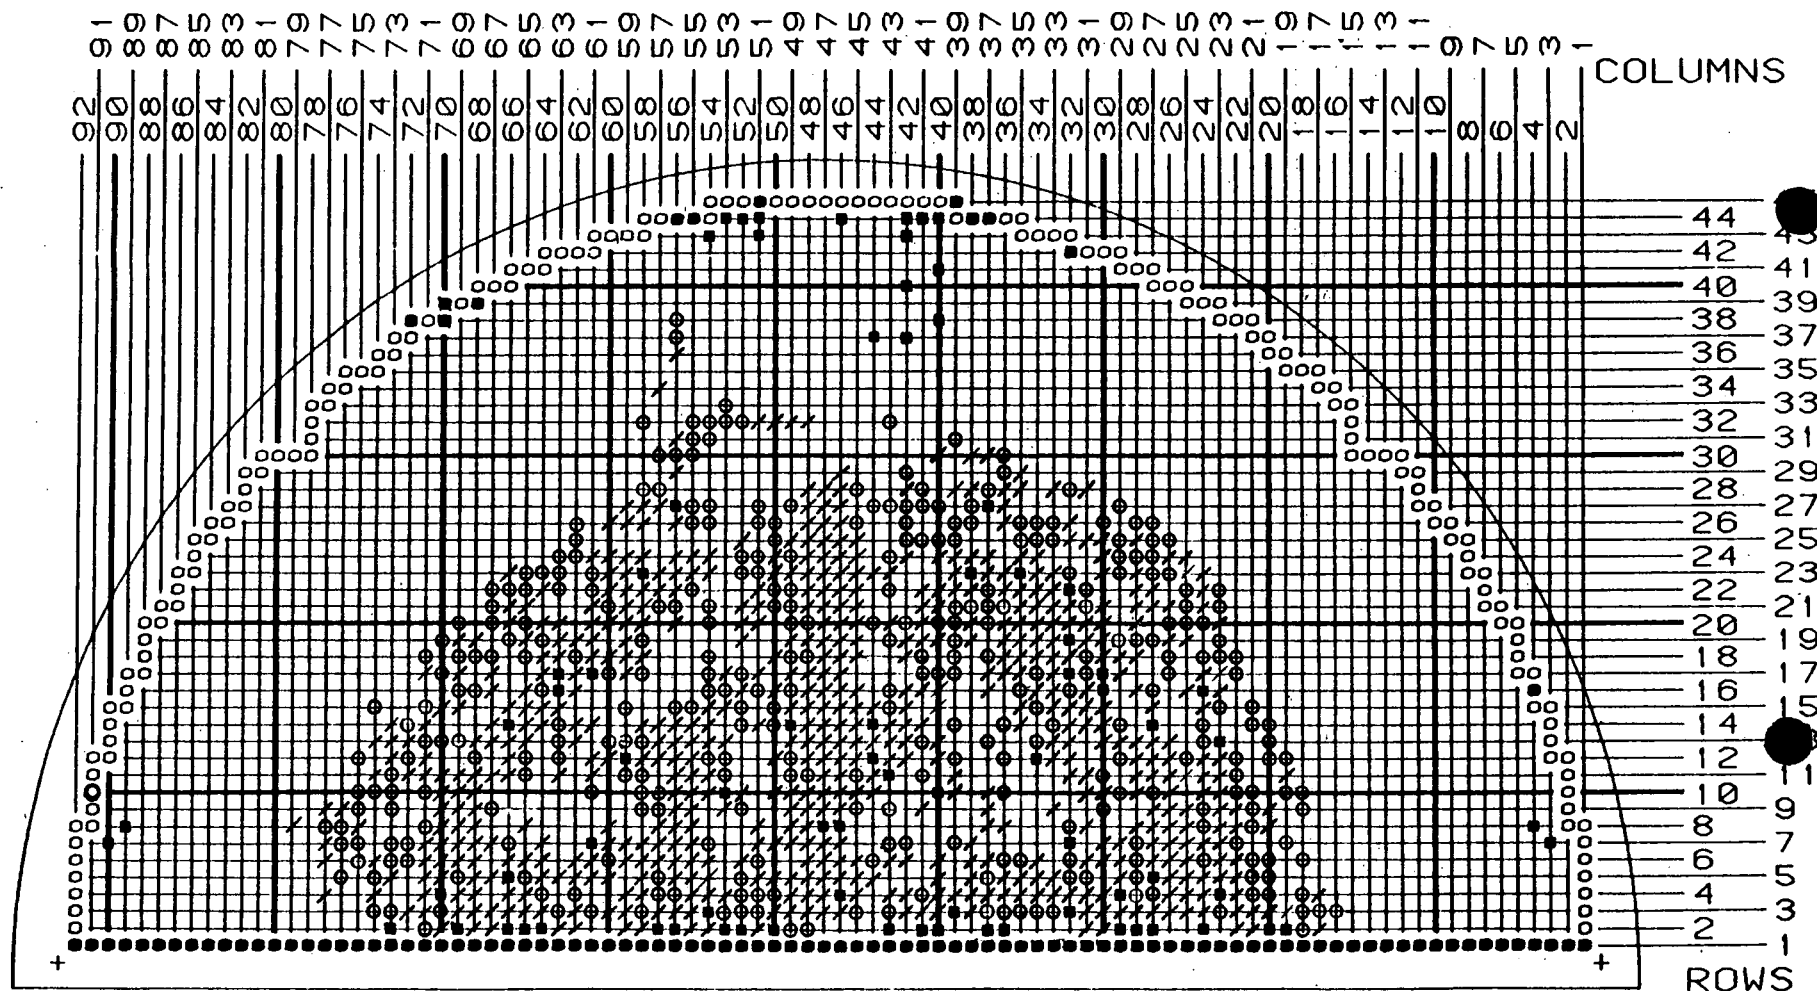
TUBESHEET MAP - 34 OUTLET

* = ≥ 50% (618)

⊕ = < 50% (342)

■ = PREVIOUSLY PLUGGED TUBES (182)

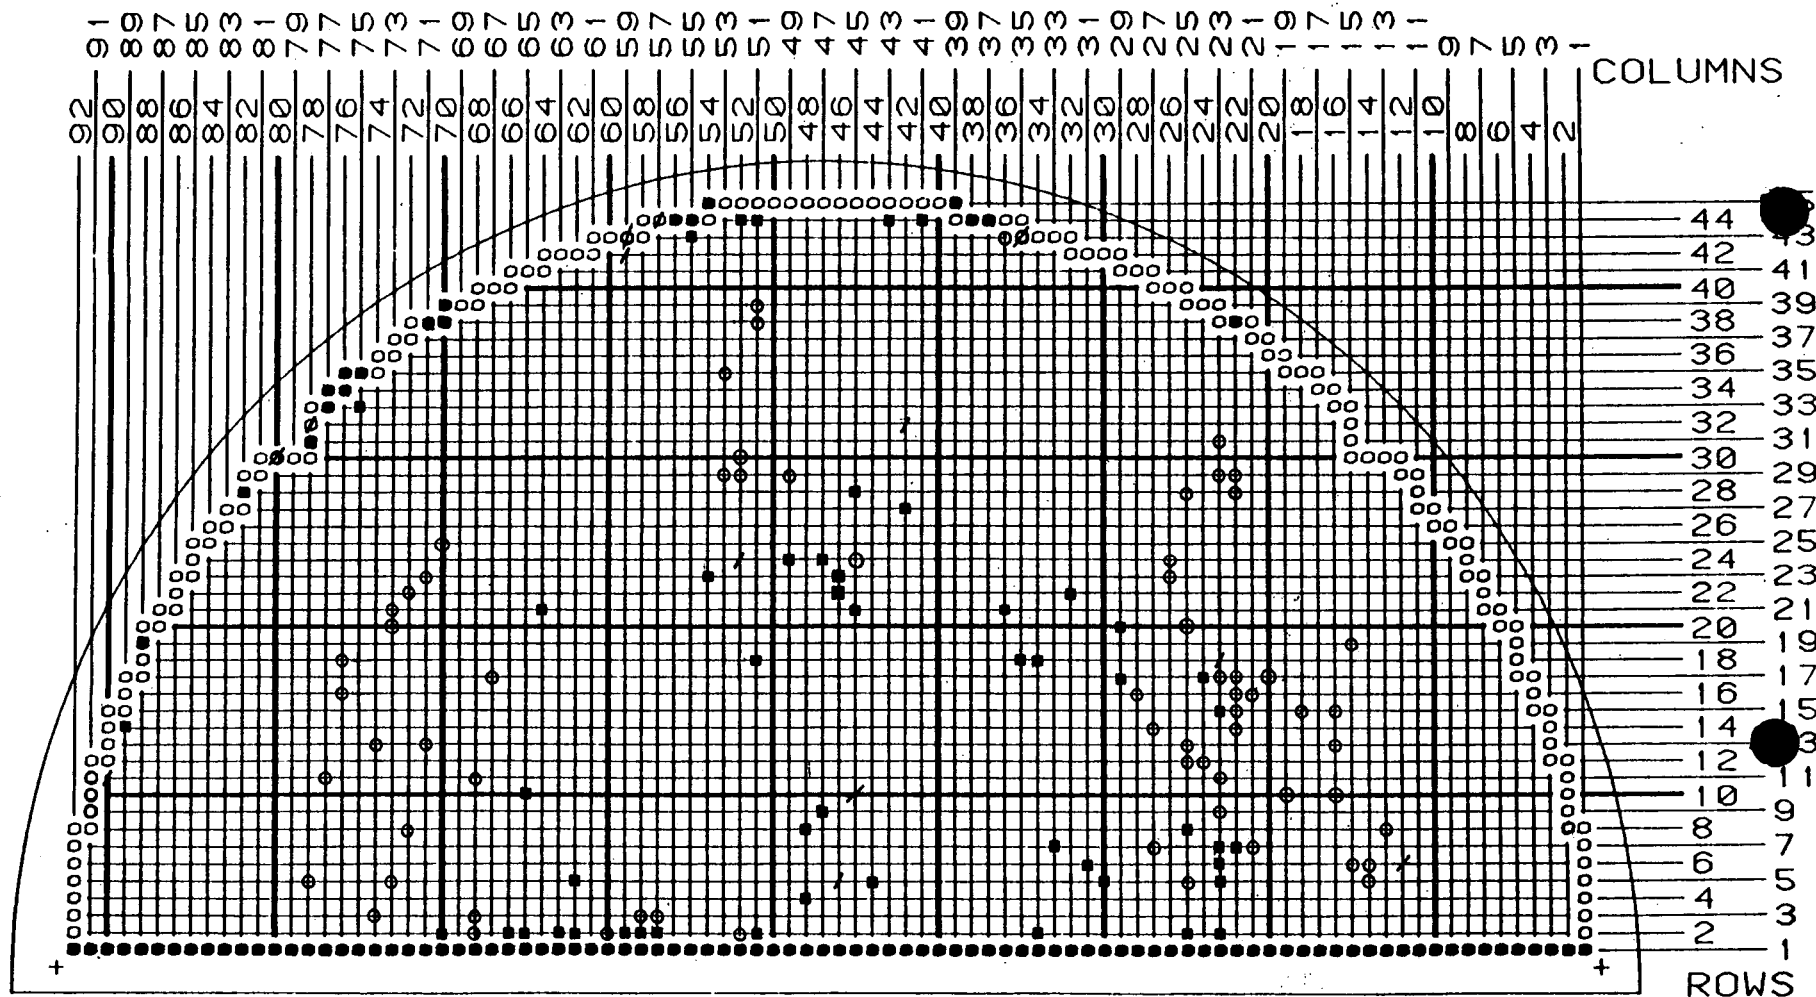
TUBESHEET MAP - 33 INLET

* = ≥ 40% (12)

⊗ = < 40% (69)

⊠ = PREVIOUSLY PLUGGED TUBES (167)

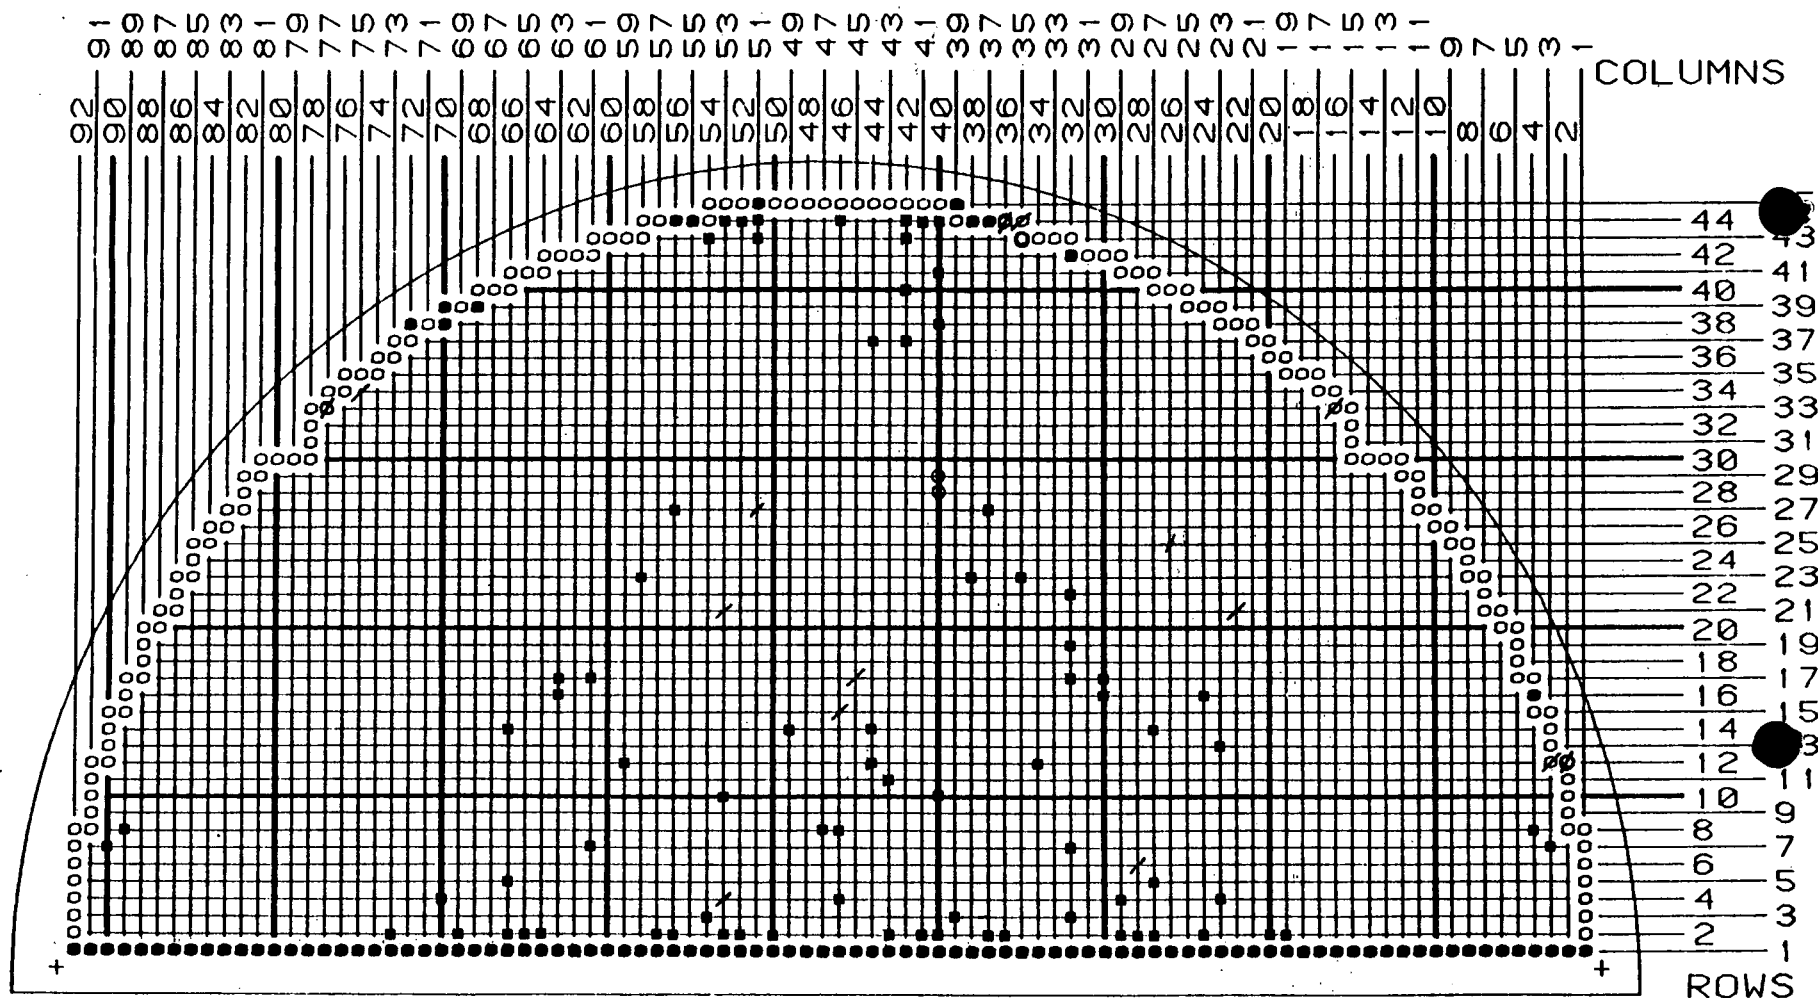
TUBESHEET MAP - 34 INLET

* = $\geq 40\%$ (14)

⊗ = $< 40\%$ (3)

■ = PREVIOUSLY PLUGGED TUBES (182)

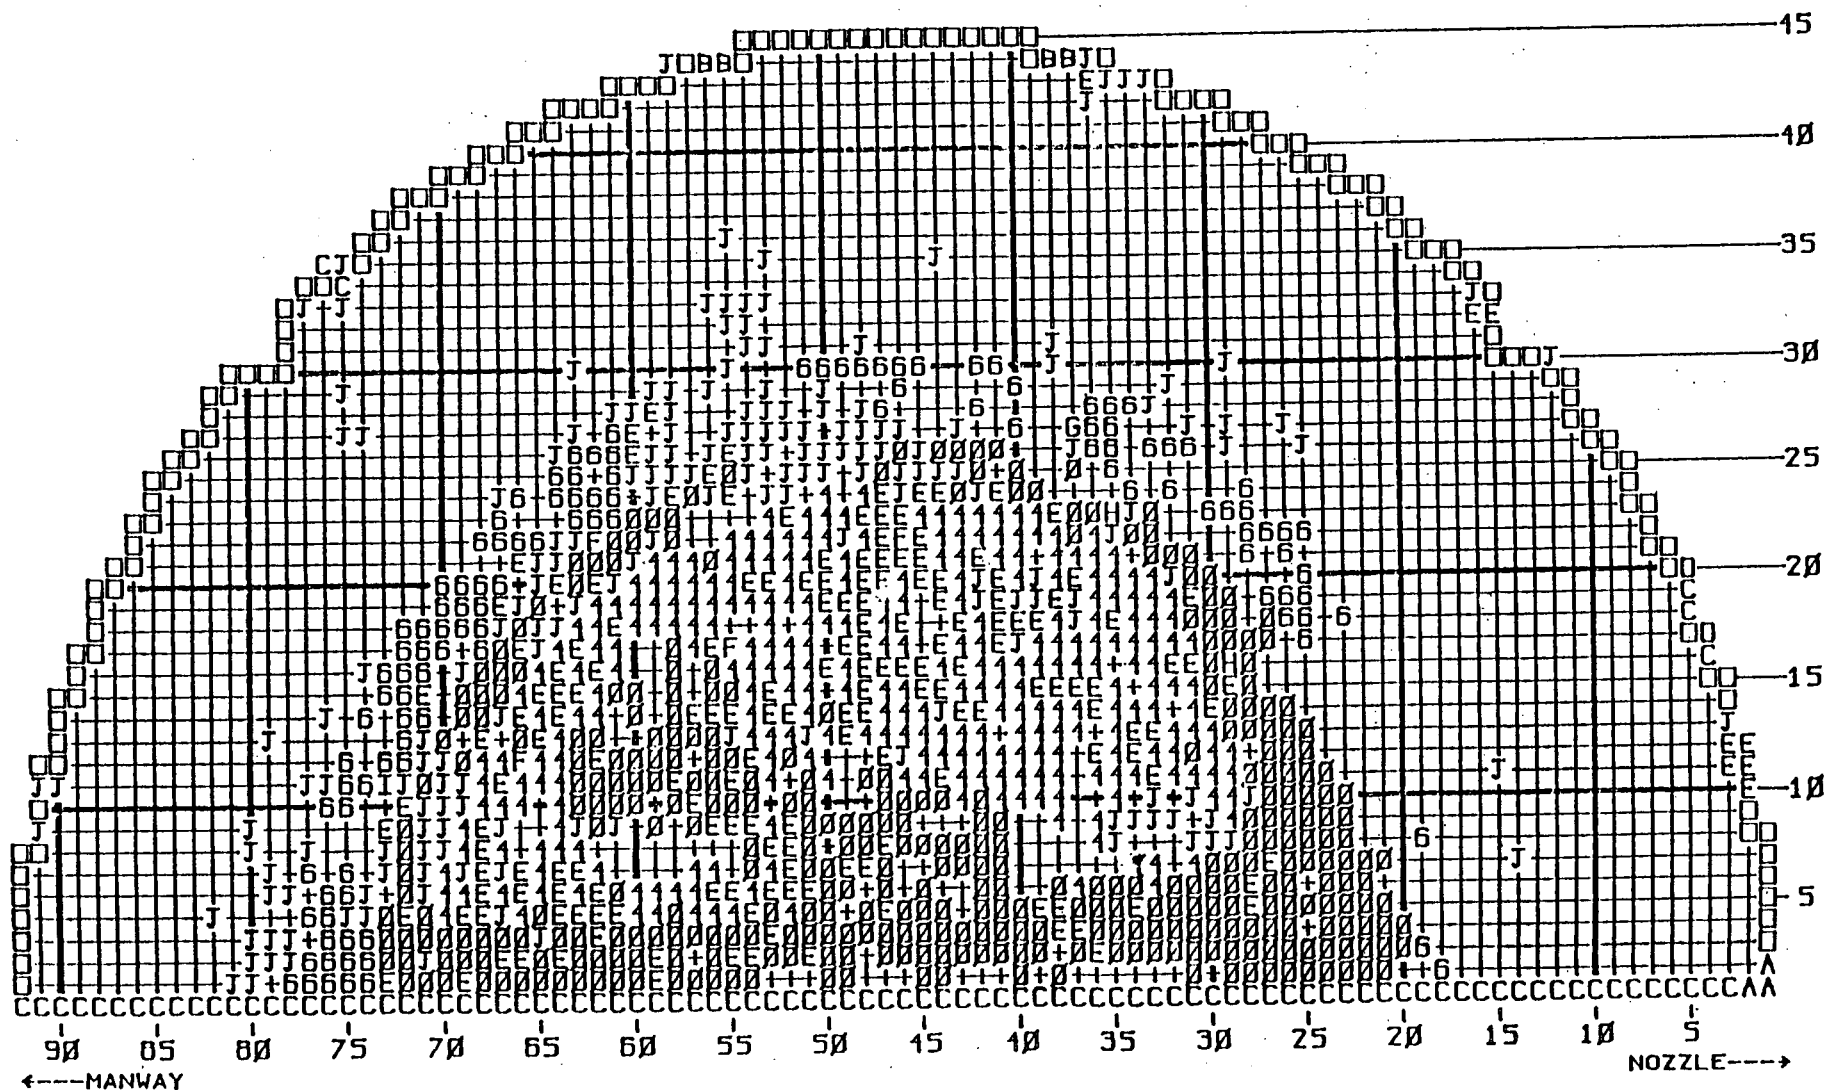
STEAM GENERATOR 31 TUBE STATUS

A	3	8/78; TUBES PLUGGED	J	194	01/83; MECH PLUGGED
B	4	3/79; TUBES PLUGGED	4	285	01/83; 44-INCH SLEEVE
C	95	11/79; TUBES PLUGGED	0	365	01/83; 40-INCH SLEEVE
D	2	11/79; TUBES PLUGGED	6	118	01/83; 36-INCH SLEEVE
E	177	10/81 MECH PLUGGED			
F	4	10/81 M/P HL; W/R CL			
G	1	01/83; 36-IN SLV CL, M/P HL			
H	2	01/83; SLEEVE STUB CUT, M/P			
I	1	01/83; SLEEVE PLUG

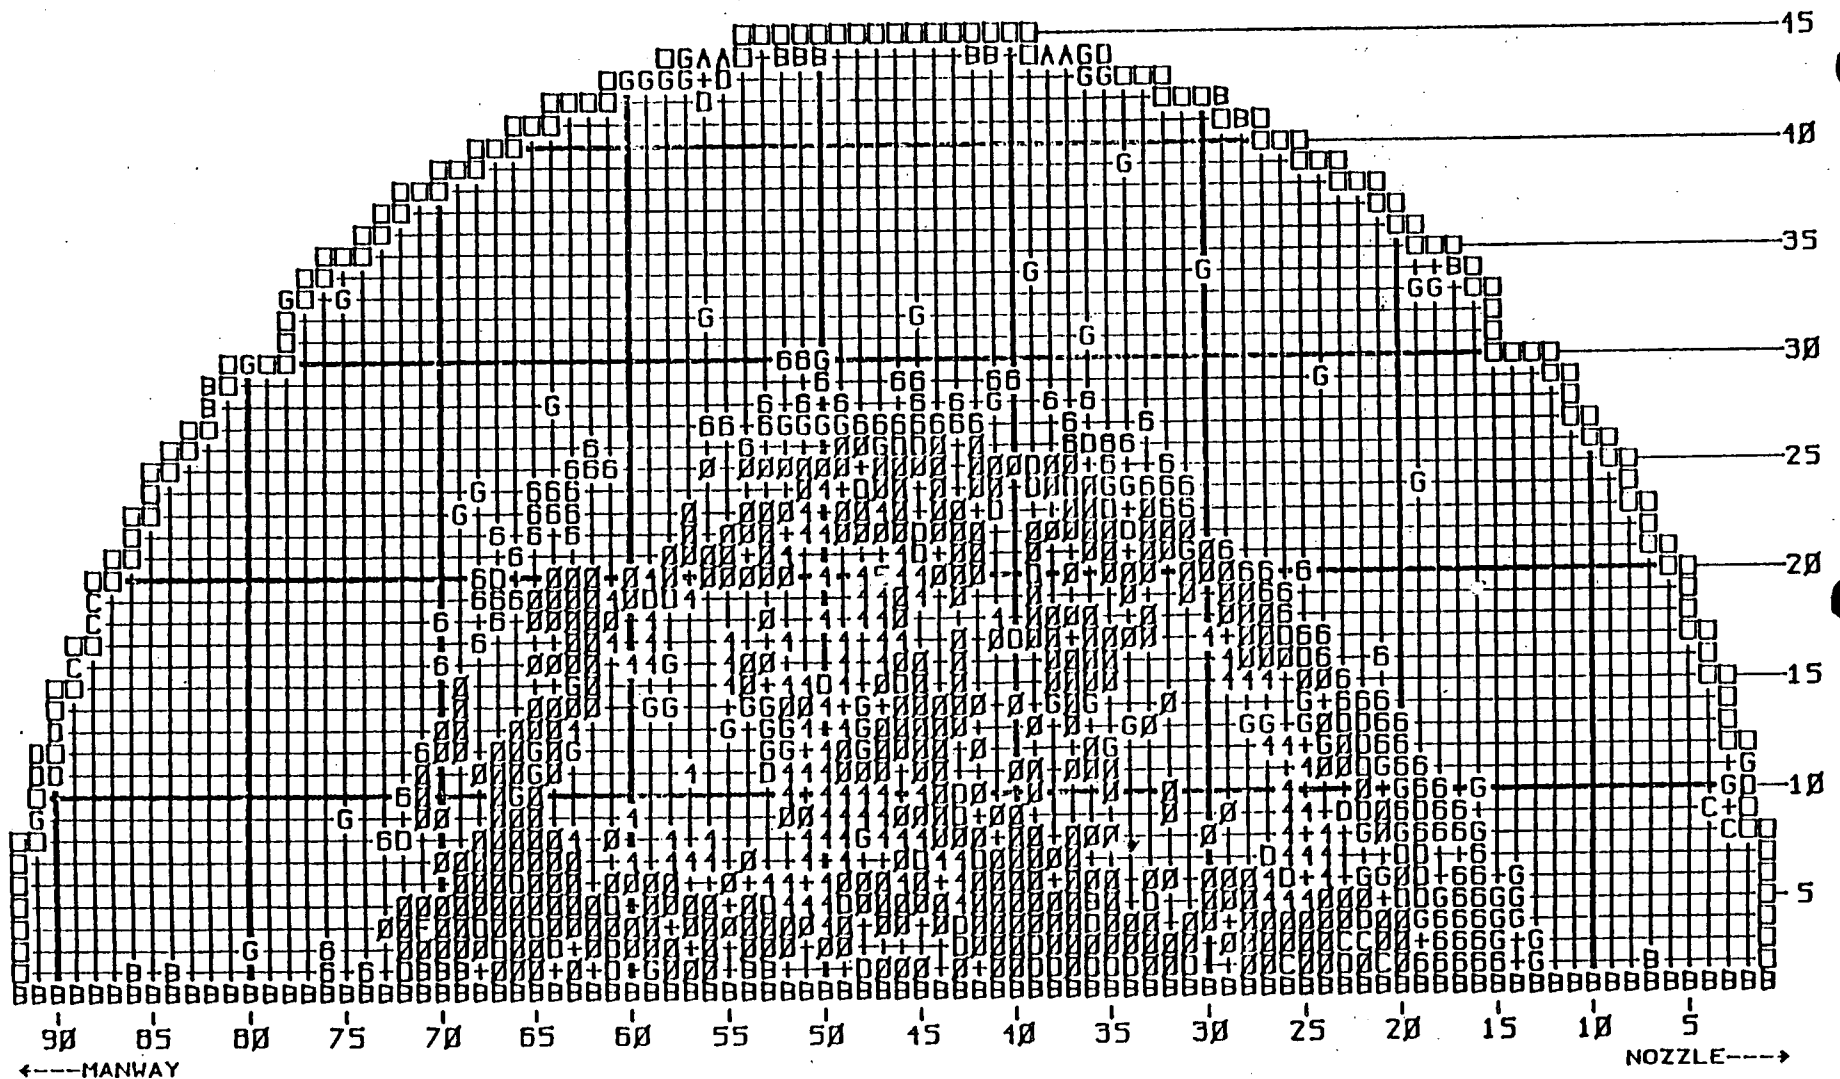
INDIAN POINT 3
STEAM GENERATOR 32 TUBE STATUS

A	4	3/79; TUBES PLUGGED
B	111	11/79; TUBES PLUGGED
C	9	10/80; MECH PLUGGED
D	74	10/81; MECH PLUGGING
E	1	01/83; SLEEVE PLUG
F	1	01/83; SLEEVE STUB CUT, M/P
G	86	01/83; MECH PLUGGED
4	106	01/83; 44-INCH SLEEVE
0	435	01/83; 40-INCH SLEEVE

6 110 01/83; 36-INCH SLEEVE

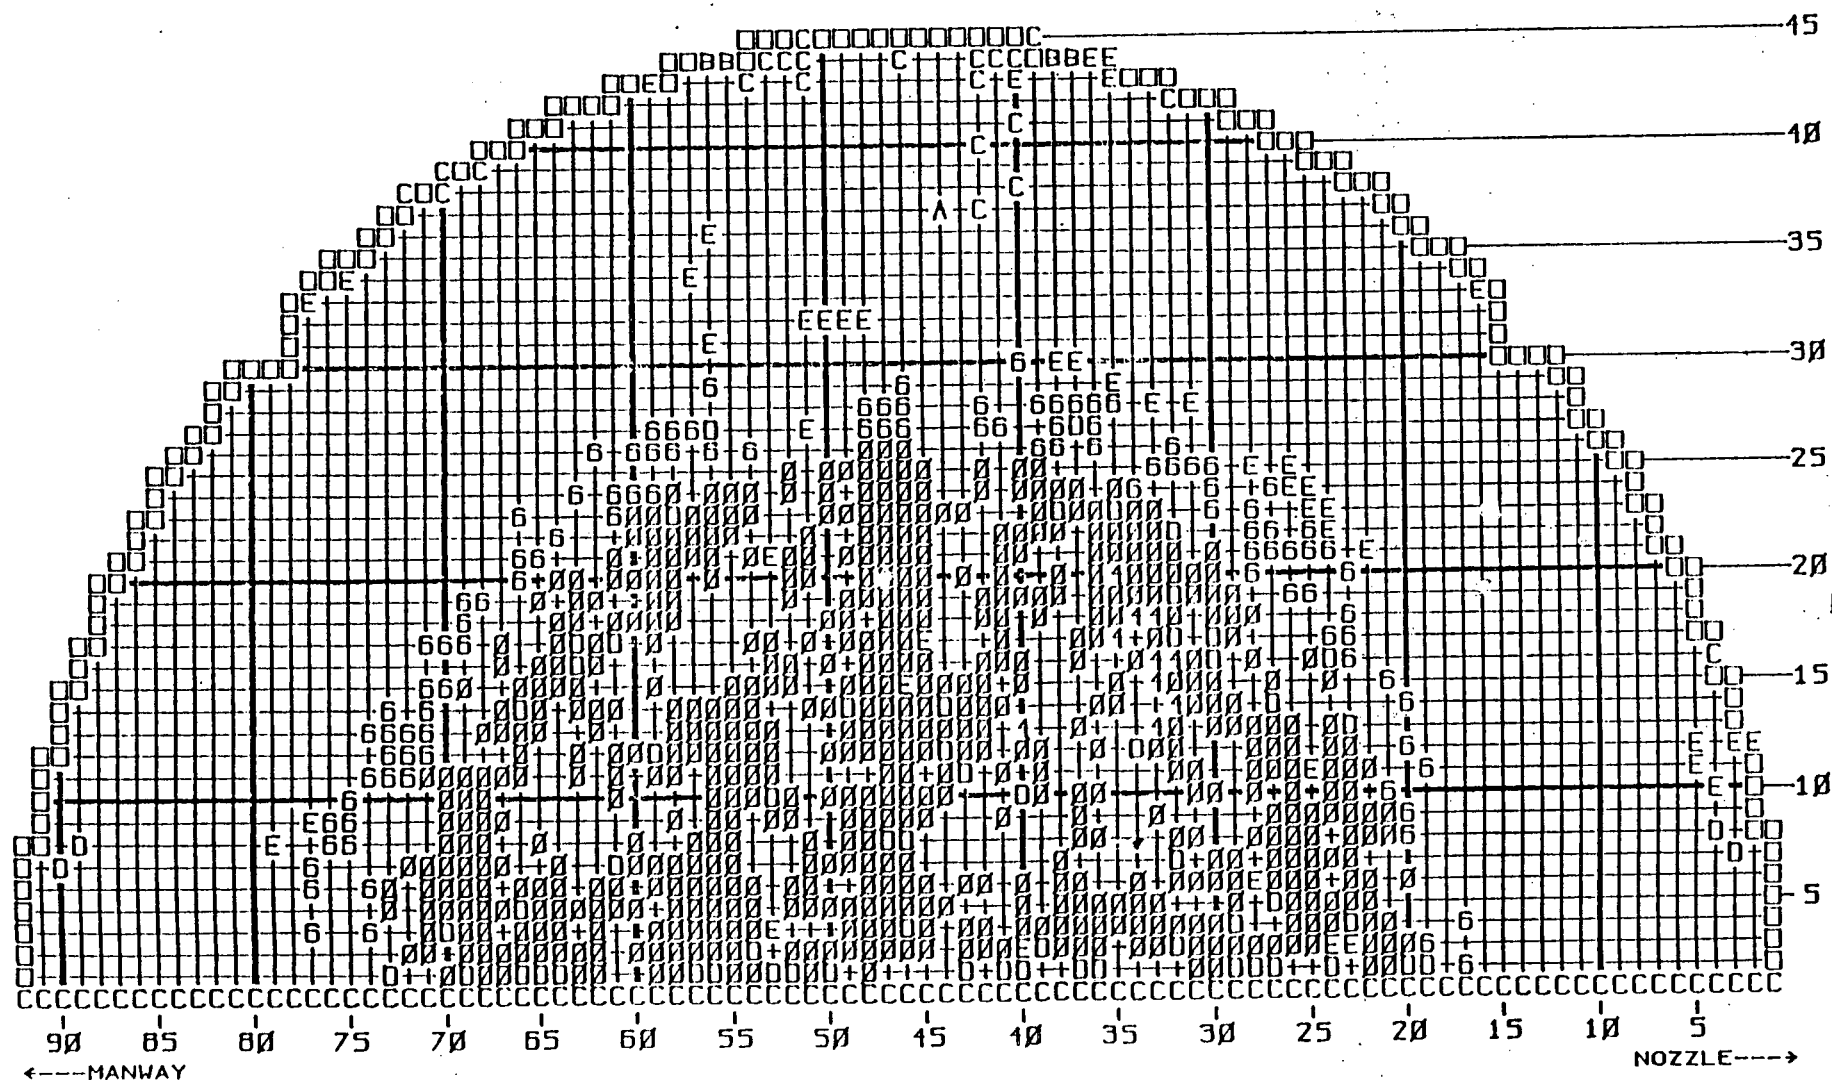
INT-34

A	1	HOLE OMITTED; MANUF. ERROR
B	4	3/79; TUBES PLUGGED
C	114	11/79; TUBES PLUGGED
D	63	10/81; MECH PLUGGED
E	45	01/83; MECH PLUGGED
4	10	01/83; 44-INCH SLEEVE
0	584	01/83; 40-INCH SLEEVE
6	107	01/83; 36-INCH SLEEVE
