November 8, 1984
IPN-84-54

SUBJECT: INDIAN POINT 3 NUCLEAR POWER PLANT
DOCKET NO. 50-286
STARTUP REQUEST FOLLOWING
MID-CYCLE STEAM GENERATOR INSPECTION

RESPONSE TO NRC QUESTIONS FROM MEETING OF NOVEMBER 2, 1984

STEAM GENERATOR MIDCYCLE (IV) INSPECTION PRESENTATION

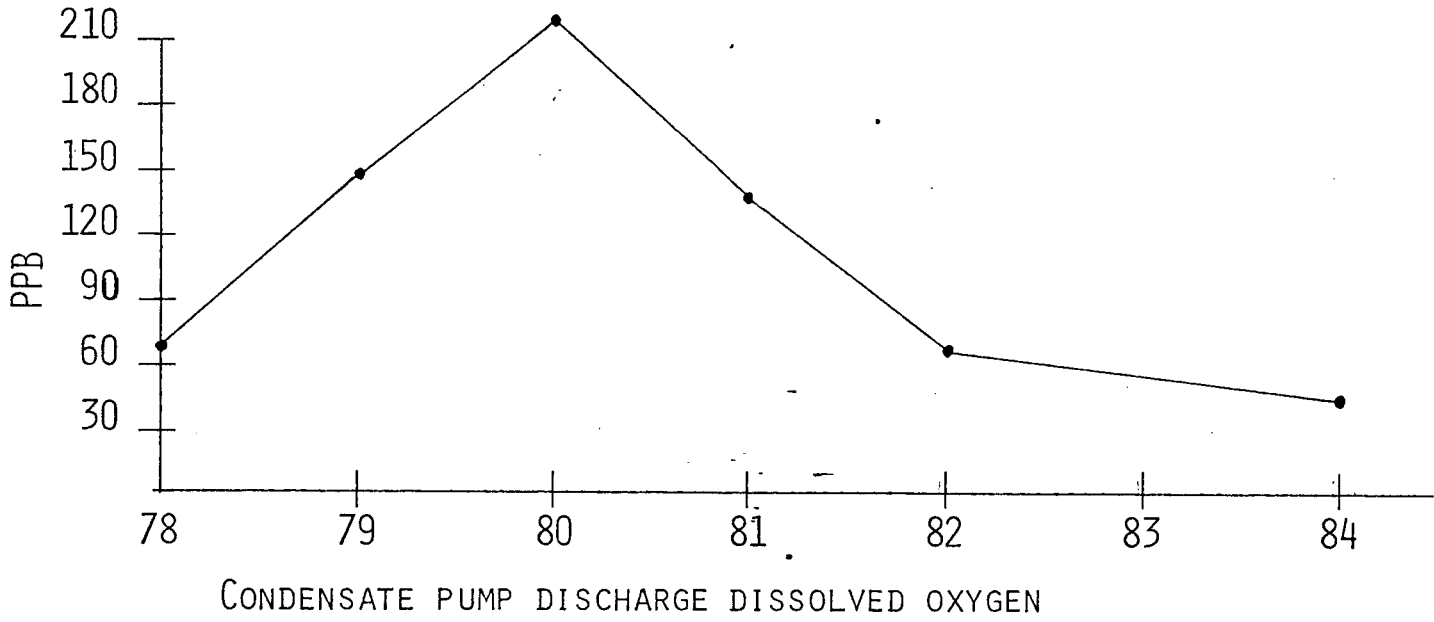
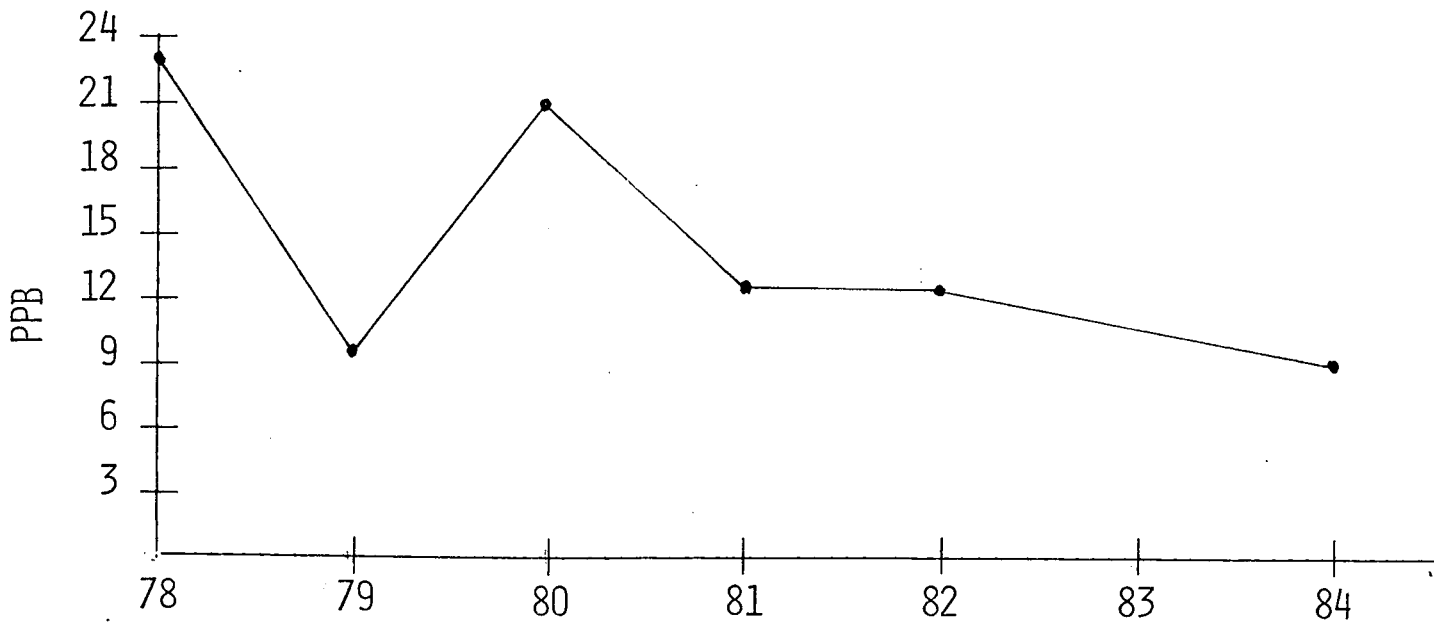
SG BLOWDOWN CHLORIDES

- 0 INDIAN POINT 3 HAS OPERATED SUCCESSFULLY OVER THE FIRST NINE MONTHS OF CYCLE IV WITH NO STEAM GENERATOR TUBE LEAKS.
- 0 THE CAPACITY FACTOR OVER THIS OPERATING PERIOD WAS 89.8%.
- 0 SECONDARY PLANT WATER CHEMISTRY CONTINUED TO SHOW IMPROVEMENT.

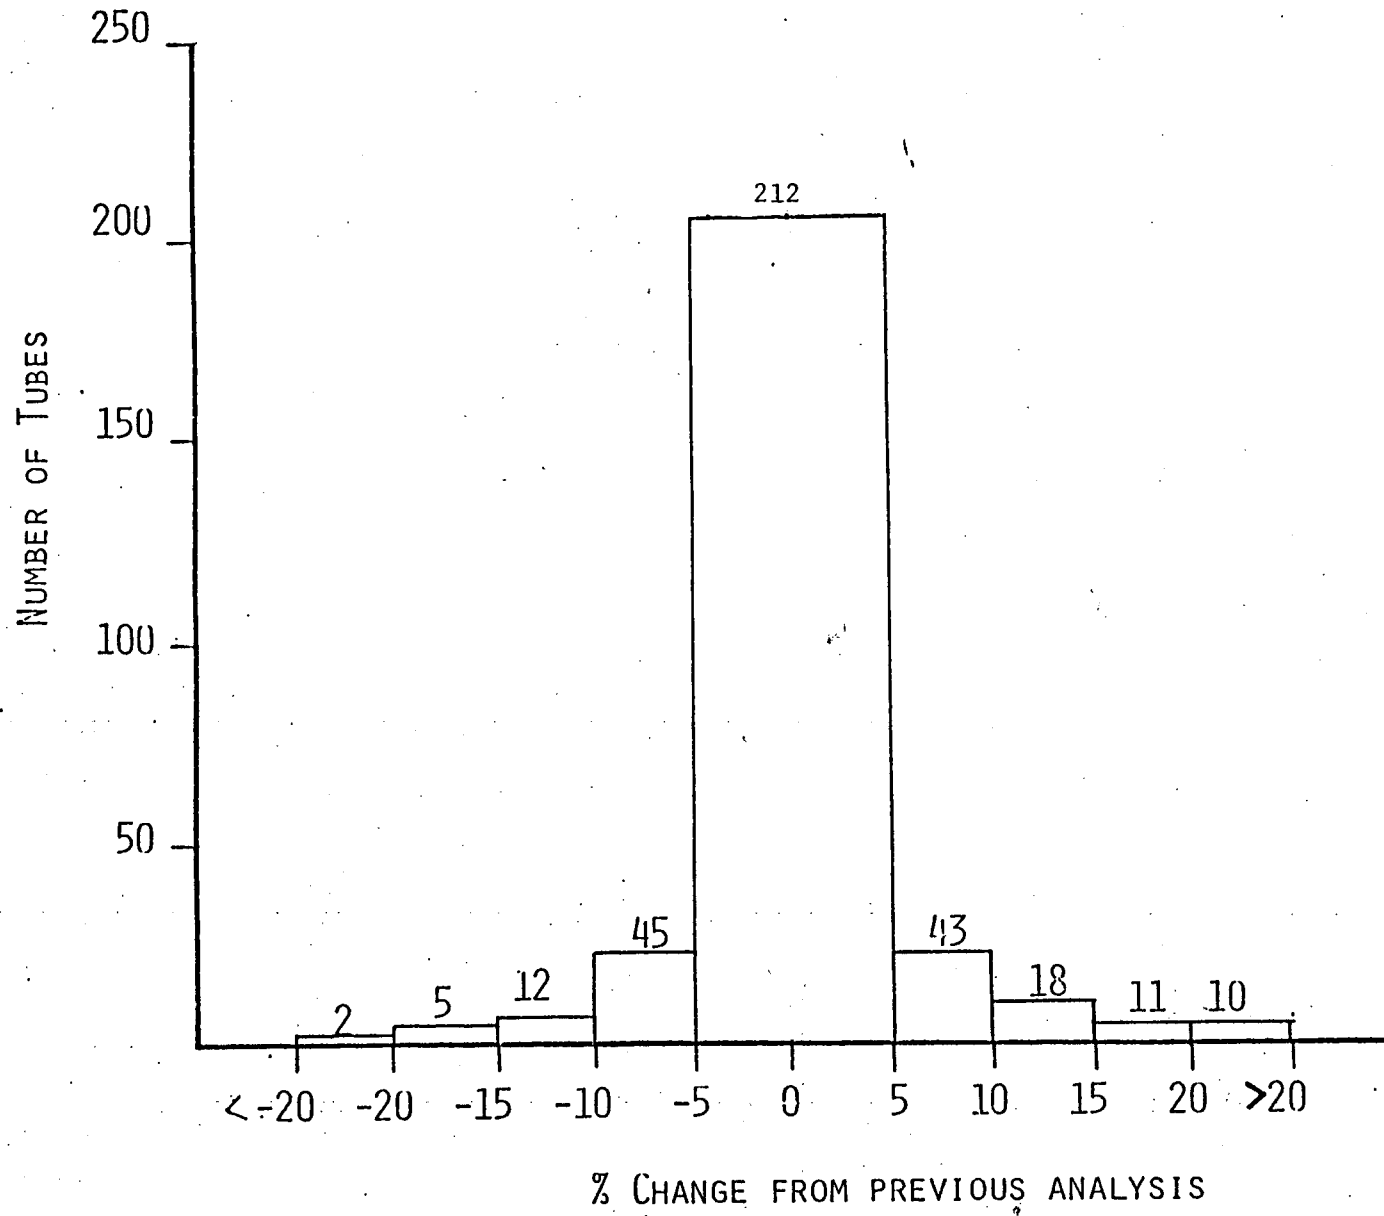
INDIAN POINT 3
1982 DATA RE-EVALUATION
(SAMPLE PROGRAM)

- O IMMEDIATELY PRECEDING PLANT SHUTDOWN, A COMPLETE REANALYSIS OF THE 1982 DATA PERTAINING TO THE TUBE SAMPLE PROGRAM WAS CONDUCTED USING THE SAME EQUIPMENT AND ANALYSTS TO BE USED FOR THIS OUTAGE.
- O THE RESULTS OF THIS REANALYSIS WERE VERY CONSISTENT WITH THE 1982 ANALYSIS.

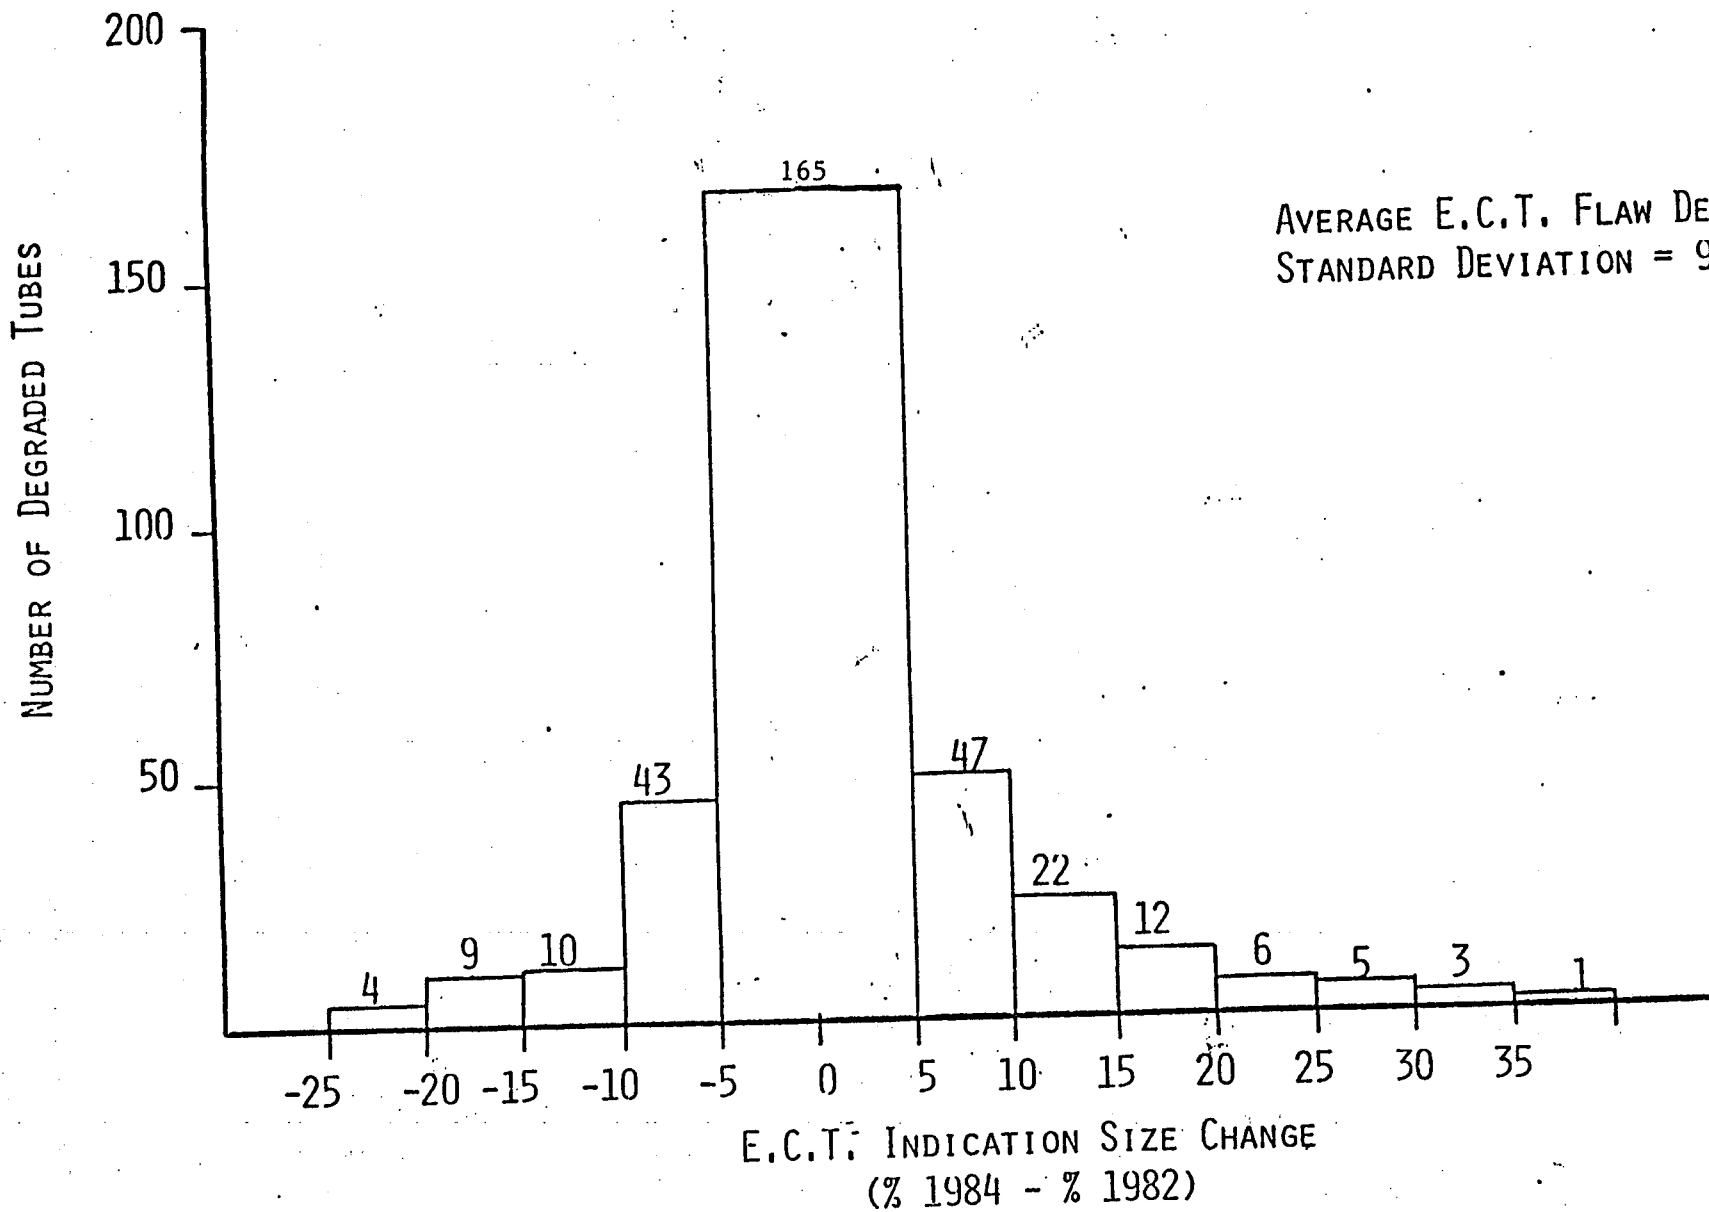
Figure 2 Rev 1

- 0 AVERAGE GROWTH RATE OF OUTLET LEG FLAWS OVER THE FIRST 9 MONTHS OF CYCLE IV OPERATION IS 1.5%.
- 0 CALCULATED GROWTH RATE OF LESS THAN .2% PER MONTH IS AN ORDER OF MAGNITUDE LESS THAN THE 1.7% OBSERVED DURING THE PREVIOUS INSPECTION.
- 0 THE ESTIMATED GROWTH OF 1.2% OVER THE BALANCE OF CYCLE IV OPERATION IS WELL WITHIN THE 2% CORROSION ALLOWANCE USED IN SETTING THE PROPOSED OUTLET LEG PLUGGING LIMIT.

INDIAN POINT 3
1982/1984 INDICATION GROWTH DISTRIBUTION
(SAMPLE PROGRAM)

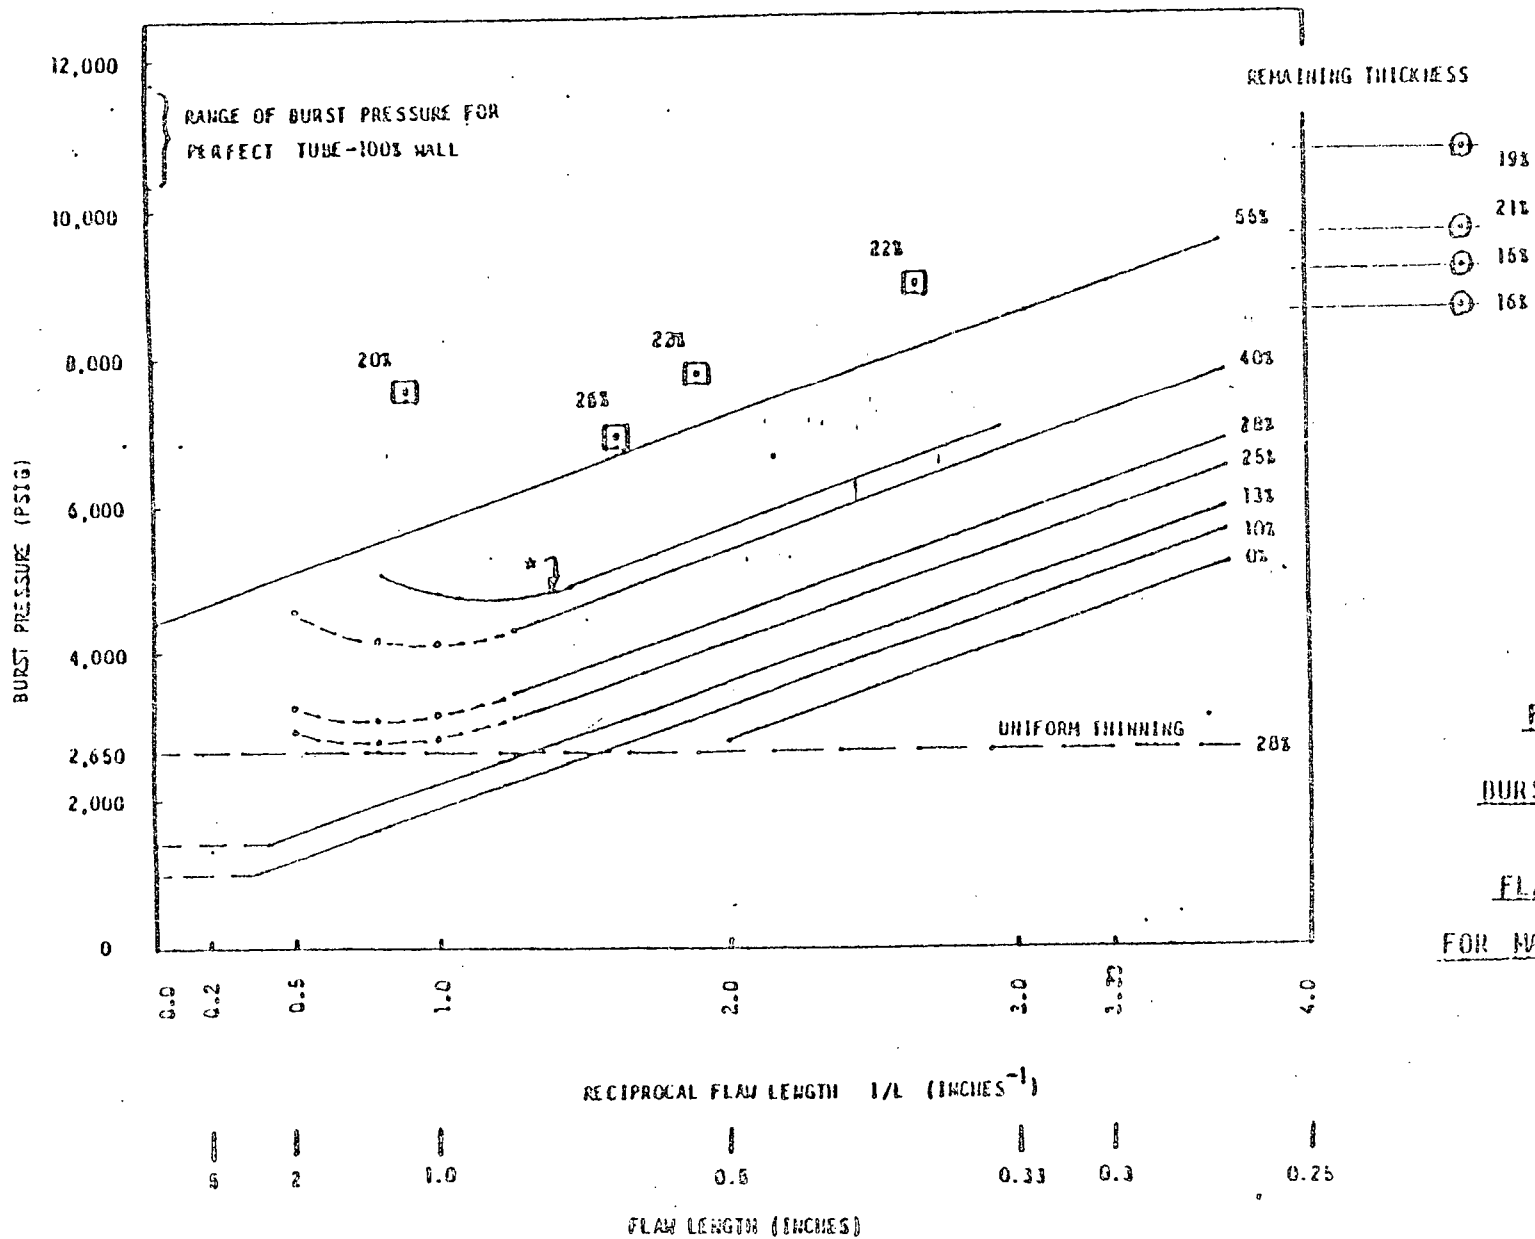
FIGURE 1
BURST PRESSURE
VS
FLAW LENGTH
FOR MACHINED FLATS

o PROPOSED LIMIT OF 63% WITHIN THE TUBE PITTING REGION IS BASED ON:

MINIMUM BURST THICKNESS -----	25%	(.0125")
ALLOWANCE FOR ECT-----	10%	(.005")
CORROSION ALLOWANCE OVER BALANCE OF CYCLE IV OPERATION BASED ON MIDCYCLE OBSERVATIONS-----	2%	(.001")
<hr/>		
TOTAL THICKNESS REQUIRED	=	37% (.0185")

o TUBES WITH FLAWS GREATER THAN OR EQUAL TO 63% ARE TO BE PLUGGED PRIOR TO RESUMING CYCLE IV OPERATION.
