August 22, 1985
IPN-85-44

Subject: Indian Point 3 Nuclear Power Plant
Docket No. 50-286
Steam Generator Eddy Current Testing Results

INDIAN POINT 3
RESULTS OF STEAM GENERATOR INSPECTIONS
AGENDA

AUGUST 20, 1985

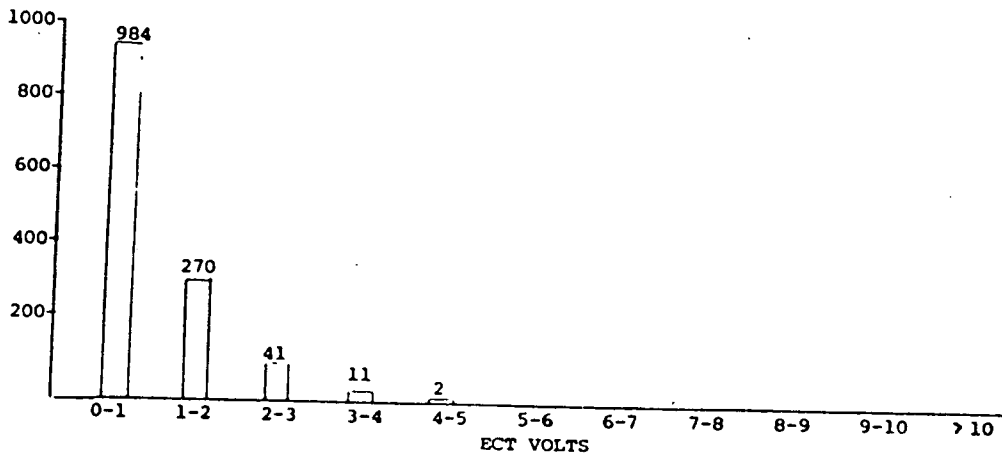
COLD LEG

INDIAN POINT 3
INDICATION VOLTAGES

o AT INDIAN POINT 3, THE FOLLOWING DISTRIBUTION OF DEFECTS WERE LOCATED:

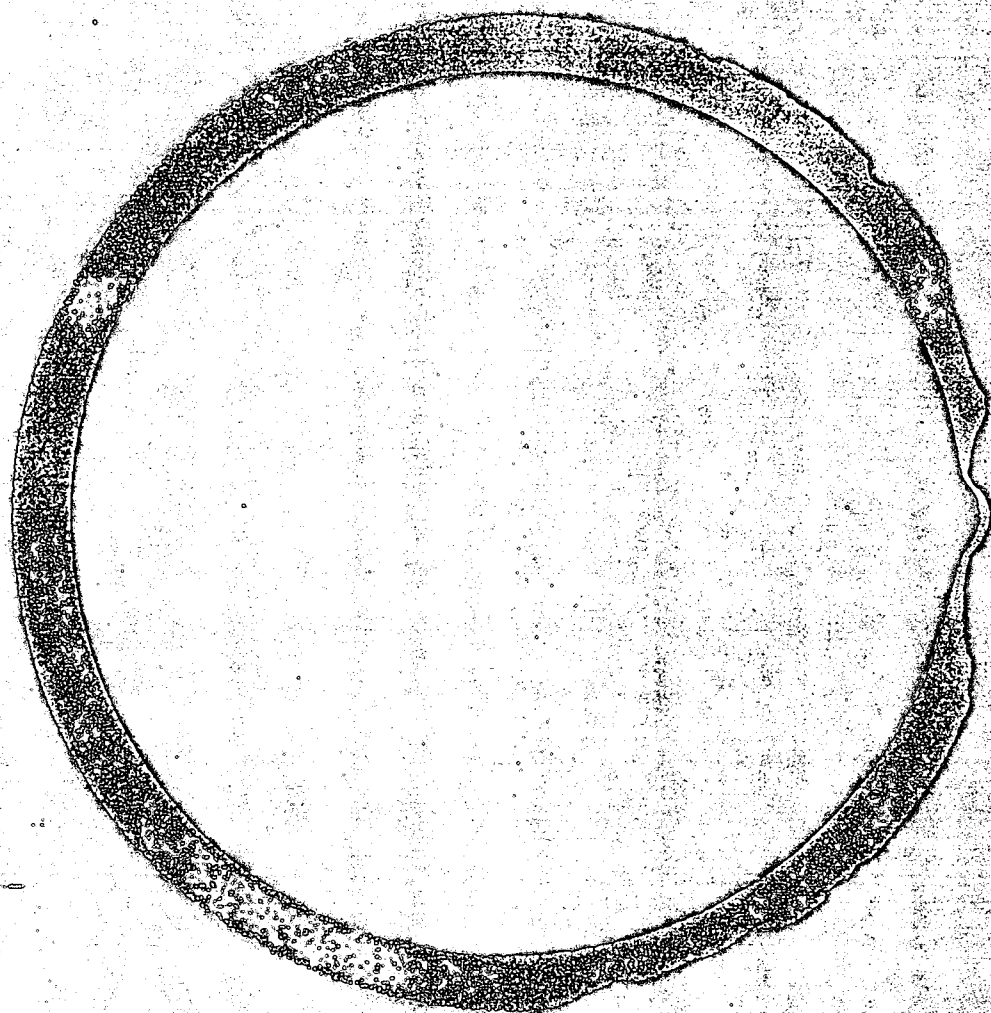
- o PRINCIPAL CORROSION MECHANISM ON THE TUBES IS PITTING.
- o ONE LARGER INDICATION ON EACH TUBE IS DUE TO WASTAGE.
- o NO CRACKING WAS FOUND.
- o CHARACTERISTICS OF CORROSION DEPOSITS INCLUDE
 - CHROMIUM RICH OXIDE
 - SULFUR
 - COPPER
 - CHLORIDE NOT IDENTIFIED

FIGURE 1. COLOR OPTICAL PHOTOGRAPH OF THE PRINCIPAL DEFECT ON TUBE R30C46 4.3X

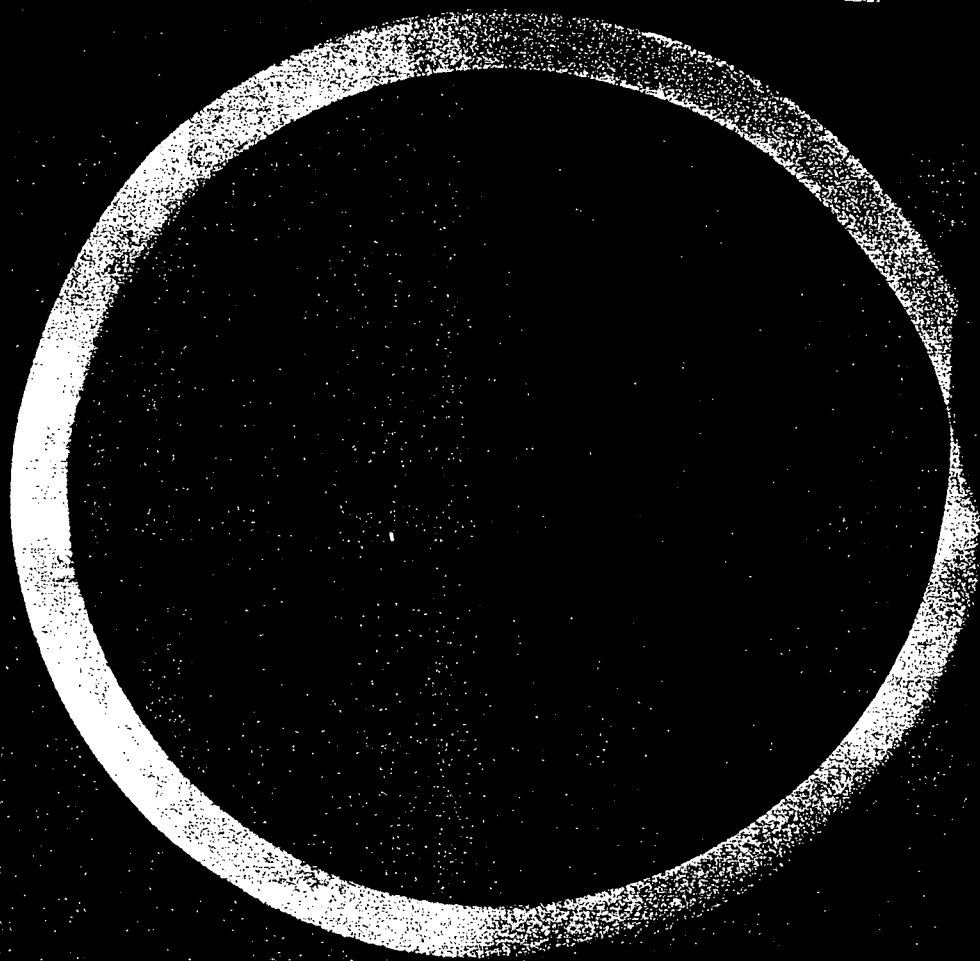
FIGURE 2. COLOR OPTICAL PHOTOGRAPH OF THE PRINCIPAL
DEFECT REGION ON TUBE R15C47

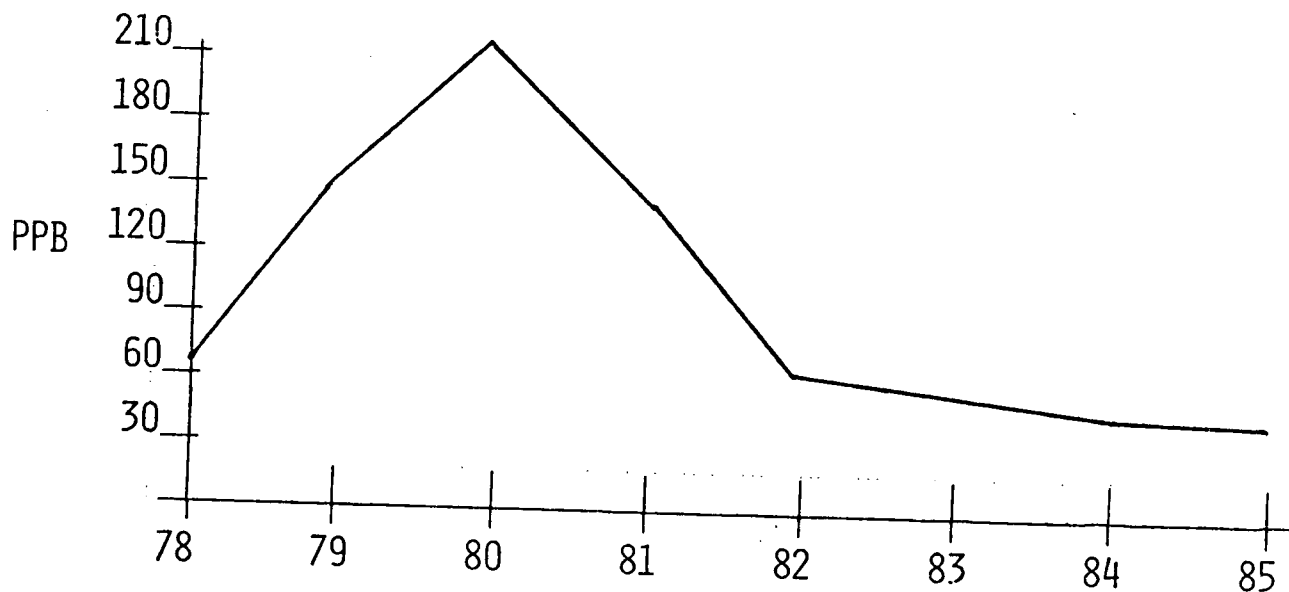
SG BLOWDOWN CHLORIDES

- o SECONDARY WATER CHEMISTRY CONTINUED TO IMPROVE IN MOST AREAS.
- o INSTANCES OF CONDENSER LEAKAGE HOWEVER, CONTINUED TO BE A PROBLEM.
- o MODIFICATIONS BEING COMPLETED AT THIS REFUELING OUTAGE SHOULD RESULT IN SUBSTANTIAL IMPROVEMENT IN SECONDARY WATER CHEMISTRY BY:
 - REDUCING THE LEVEL OF IMPURITIES
 - REDUCING THE VARIABILITY OF SECONDARY CHEMISTRY

- o CONDENSER REPLACED WITH TITANIUM TUBES AND IMPROVED DEAERATING CAPABILITIES.
- o COPPER BEARING HIGH PRESSURE FEEDWATER HEATERS REPLACED WITH STAINLESS STEEL HEATERS.
- o IMPROVEMENT IN MAKEUP WATER DEAERATOR AIR REMOVAL CAPABILITIES.
- o FURTHER IMPROVEMENTS TO CONDENSATE STARTUP CLEANUP LOOP.
- o USE OF COMBUSTION ENGINEERING'S PERIPHERAL STEAM GENERATOR SLUDGE LANCING PROCESS FOR IMPROVED SLUDGE REMOVAL.
