January 19, 1989
IPN-89-006

Subject: Indian Point 3 Nuclear Power Plant
Docket No. 50-286
Turbine Disc Inspection

ATTACHMENT II TO IPN-89-006
TIME SEQUENCE

SUBJECT: INDIAN POINT UNIT 3
LOW PRESSURE TURBINE ROTORS
HEAVY DISC INSPECTION INTERVAL

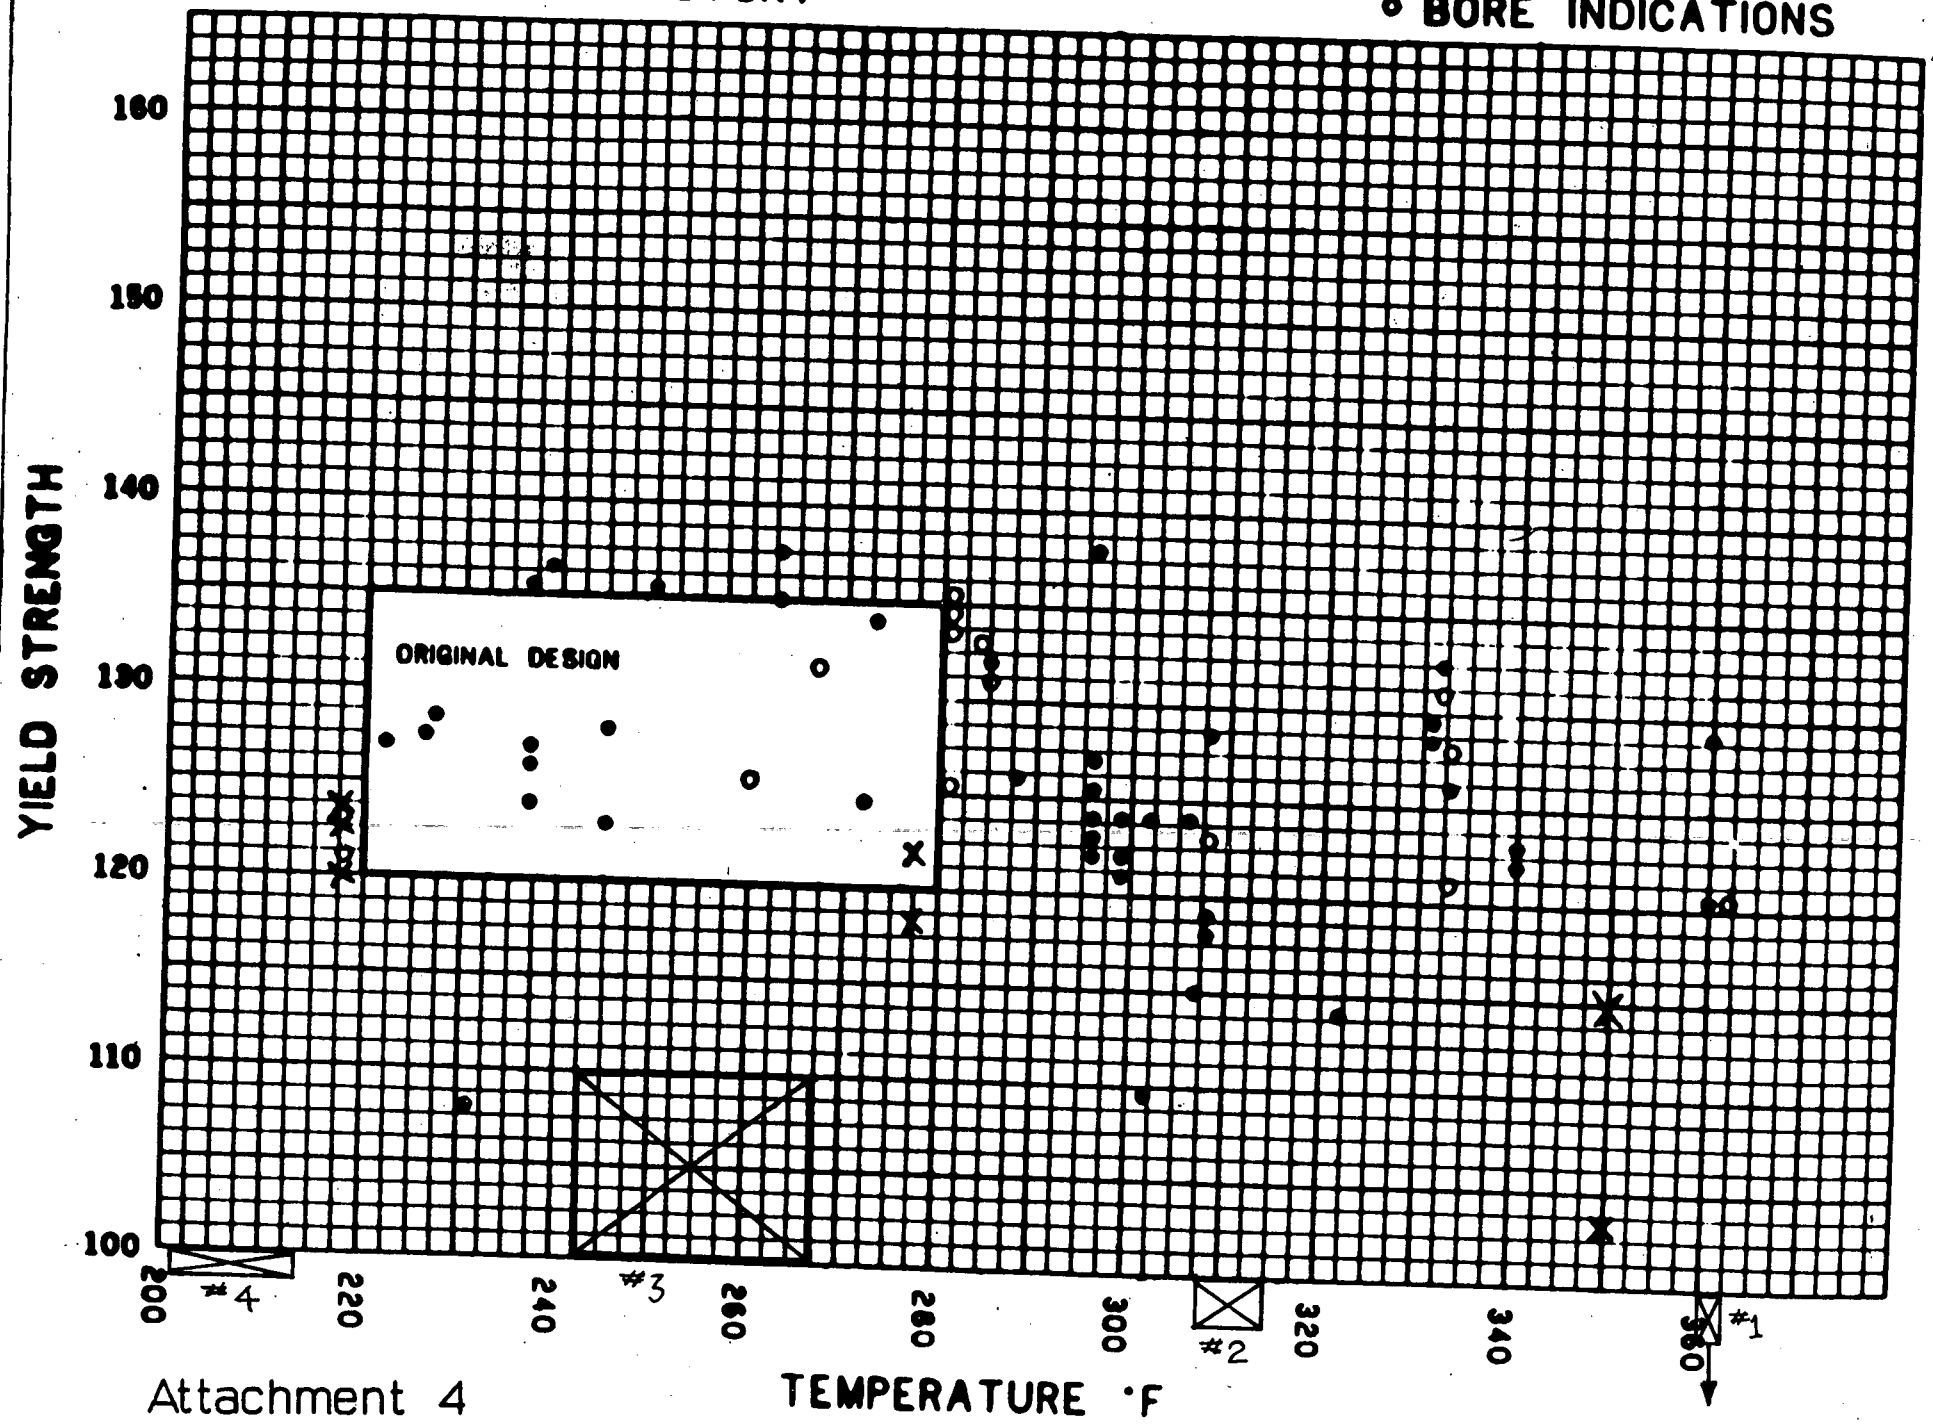
DISC INSPECTION HISTORY

Attachment 4 is a chart which shows the history of disc inspections in terms of at what yield strength and temperature allbore and keyway indications have been found in the light discs. The red boxes drawn on the graph indicate the design region of the heavy discs with key plates. The heavy disc design reduced nominal bore stresses to 85% of those in the light disc. Yield strengthes of the redesigned heavy disc were also reduced to 80% of the light discs. Peak

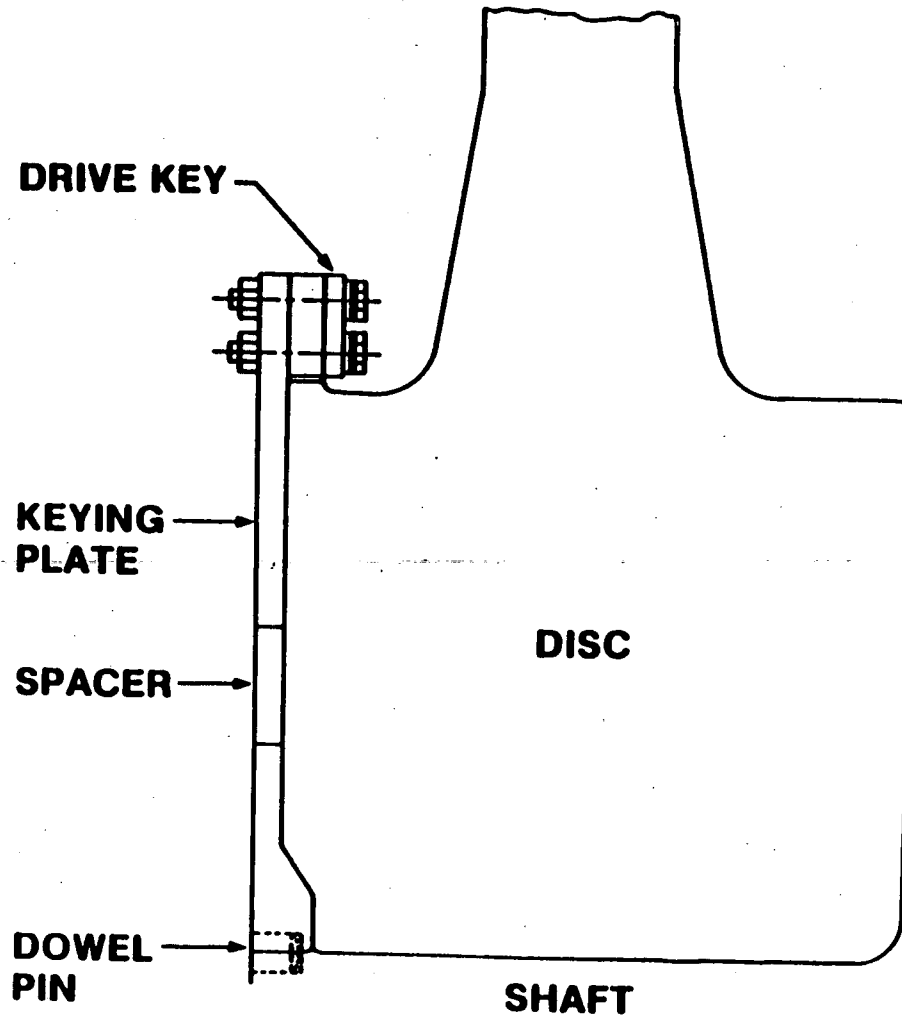
HEAVY DISC AND KEYPLATE

stresses at the disc bore were further reduced by eliminating the stress concentration associated with the round keyway and utilizing a new attachment system consisting of keying plates, circular spacers, dowel pins and drive keys.

This new configuration is depicted in Attachment 5.
