Indian Point 3  
Nuclear Power Plant  
P.O. Box 215  
Buchanan, New York 10511  
914-736-8000

LICENSEE EVENT REPORT (LER)

FACILITY NAME (1) Indian Point Unit 3	DOCKET NUMBER (2) 0 5 0 0 0 2 8 6	PAGE (3) 1 OF 0 5
--	--------------------------------------	----------------------

TITLE (4)  
125VDC System Lack of Coordination

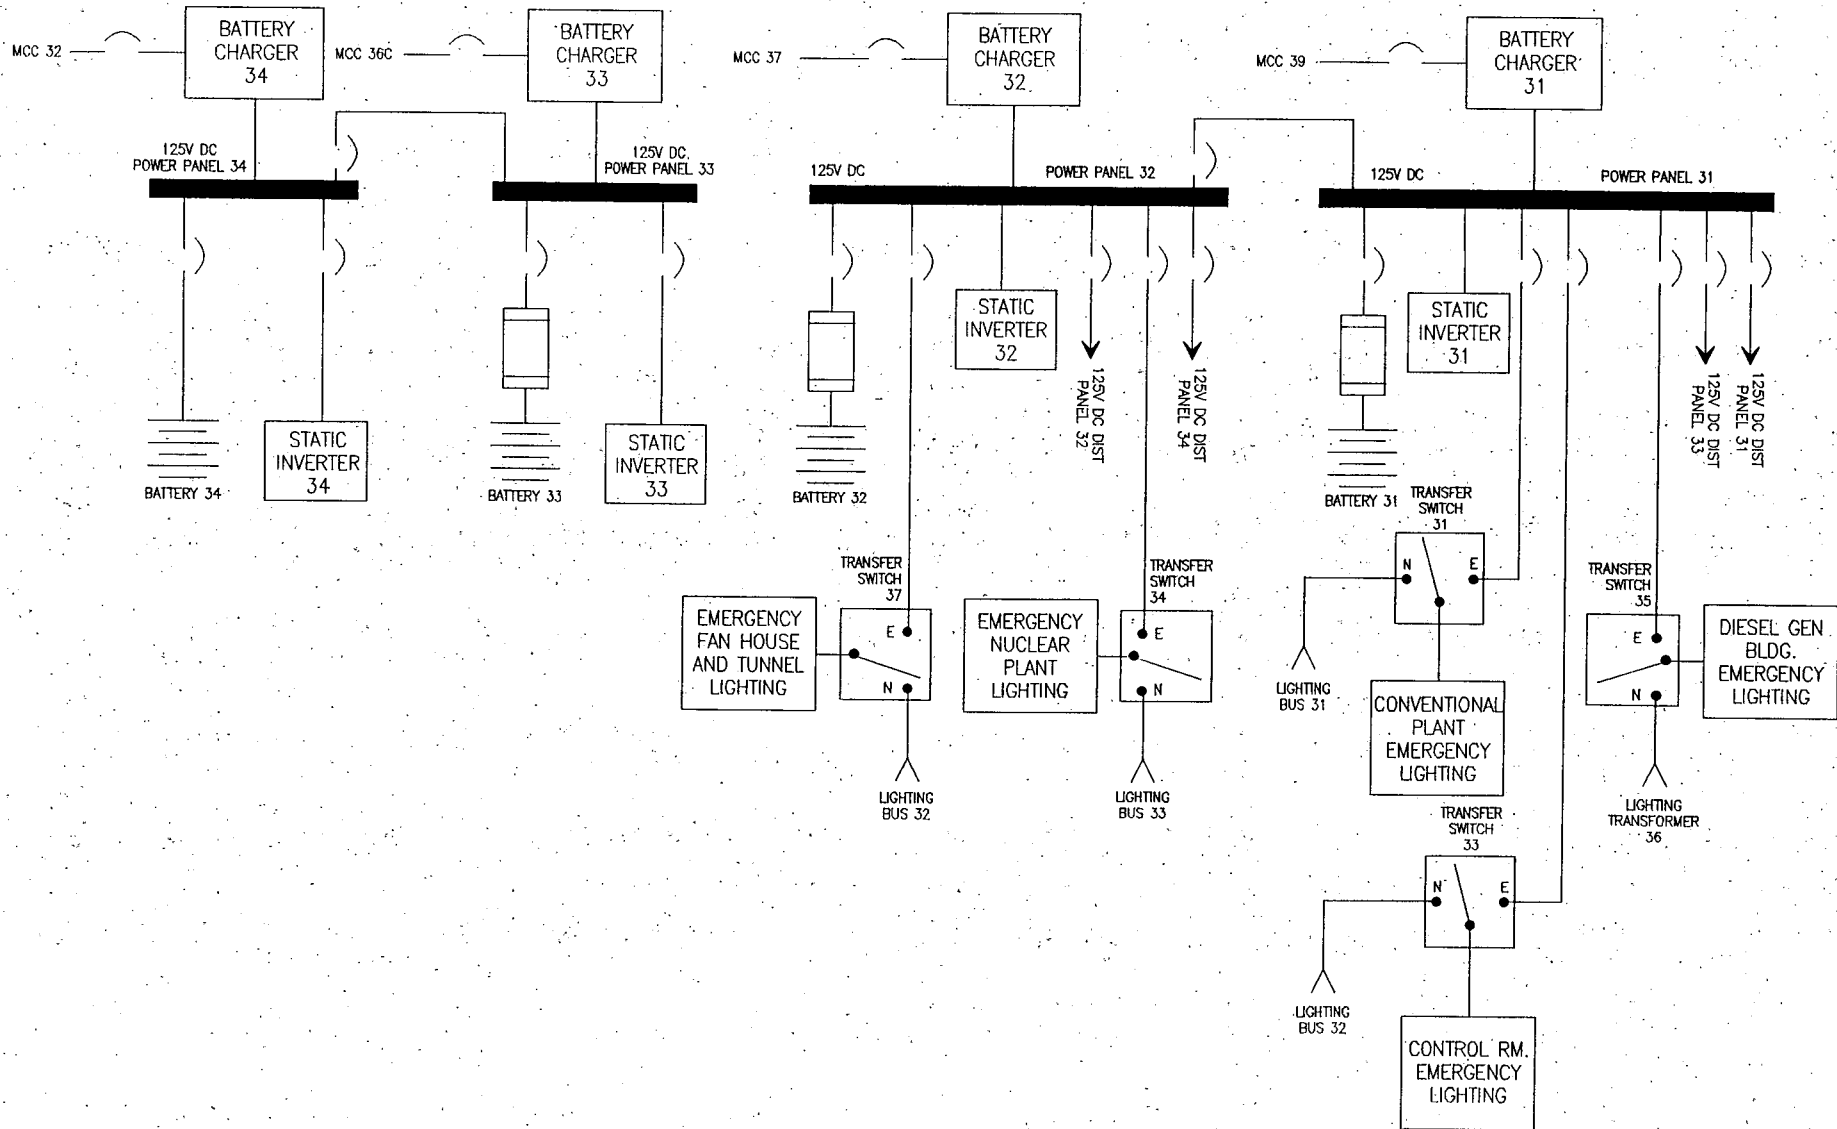
# 125 VDC DISTRIBUTION

The 125V DC system is comprised of the following:

- \* Four (4) 125V DC lead acid batteries numbers 31-34
- \* Four (4) power panels (PP) numbers 31-34
- \* Six (6) distribution panels (DPs) numbers 31-34, 31A, 32A (31A and 32A are subpanels of 31 and 32 DPs)
- \* Five (5) battery chargers numbers 31-35 (35 is a spare)
- \* Four (4) static inverters numbers 31-34

1. Lack of short circuit protection
2. Lack of system coordination between power panels, circuit breakers and downstream protective devices (fuses or breakers)
3. Lack of system coordination between power panel circuit breakers and upstream fuses in the battery circuit
4. Insufficient DC interrupt rating for battery fuses.

On June 4, 1992, it was determined that these deficiencies could potentially result in de-energizing power panels PP31 and PP32, and distribution panels DP31 and DP32. DP31 and DP32 provide control power to EDGs 32 and 33 respectively. A loss of power to these panels would render the EDGs inoperable. A significant safety impact was identified and a Reasonable Assurance for Safety evaluation was initiated.

- \* Replace existing fuses for batteries 31 and 32 with new fuses having adequate interrupting rating and protection characteristics.
- \* Replace circuit breakers and/or install fuses for the affected circuits on power panels 31 and 32.
- \* Several new sections of cables were added to increase impedance to achieve coordination and reduce the available fault current at DC distribution panels 31, 32, 33, and 34.

The modification achieves coordination at the distribution panel level and for the eight affected power panel circuits.
