LICENSEE EVENT REPORT (LER)

FACILITY NAME (1) Indian Point Unit 3	DOCKET NUMBER (2) 0 5 0 0 0 0 2 8 6 1	PAGE (3) OF 0 8
--	--	--------------------

TITLE (4)
Weld Channel and Containment Penetration Pressurization Supply Line Disconnect, Caused By Personnel Error, Placed Plant Outside Design Basis.

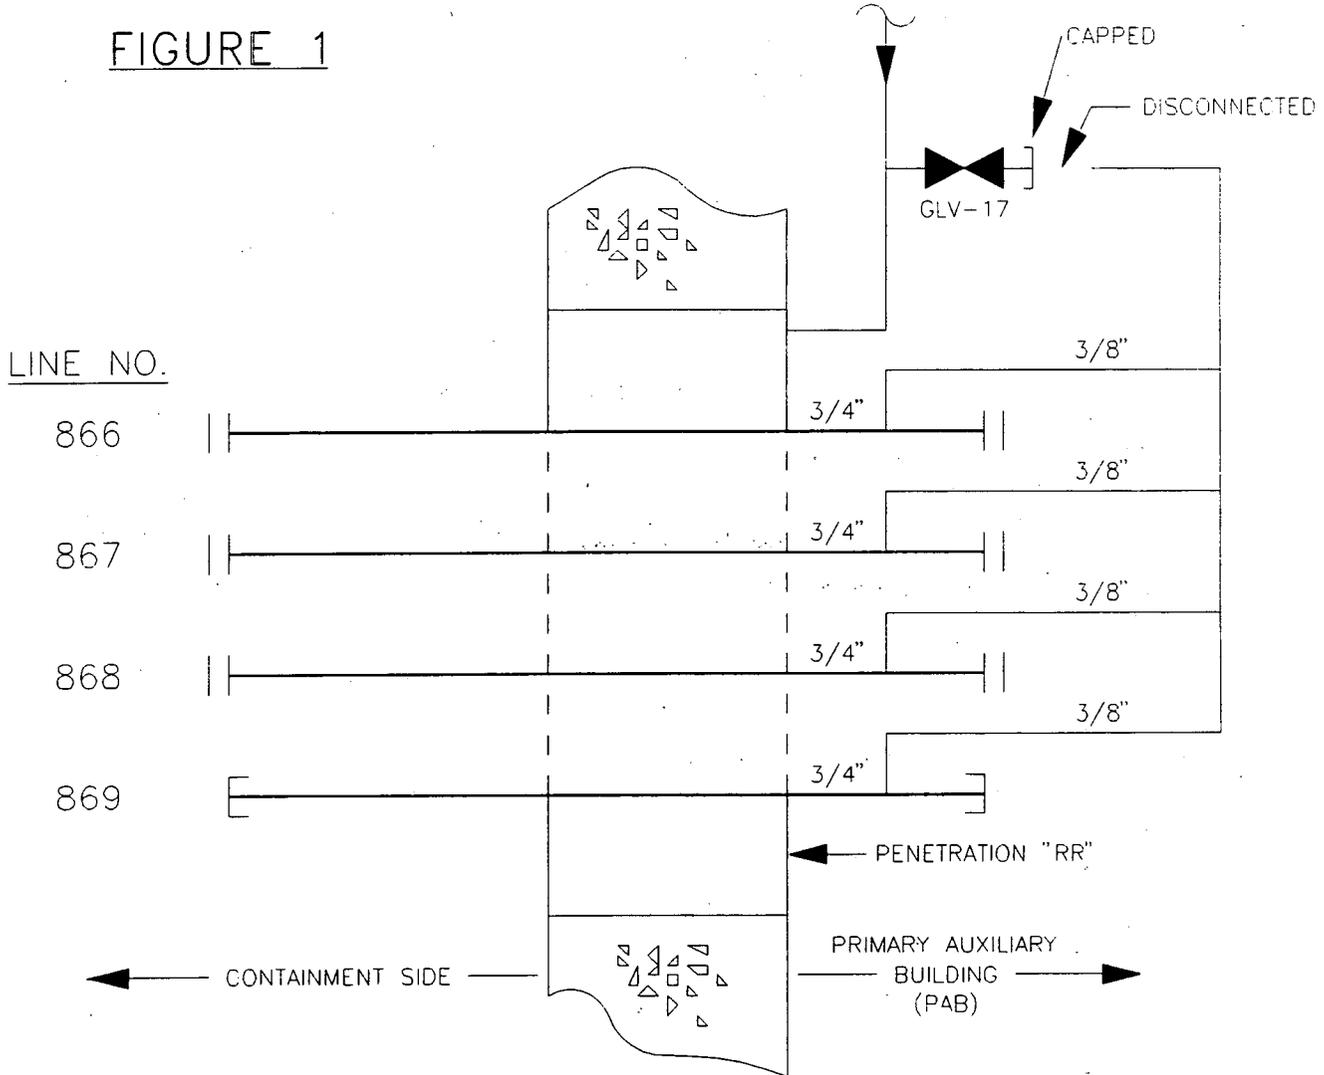
FIGURE 1

On April 6, 1993, with the plant in the cold shutdown condition, a quality control (QC) inspector found a disconnected 3/8" Weld Channel and Containment Penetration Pressurization (WCCPP) (BD) supply line which leads to lines 866, 867, 868, and 869 in containment penetration "RR" (see attached Figure 1). Lines 867 and 868 are utilized during the performance of the Integrated Leakage Rate Test (ILRT) and lines 866 and 869 are spares. Three of the ILRT test lines (866, 867, and 868) are closed at both ends by gasketed blank flanges and line 869 is capped at both ends. A WCCPP supply line runs directly to penetration "RR" and branches to feed the four leak rate test lines. Valve GLV-17 is a WCCPP isolation valve located on the line leading to the four ILRT test lines. This valve was found closed and capped downstream of the valve and the line leading to the four ILRT test lines was found open. This disconnect resulted in a configuration where only one boundary existed between the Vapor Containment (VC) and the Primary Auxillary Building (PAB) atmosphere.

The WCCPP supply line was most probably disconnected during ILRT preparation work which was required for the ILRT conducted during the 7/8 refueling outage. The ILRT was completed on December 2, 1990 and the 7/8 refueling outage ended on December 23, 1990. Since that time the plant has operated almost continuously with the exception of the 8/9 refueling outage which ran from April 18, 1992 through August 3, 1992. Containment integrity was required for the periods of time when the plant was above cold shutdown, refueling, or in mid-loop operation.

WELD CHANNEL AND CONTAINMENT PENETRATION
PRESSURIZATION (WCCPP) AIR SUPPLY

Maintenance reconnected the WCCPP supply line at approximately 2141 hours on April 7, 1993. This action restored the required configuration. The Operations Test Group successfully completed the "as-found" leak rate test of the penetration "RR" ILRT test lines on April 23, 1993.
