Indian Point 3
Nuclear Power Plant
P.O. Box 215
Buchanan, New York 10511
914 736.8001

SUBJECT: Indian Point 3 Nuclear Power Plant
Docket No. 50-286
License Event Report # 93-029-00
"Technical Specification Violation Caused by
Nonfunctional Penetration Fire Seals and Fire
Barriers Due to Personnel Error When Specified
Penetration Material Was Not Installed per
Design Drawings."

TITLE (4) Technical Specification Violation Caused by Nonfunctional Penetration Fire Seals and Fire Barriers Due to Personnel Error When Specified Penetration Material Was Not Installed per Design Drawings.

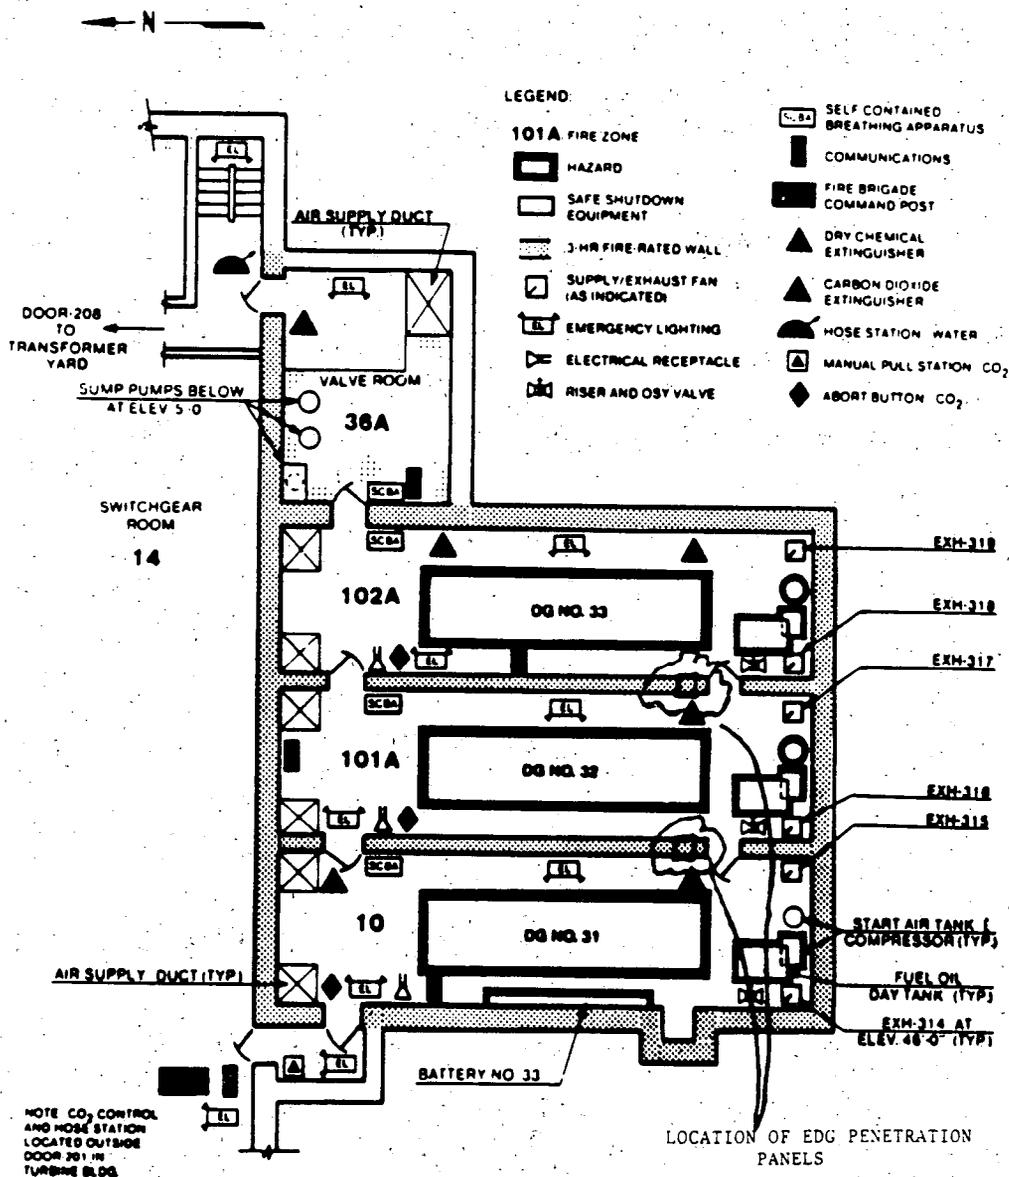
DIESEL GENS. 31, 32, 33 - DIESEL GEN. BLDG.
Elev. 15'-0" Fire Area CTL-3

On August 19, 1993, with the plant in cold shutdown, a Nuclear Engineering and Design (NED) Fire Protection Engineer identified that two penetration fire seals and their associated fire barriers were nonfunctional. The nonfunctional fire seals are located in the walls between the 31/32 and 32/33 Emergency Diesel Generator (EDG) cells, respectively. The nonfunctionality of the seals and barriers is due to their physical configuration which does not conform to a qualified 3 hour fire rated assembly. This condition is a violation of Technical Specification section 3.14.C and has existed since the issuance of Amendment 24 to the Indian Point 3 (IP3) Operating License dated March 6, 1979. The cause of this event was personnel error in that a previous analysis of the assemblies in 1992 (for which a Special Report was sent) did not consider all possible fire effects on the assemblies. The ongoing inspection of 100% of the IP3 penetration fire seals will be completed prior to unit startup from the current plant outage to address all penetration fire seal deficiencies. In addition, a modification to the affected EDG penetration fire seals to provide a qualified 3 hour fire rated assembly will be completed prior to unit startup from the current outage.

On August 18, 1993, as part the Authority's ongoing penetration fire seal inspection effort (using the guidance provided in Information Notice (IEIN) 88-04), two penetration (PEN) fire seals (SEAL) were inspected and declared nonfunctional. This nonfunctionality determination was made because of the lack of a qualified 3 hour fire rated assembly in each case. The two penetration fire seals are located between the 31/32 and 32/33 Emergency Diesel Generator (EDG) (DG) cells (NB), respectively. The penetration seals consist, in each case, of two 1/8 inch thick steel panels (PL), 6'6" by 3'0", with 16 inches of air space in between the panels on each side of the barrier. (See diagram attached which shows location of the panels) The panels are in place to permit maintenance of the EDG jacket water and lubrication oil coolers (HX).

On August 19, 1993, the inspection of the two penetration fire seals was reviewed along with historical information on Indian Point 3 (IP3) fire barriers. This information led to the conclusion that the fire barriers between the 31/32 and 32/33 EDGs, respectively, were nonfunctional because of the size of the nonfunctional seals found on August 18, 1993 and the probability that some buckling of the metal panels (with no material between) would occur during an exposure fire.

- A modification to the affected penetration fire seal assemblies to bring their physical condition into compliance with a 3 hour fire rated configuration has been initiated. Modification of the assemblies will be completed prior to startup from the current outage.

- Until such time as the affected penetration fire seals are upgraded to 3 hour fire rated configurations, an existing roving fire watch will remain in place.
