Indian Point 3
Nuclear Power Plant
P.O. Box 215
Buchanan, New York 10511
914 736.8001

SUBJECT: Indian Point 3 Nuclear Power Plant
Docket No. 50-286
License Event Report # 93-036-00
"Improper Seismic Mounting of Damper
Actuators in the Central Control Room
Ventilation System Resulted in a Condition
Prohibited by Technical Specifications Due to
Personnel Error"

TITLE (4) Improper Seismic Mounting of Damper Actuators in the Central Control Room Ventilation System Resulted in a Condition Prohibited by Technical Specifications Due to Personnel Error

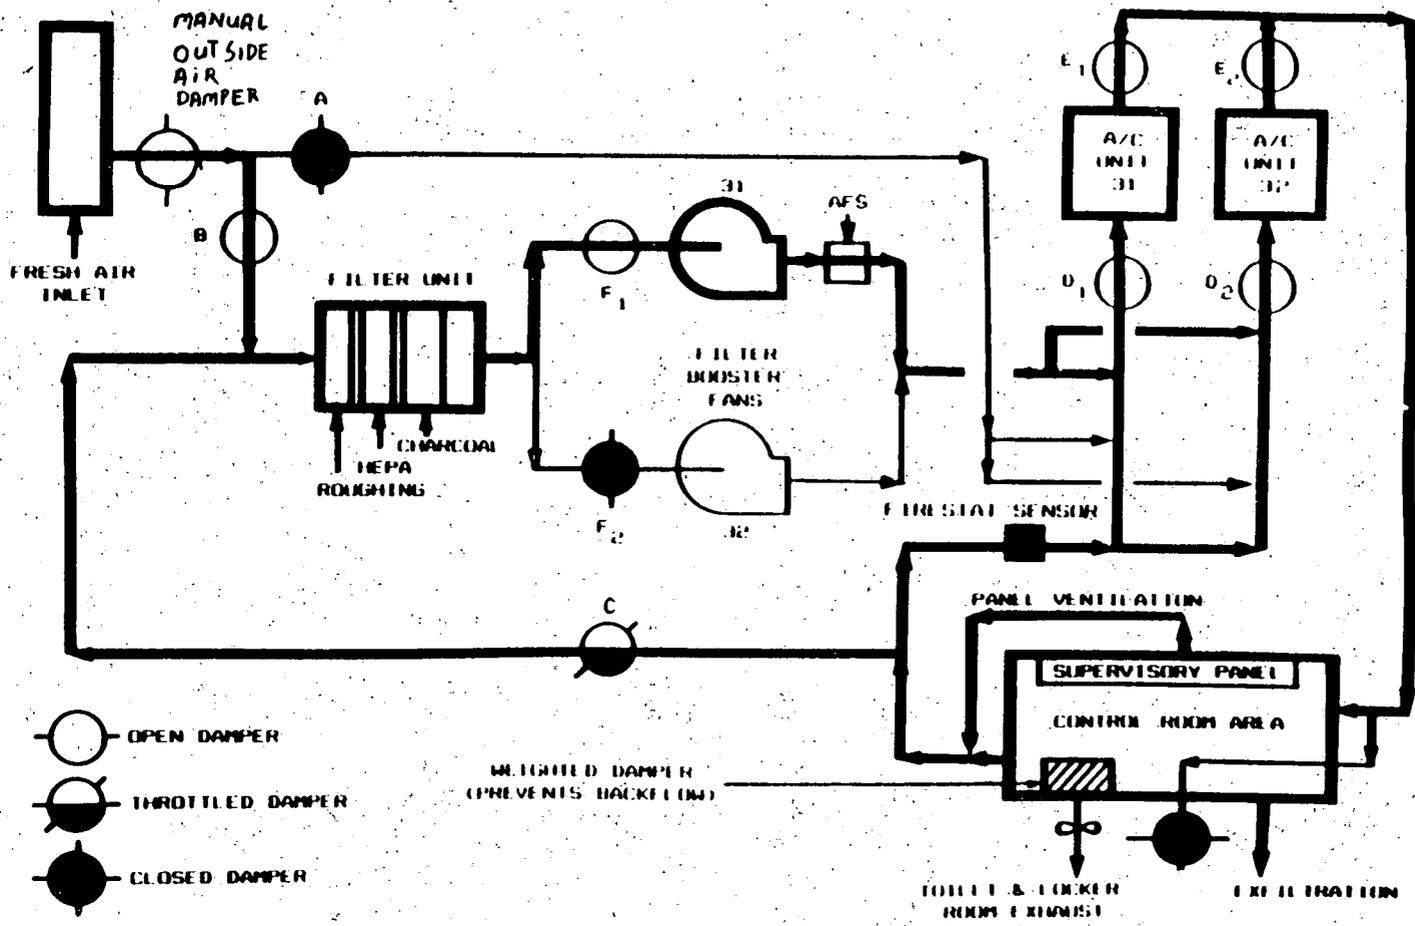
FIGURE 1
**CONTROL ROOM VENTILATION SYSTEM
 PARTIAL RECIRCULATION
 (CONTROL ROOM PRESSURIZED)**

The system engineer and seismic engineer inspected the mounting of the damper actuators and the setting of the stop nuts on the actuators in the CCR Ventilation System. The stop nuts on damper actuators B, C, D2, F1 and F2 (see attached figure) were found to be loose. The engineers determined that the mounting of damper actuators A, B, C, D1, D2, F1 and F2 appeared not to be seismically mounted and required detailed evaluation.

A detailed evaluation was performed for the A, B, C, D1, D2, F1 and F2 damper actuator mountings. This evaluation concluded that damper actuators A, B, D1 and D2 were adequately mounted so that the damper actuators would have been operable following a seismic event. This conclusion is based on the assumption that the damper actuators are seismically qualified. An ongoing search is being conducted to locate the documentation showing the seismic qualification of the actuators. If this search is unsuccessful the seismic qualification of the actuator will be evaluated through testing. If the conclusions presented here are invalidated by the results of these efforts, the Authority will provide a supplement to this LER. Although damper actuators A and D2 would have been operable following a seismic event, the mounting of the damper actuators are going to be improved. Damper actuators B and D1 are not going to be modified in any way. Damper actuators C, F1 and F2 require mounting improvements.

Dampers A, B, C, F1 and F2 are required to operate automatically following a Safety Injection signal or high radiation signal. The dampers can also be operated by manually switching the system's operating mode. If the stop nuts on damper actuators B and C are not set at the correct location, the flow through the filtration unit would not be as designed, the air would not be adequately filtered and as a result the operators would not be properly protected from radiation exposure. Damper actuator F1 is required to open to create a flow path to number 31 filtration unit booster fan (FAN) in the incident condition. In the event that number 31 booster fan fails to start, number 32 booster fan will start after a predetermined time delay and the damper actuator F2 would be required to open. Improper stop nut locations can prevent the damper actuators from performing required actions. The damper actuators are manufactured by Powers Regulator (Model 331-0240).

This event was caused by personnel error due to inadequate design control during initial installation of the dampers. Specification 9321-05-45-24, "Specification for Plant Heating, Ventilating and Air Conditioning Systems" required that the dampers satisfy seismic design criteria. However, this requirement was not met in the installation. Whether this was due to a design or installation error can not be determined because installation drawings are not available.

The cause for the loose stop nuts is personnel error, inattention to detail, during the performance of surveillance test 3PT-R032C, "Control Room Filtration System Functional". The test contains steps for adjusting the dampers. Although steps for the tightening of the stop nuts used in the adjustments are not included in the procedure, personnel are expected to address a situation such as loose stop nuts.

Damper actuators C, F1 and F2, were in a state of degraded operability during a period of intermittent plant operation above cold shutdown from initial criticality through March 7, 1993 when the plant was brought to cold shutdown. This condition is prohibited by Technical Specifications 3.3.H which requires the CCR ventilation system to be operable when containment integrity is required. During this period, while the plant was operating, there was the possibility that these damper actuators may have failed to perform their required function during or following a seismic event.

On September 16, 1993 technicians tested the flows controlled by the B and C dampers and determined no adjustments were necessary. The B and C damper actuator stop nuts positions were acceptable as found. The stop nuts on damper actuators B and C were tightened into place. On September 17, 1993 mechanics were sent out to adjust and tighten, as necessary, the stop nuts on damper actuators D2, F1 and F2. All dampers were capable of opening and closing fully in the as found conditions. The stop nuts were found to be in a position which would have allowed the actuator to stroke further than necessary. However, this condition would have caused the dampers to close tightly without damage to the damper. The stop nuts on damper actuators D2, F1 and F2 were adjusted and tightened into place.

2. The Site Engineering department will complete a modification to seismically mount the appropriate CCR HVAC damper actuators prior to plant startup.
3. The Performance department has counseled the technicians who perform surveillance test 3PT-R032C in order to assure that they address deficiencies such as the loose stop nuts.
