October 15, 1993  
IPN-93-124

Subject: Indian Point 3 Nuclear Power Plant  
Docket No. 50-286  
Licensee Event Report 93-035-00, "Weld  
Channel and Containment Penetration  
Pressurization System Outside Design Basis  
Due to Human Error"

**TITLE (4)** Weld Channel and Containment Penetration Pressurization System Outside Design Basis Due to Human Error

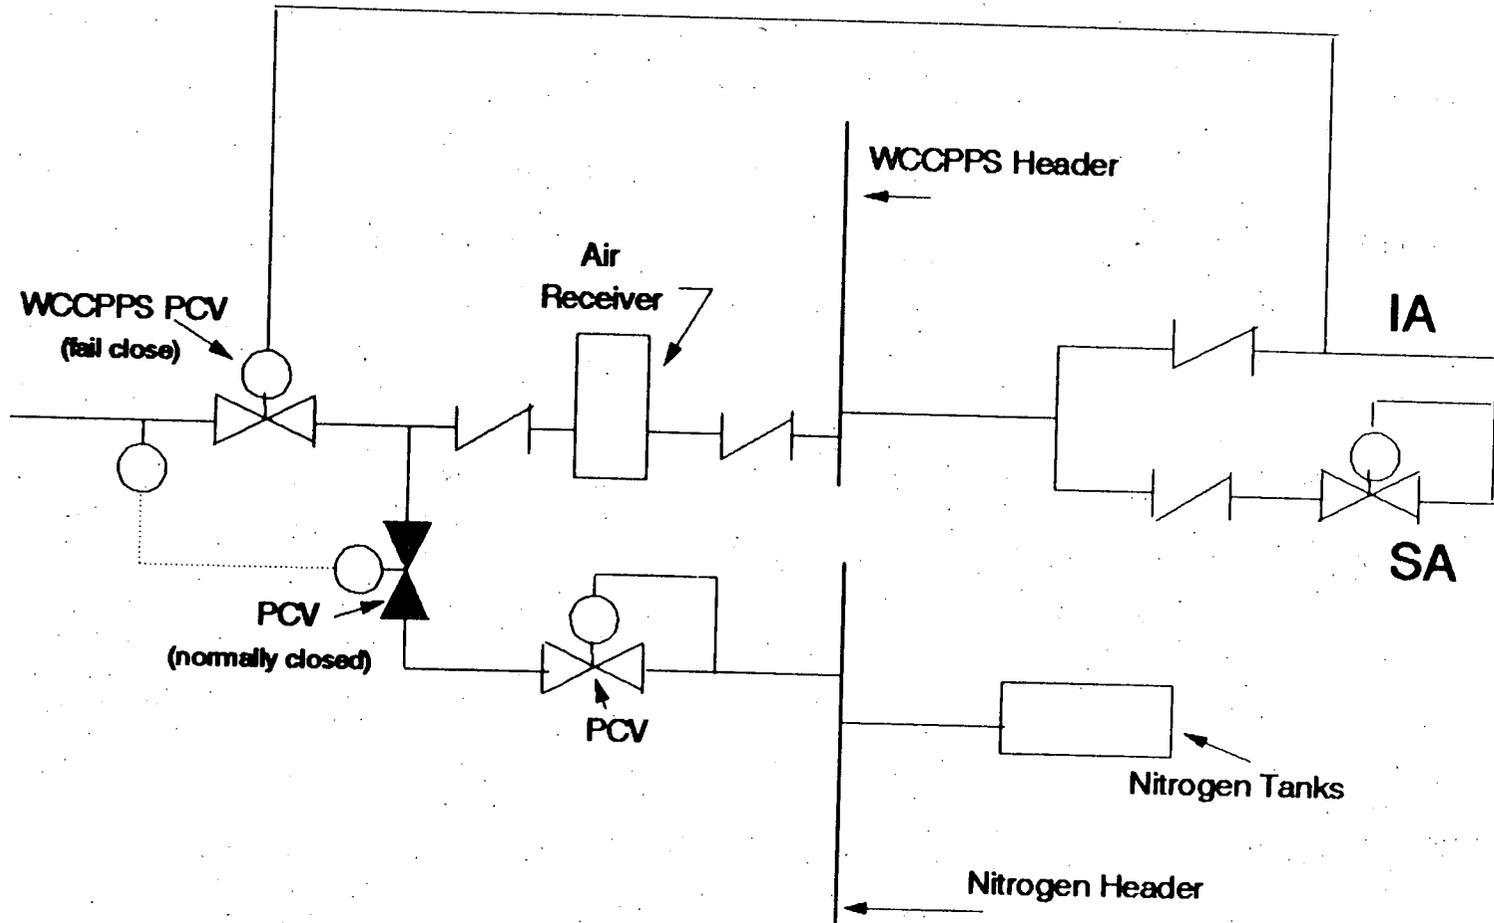
The IA system supplies compressed air at approximately 100 psig through a check valve to the WCCPPS header which supplies the four WCCPPS zones. Each zone has an air receiver (RCV) upstream of a pressure control valve (PCV) (PS-PCV-1193, 1195, 1197 and 1199 for the four channels) that is sized to maintain the air supply for at least four hours in the event the IA and SA are lost. The PCVs are designed as air-to-open valves, meaning that air pressure must be supplied to the dome of the PCV in order for the valve to open and maintain the downstream air pressure at about 46 psig. The air supply to the PCVs is supplied via piping (1" line #1155) connected to the IA system upstream of the interconnection between the IA system and the WCCPPS. The PCVs rely upon the pressure in the IA system to remain open since there are check valves (FCV) (IA-13 and either IA-31-1, 2, 3 or 4) between the WCCPPS air receivers and the connections to IA. A simplified sketch of the piping is on the last page.

An automatic SI System actuation signal with a loss of offsite power would cause a loss of IA because the safety related electrical busses are stripped and the IA and SA compressors (CMP) are not reloaded. Following a loss of the compressors, the IA system would retain sufficient pressure to operate the PCVs for about 1/2 hour. When the air pressure is insufficient to hold open the PCVs, they fail closed and all air flow to the WCCPPS stops. Manual action to regulate WCCPPS air pressure using the PCV bypass lines is feasible (each zone has a pressure relief valve set at 49 psig to prevent overpressurization) but is not considered in the system's design basis.

The backup supplies would not prevent this event. The primary source of backup is the N<sub>2</sub> supply which has sufficient capacity for 24 hours. When the pressure downstream of any PCV drops to 43 psig, the zone's pressure controller (PC) actuates a N<sub>2</sub> supply valve to deliver N<sub>2</sub> to a connection just upstream of the PCVs. This gas supply will not operate the PCVs because of intervening check valves (IA-13 and either IA-31-1, 2, 3 or 4). The secondary source of backup air is the plant's SA system which is cross-connected to the IA system. SA would also be lost when an automatic SI actuation signal occurs because the compressors are stripped from the safety related busses and not reloaded. The last backup is a permanent cross connection to the Con Ed IP2 SA system. Operation of this backup requires manual action not considered in the system's design basis.

The cause of the event was personnel error during the engineering design and design review of the WCCPPS by the Architect Engineer. The factors contributing to the personnel error could not be identified because there is insufficient information.

Simplified Sketch of IAS To Show Current Air/Gas Supply To A Typical WCCPPS Zone

1. The WCCPPS will be modified to reroute the source of air pressure to each PCV dome so that it connects to the high pressure piping downstream of the WCCPPS air receivers. This plant modification

is required prior to exceeding the cold shutdown condition. It is scheduled for completion November 20, 1993.
