SUBJECT: Indian Point 3 Nuclear Power Plant
Docket No. 50-286
Licensee Event Report # 93-045-00
"A Failure Mode Of The Central Control Room
Ventilation System Damper Actuators With The
Loss Of Instrument Air Resulted In A
Condition Prohibited By Technical
Specifications Due To Personnel Error"

LICENSEE EVENT REPORT (LER)

TITLE (4) A Failure Mode of The Central Control Room Ventilation System Damper Actuators With The Loss Of Instrument Air Resulted In A Condition Prohibited By Technical Specifications Due To Personnel Error

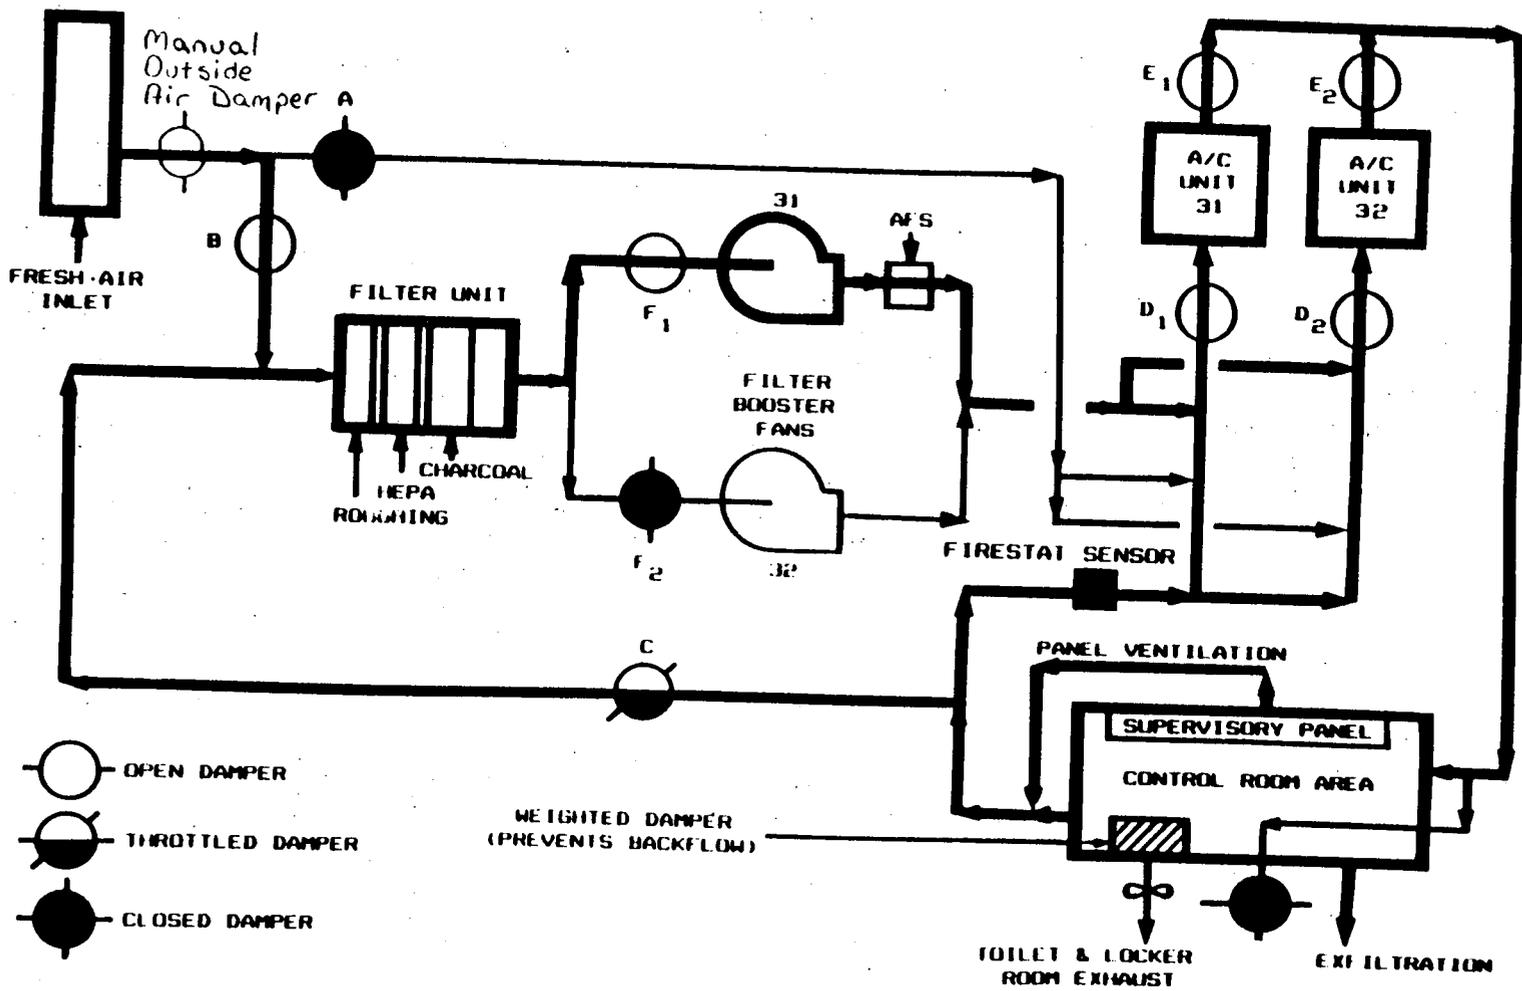
FIGURE 1
**CONTROL ROOM VENTILATION SYSTEM
 PARTIAL RECIRCULATION
 (CONTROL ROOM PRESSURIZED)**

The CCR HVAC has 7 pneumatically operated dampers (see attached Figure 1). The function of these dampers, their position in the 10% incident mode and their failure position following loss of IA are as follows:

- Dampers A and B direct the flow of air from the outside air intake into the system. The B damper, normally closed, opens to direct outside air to the filtration unit. The A damper, normally open, closes to isolate the system fans from the outside air intake. These dampers fail closed on loss of IA.

- Damper C directs CCR return air to the filtration unit. The C damper is normally closed and opens in the 10% incident mode. It fails open.
- Dampers D1 and D2 open or close the air flow path returning to the associated HVAC unit. These dampers are normally open if the corresponding HVAC unit fan is running. Closure of a damper stops the corresponding HVAC unit fan resulting in a loss of a CCR cooling unit. These dampers both fail closed.

- The F1 or F2 dampers are each on the inlet to a filter booster fan and isolate the filtration unit. These dampers are normally closed and open in the 10% incident mode. These dampers fail closed.

The failure modes identified above isolate outdoor air from the system and result in a loss of pressurization, filtration and cooling in the CCR. This prevents the CCR HVAC system from performing its required function in any of its modes.

The event was caused by personnel error of an indeterminate origin during the system design. The architect engineer did not evaluate this failure mode during initial design or when upgrading the system from a non safety system to a safety system prior to initial operation.

1. The Authority's Modification Control Manual (MCM) program procedures require the failure modes for equipment to be analyzed. The MCM program was not in place at the time of this design and installation. Adherence to this MCM program assures that this event will not occur in future modifications.
2. Priority I and II design document open items for the CCR HVAC will be evaluated prior to startup to assure they do not affect system operability. (Reference commitment number 4 in NYPA letter IPN-93-145, dated November 18, 1993)
3. An evaluation is being performed to define the corrective actions to the CCR HVAC system necessary to address the deficiencies that result from loss of instrument air. A supplement to LER 93-045 will be issued to identify this corrective action.
