WOLF CREEK NUCLEAR OPERATING CORPORATION

Subject: Docket 50-482: Response to NRC Integrated Inspection Report
05000482/2009004

Attachment I provides WCNOC's denial of NCV 2009004-03, "Inadequate Evaluation of Emergency Diesel Generator for Common Cause Failure in the Supporting Essential Service Water System." Attachment II provides WCNOC's denial of NCV 05000482/2009004-06, "Performing Prohibited Elective Maintenance on Safety Bus NB02 Channel 4 during Emergency Diesel Generator Maintenance."

DENIAL OF NONCITED VIOLATION 2009004-03

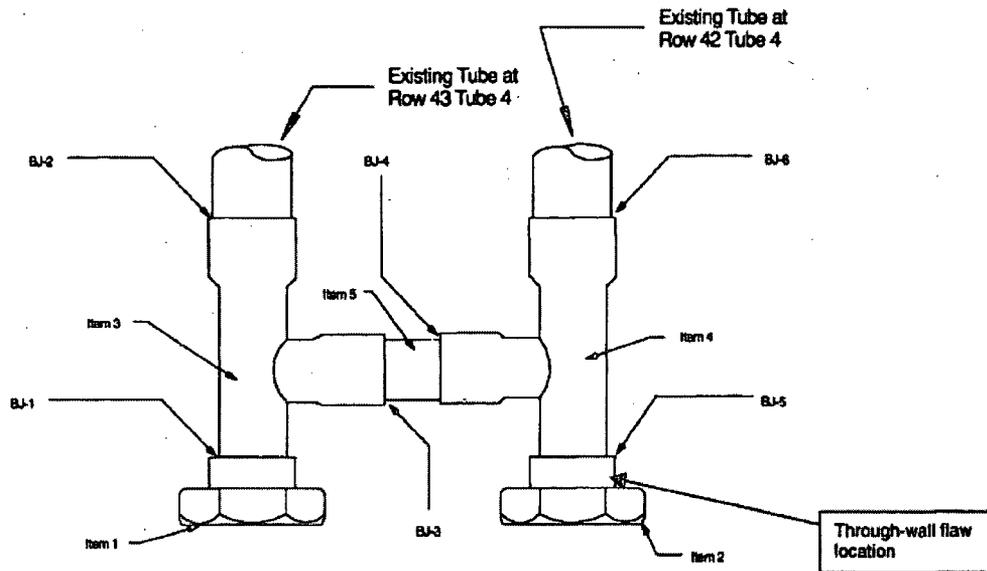
Room Cooler H-Bend Assembly

An evaluation was performed to determine if the "A" ESW train would have been capable of performing its specified safety function on February 13, 2008 at 1420 CST to February 13, 2008 at 1613 CST with the leak on the "A" CCP room cooler H-bend assembly.

The H-Bend assembly arrangement is composed of two tees joined together (see sketch below), and a threaded nut on one end of each tee. All of this is brazed together into a solid unit. An end plug (not shown) threaded into each nut and sealed by an o-ring completes the assembly.
