REPORT ON THE
CONTAINMENT BUILDING LINER
PLATE BUCKLE
IN THE VICINITY OF THE
FUEL TRANSFER CANAL

INDIAN POINT GENERATING STATION

UNIT NO. 2

JANUARY, 1968

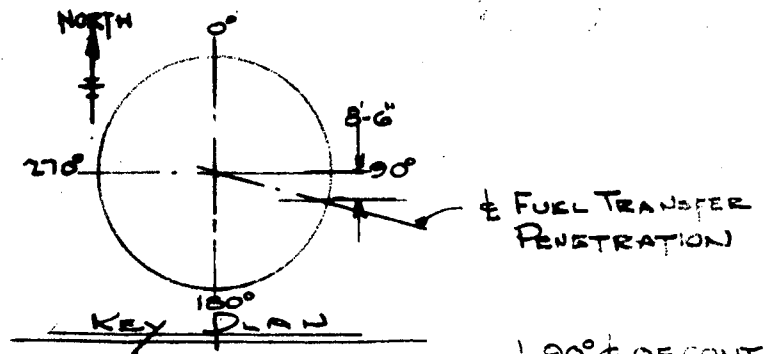
FIGURE 1

During a routine inspection of the Vapor Containment liner by Quality Control personnel on August 4, 1967, a buckle was noted in the liner plate near the fuel transfer tube between elevations 56'-7" and 59'-7". Chicago Bridge & Iron's drawing No. 5 designates these plates as 3H and 3J. Figure 1 shows the location of the plates.

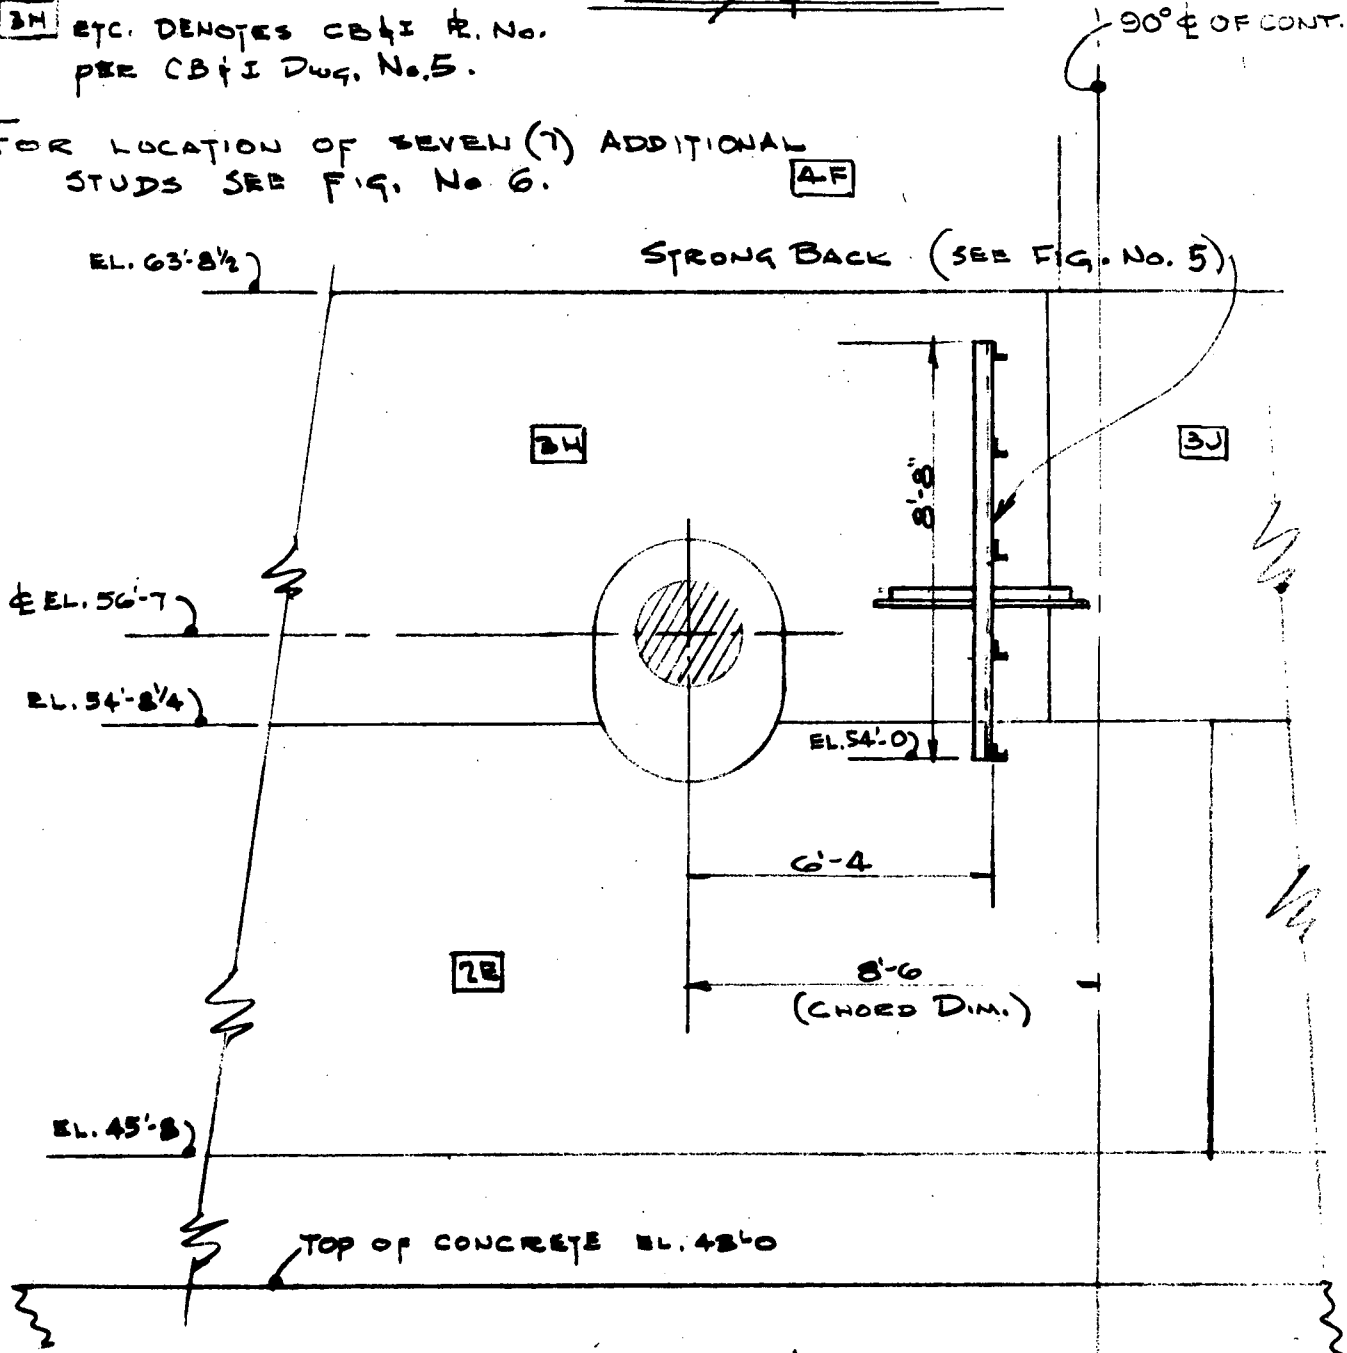
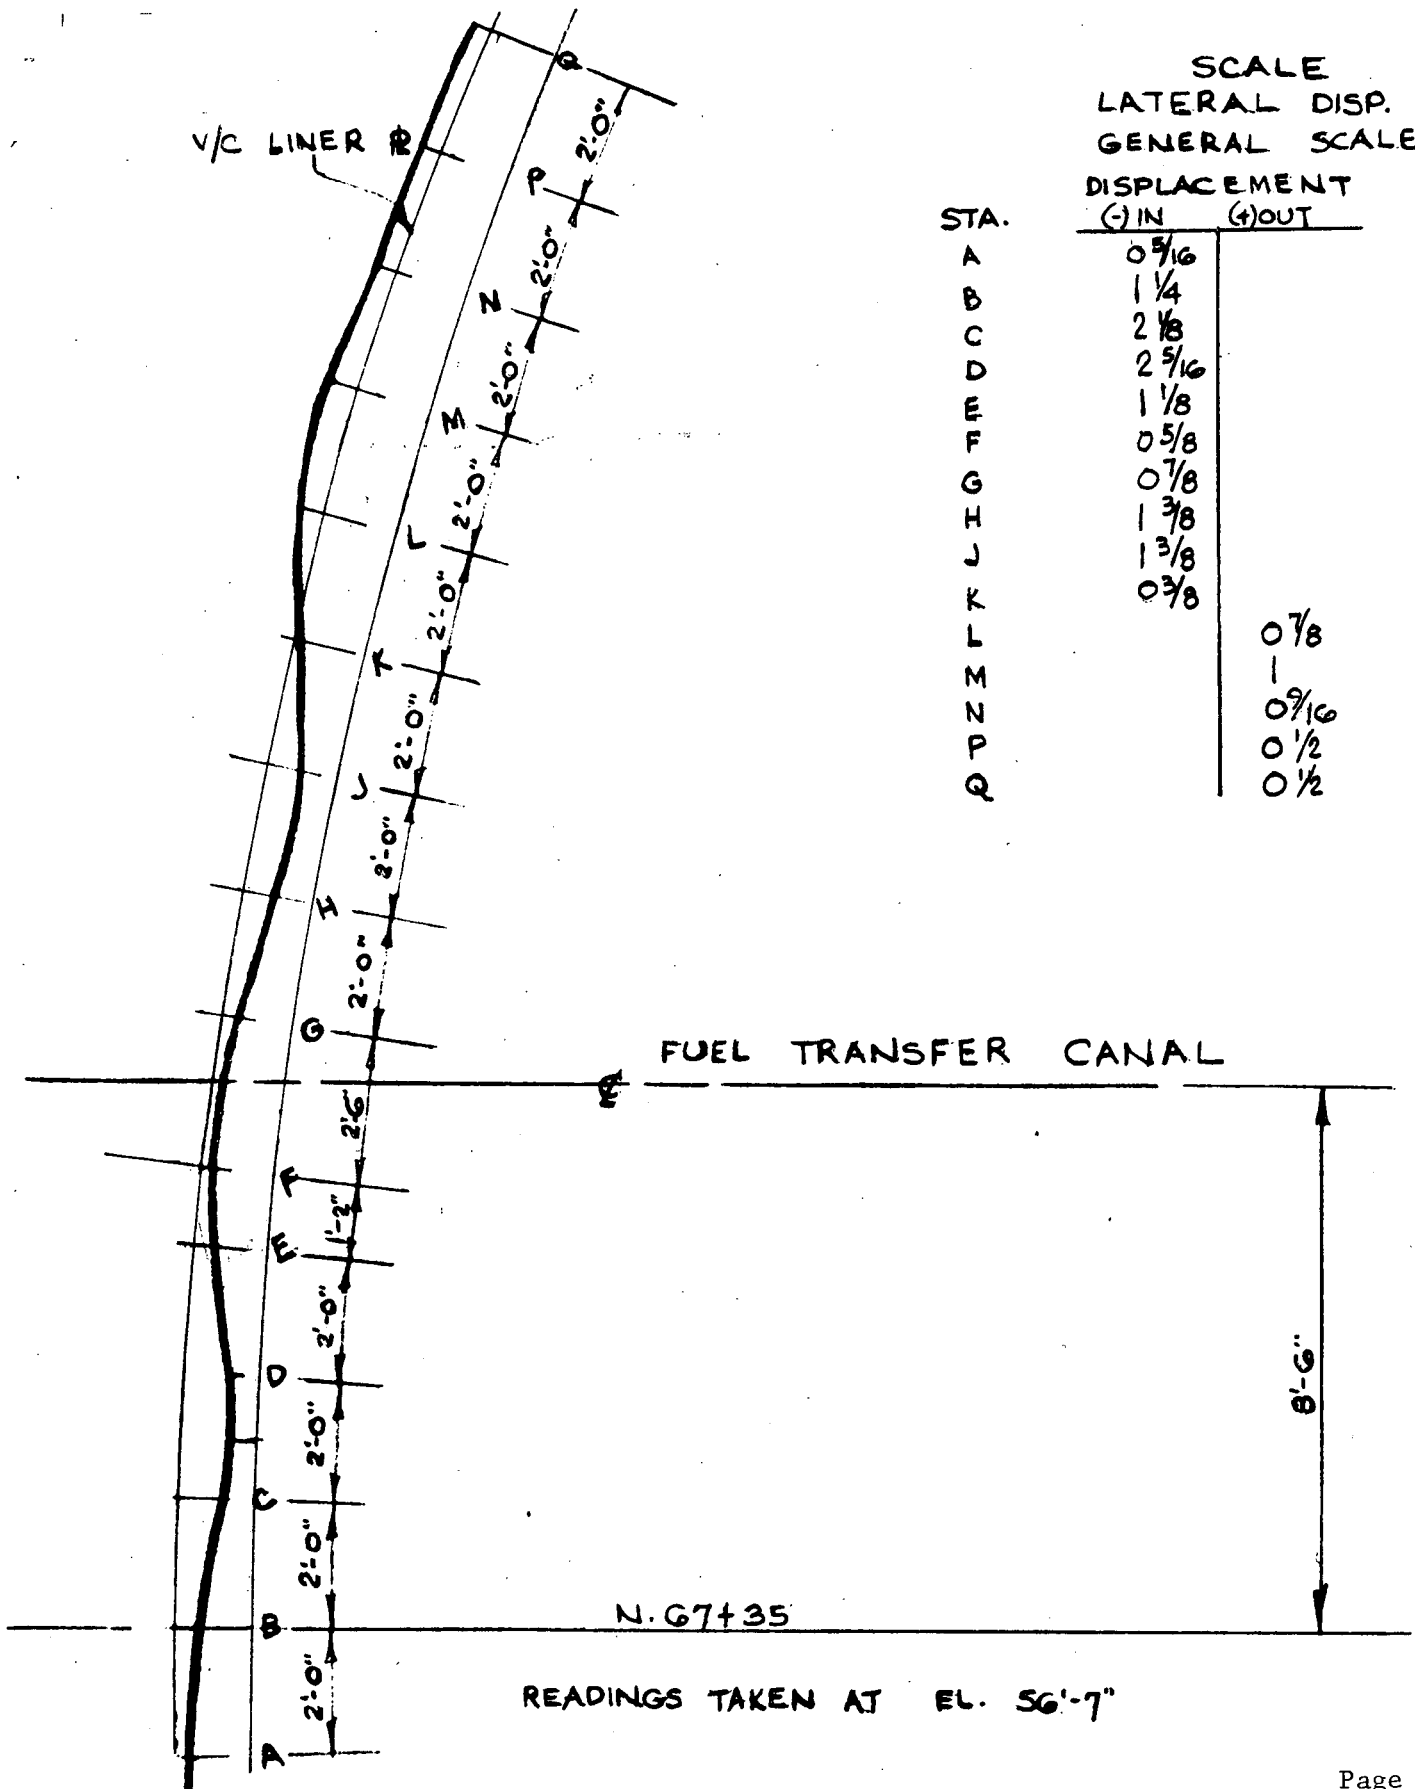
FIGURE 2

Field measurements were taken at the buckled zone (elevations 56'-7" and 59'-7"). The measurements show the distance the liner had buckled from a normal position at various stations. This information is shown on the attached Figures 2 and 3. Figure 4 is a plot of this data in the form of a contour map of the buckled zone.

Specification 9321-01-225-3, Containment Building Liner, allows 2" tolerance for local buckling. From the above information, it is noted that points C and D at elevation 56'-7" were beyond the acceptable limits by 1/8" and 5/16", respectively.

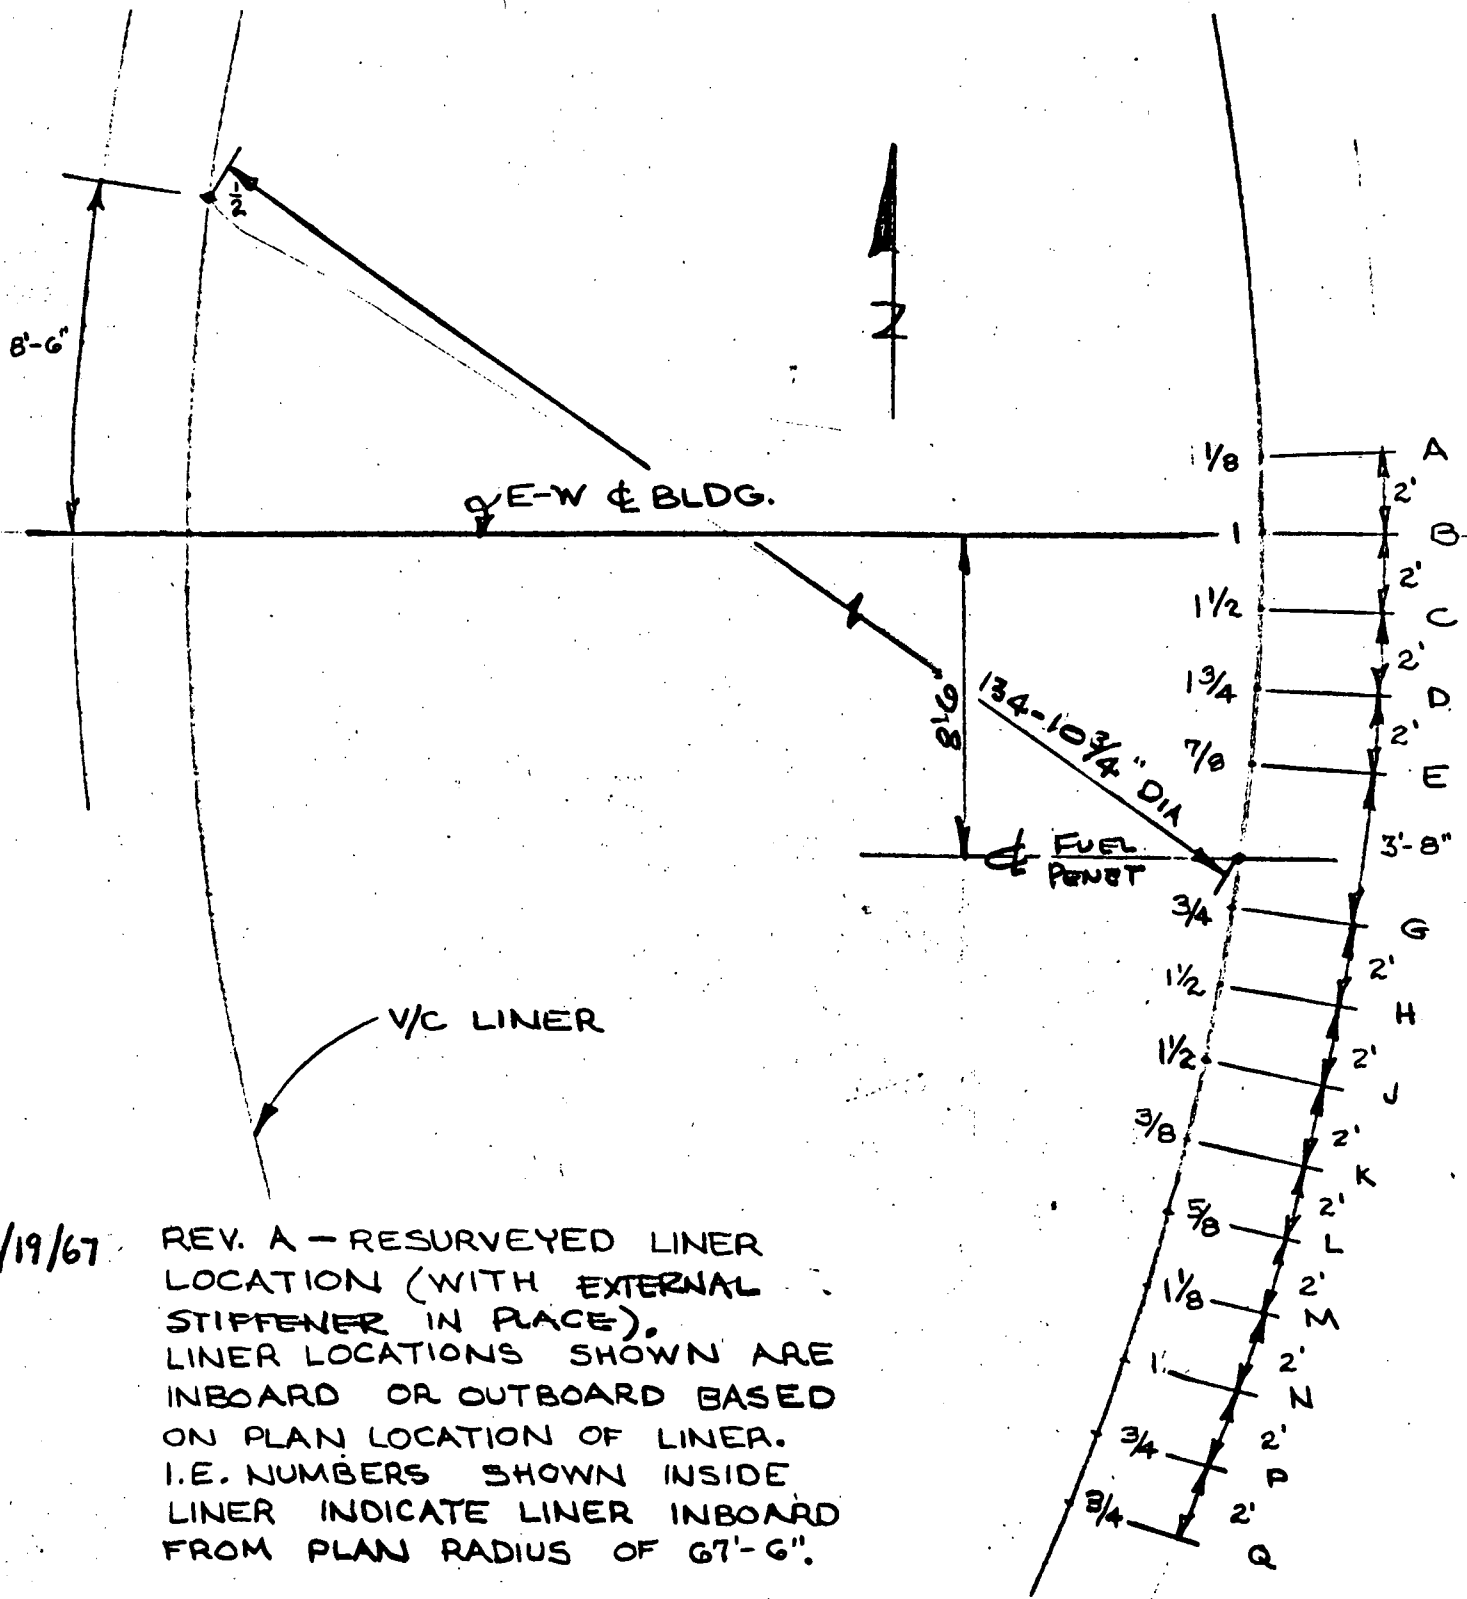
FIGURE 7

Figures 7, 8 and 9 show the liner configuration after corrective action was taken. Figure 10 is a contour map of the buckled zone after corrections and in addition, all of the studs including the original installation and the additional studs are shown. At all points the liner is within the allowable tolerances.
