Indian Point Unit No. 2
Results of Test Program Following
Modifications to Steam Generator Internals

August 30, 1974

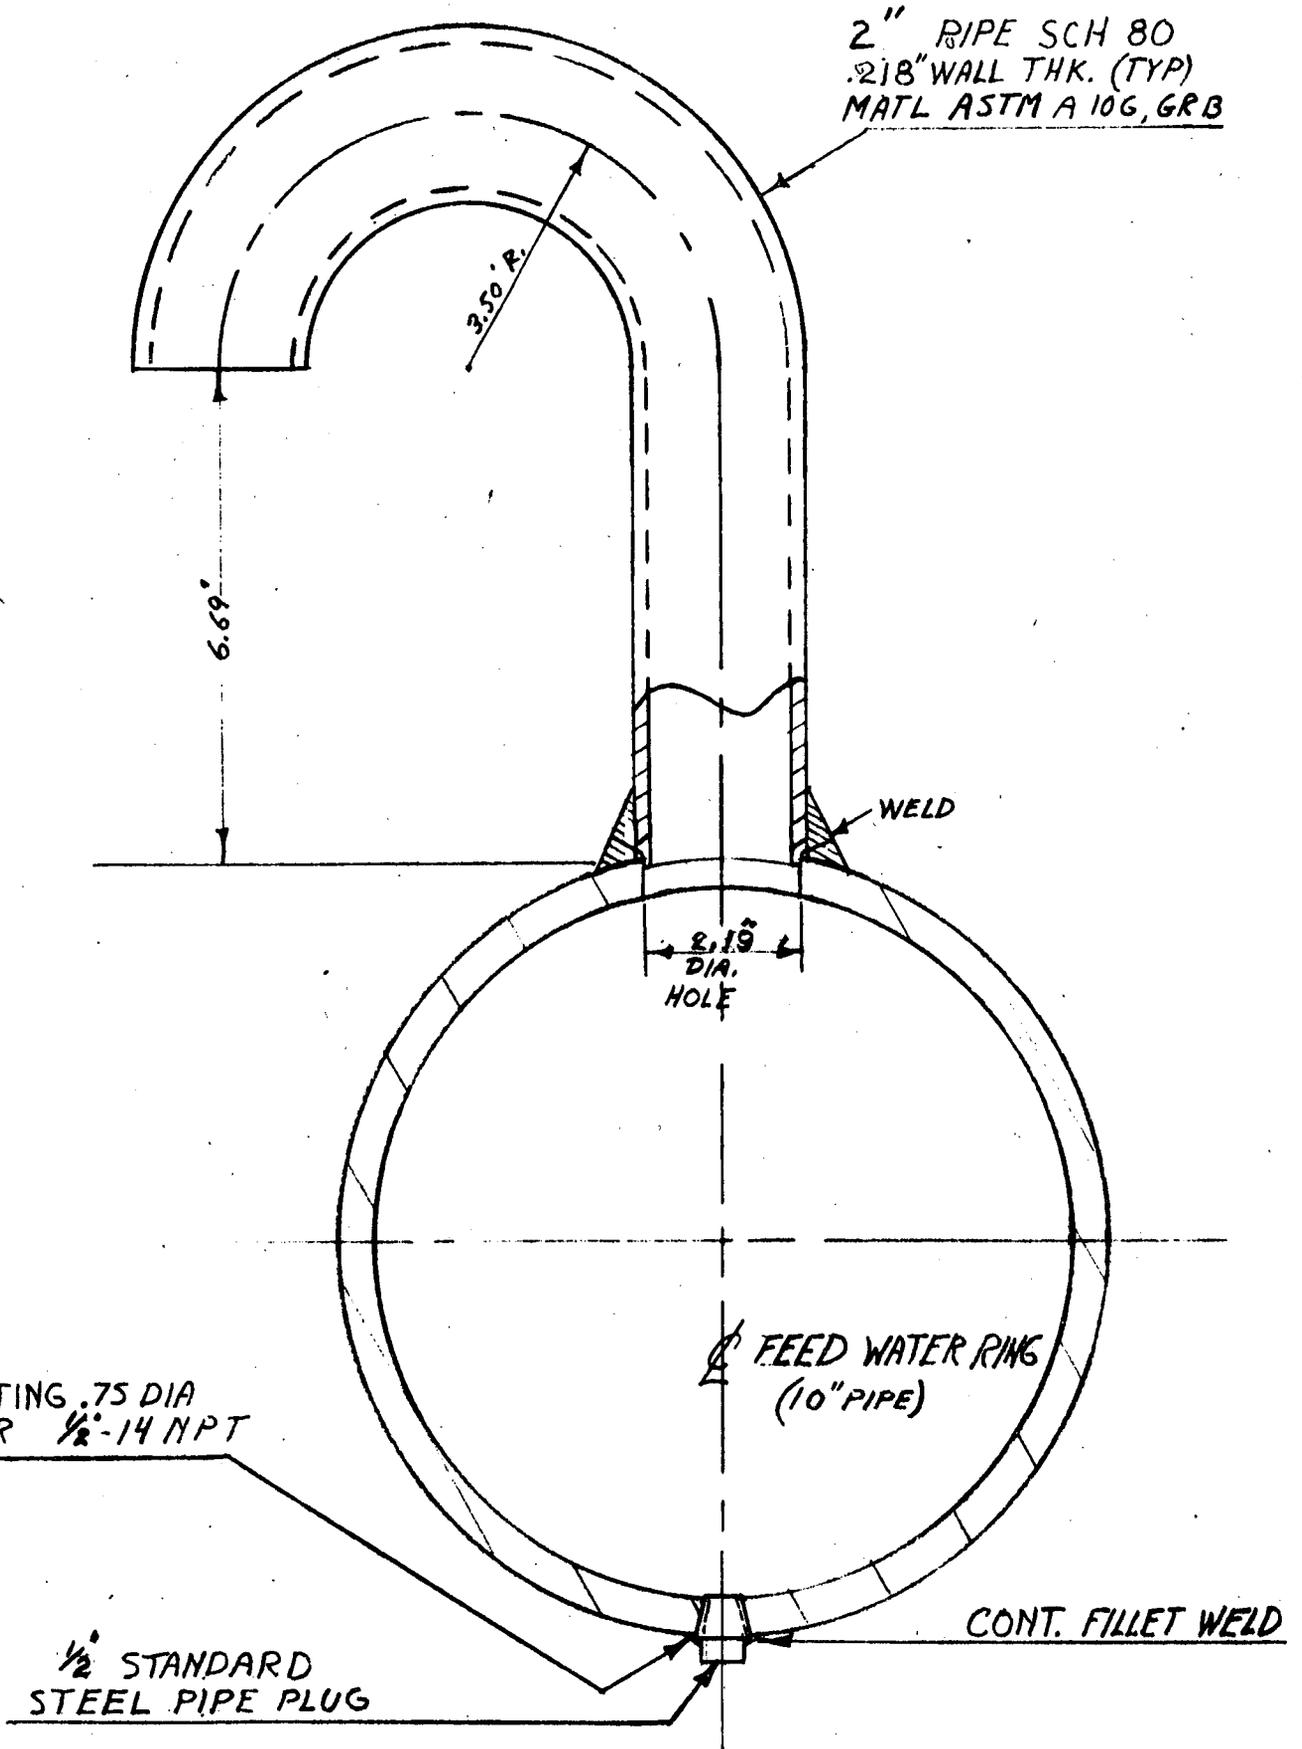
Figure No. 1

To confirm the leak tightness of the welds made during modifications to the steam generator feedwater rings (Figure 1 and 2), hydraulic leak tests of the modified rings were performed with the reactor in the cold shutdown condition. The feedwater rings were filled to overflowing using a motor-driven auxiliary feedwater pump, and the welds were visually inspected for leakage. The results were acceptable for all four steam generators. During these tests, there was a small continuous leakage around the thermal sleeve annulus in the feedwater nozzle, as would be expected from the design of the sleeve.

Indian Point Unit No. 2
Modifications to Steam Generator Feedwater Ring
(Typical)

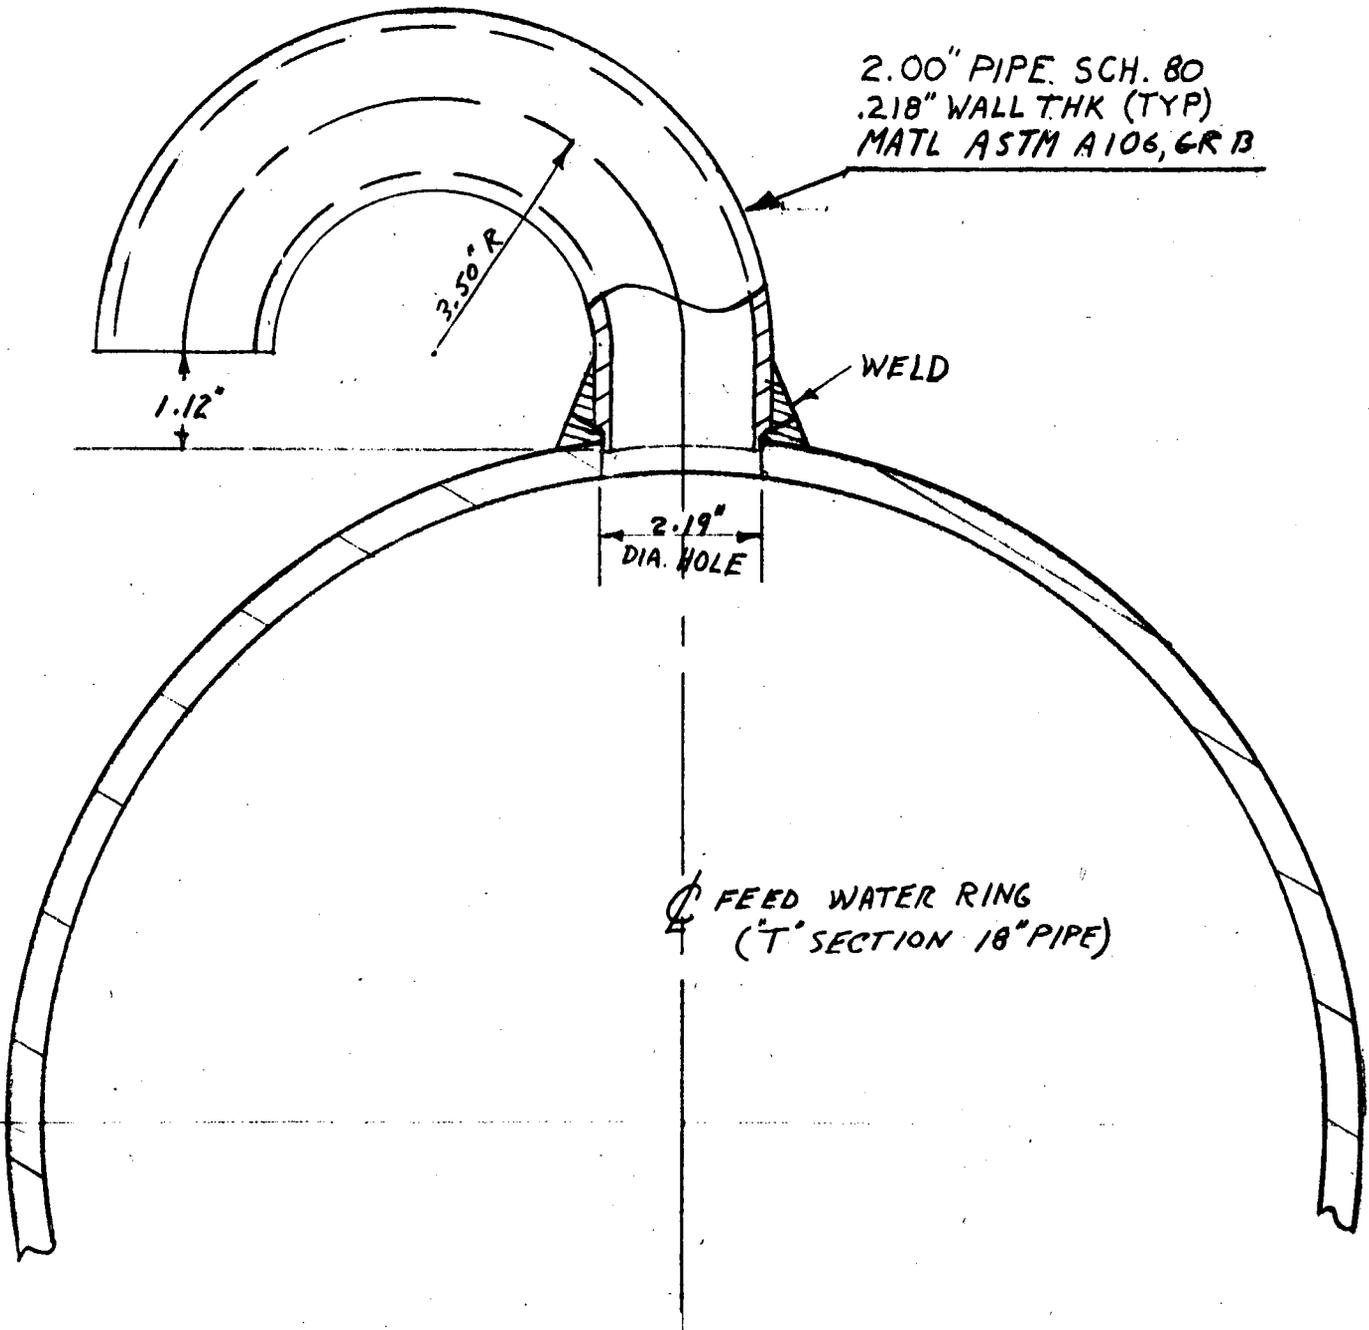
Figure No. 2

Indian Point Unit No. 2
Modification to Steam Generator Feedwater Ring
at 18" Tee (Typical for 2 Locations/Steam Generator)

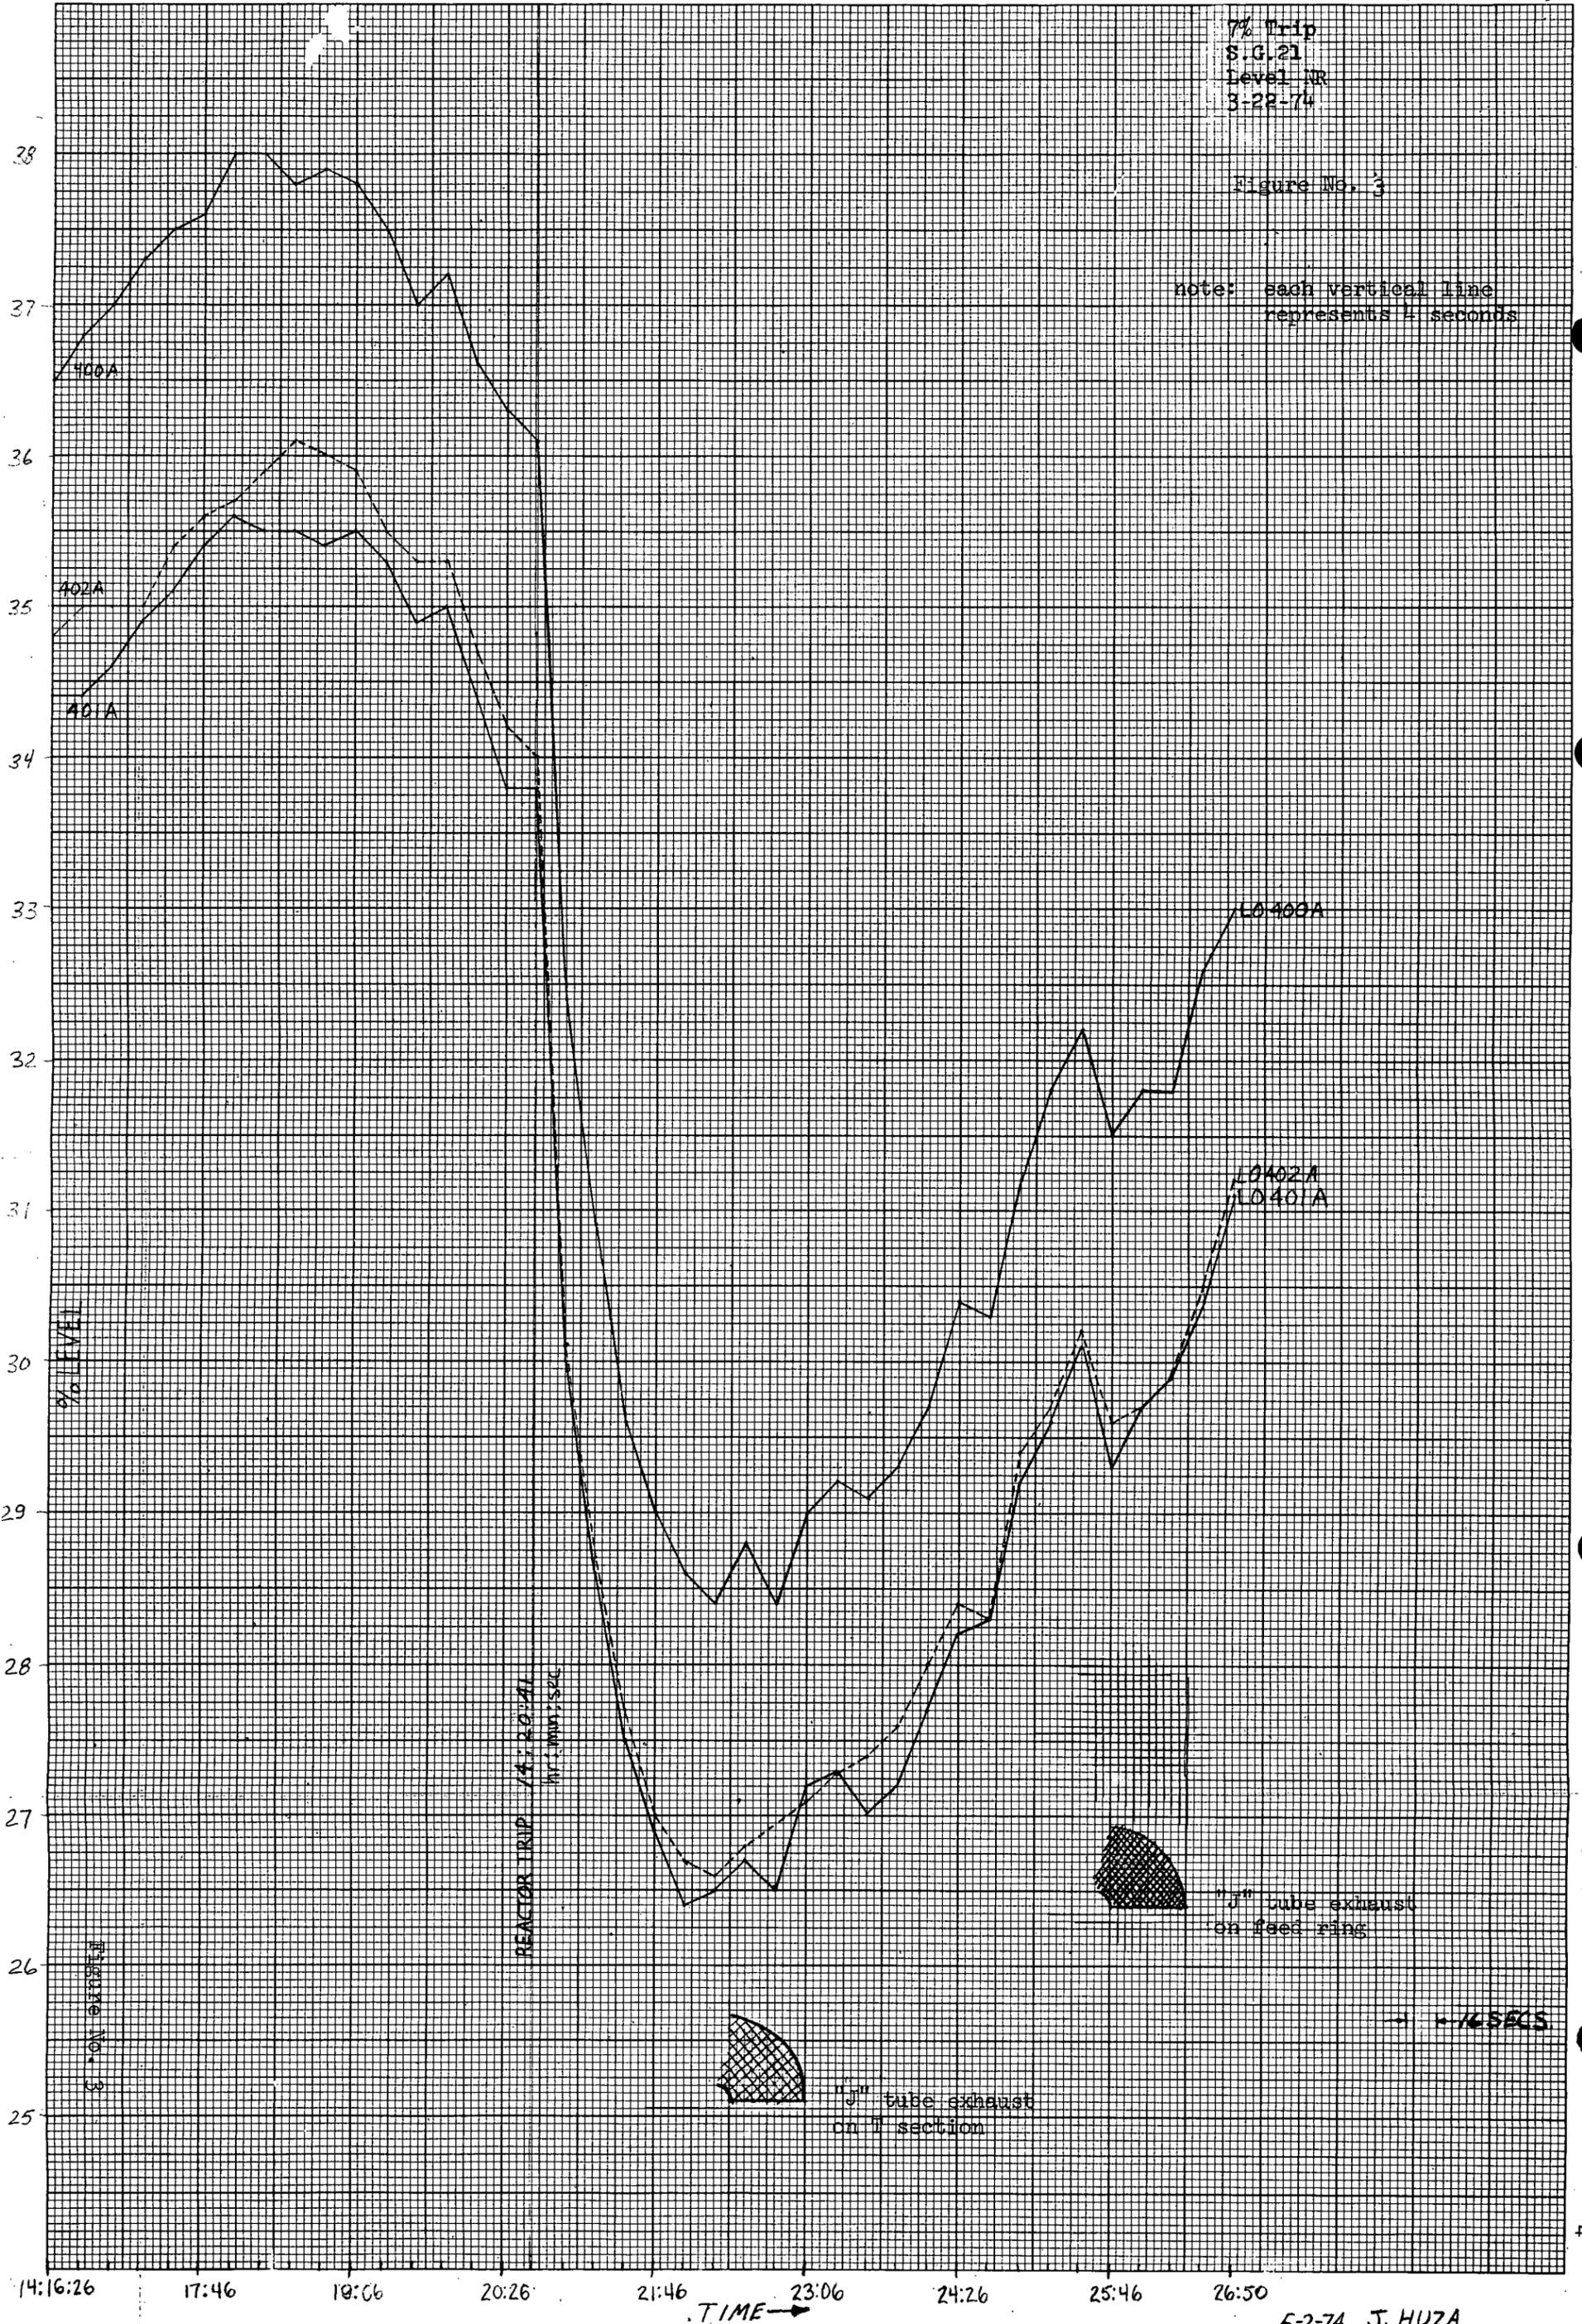
Figure No. 3

Following successful completion of tests with the reactor subcritical on March 21, 1974, the reactor was brought to a power level of approximately 7% with feedwater under manual control. This condition simulated that which existed on November 13, 1973, just prior to the incident which resulted in the feedwater pipe failure. Level in the steam generators was lowered until a low-low level reactor trip was initiated. Following this trip, the main feedwater pump was manually tripped and the auxiliary boiler feed pumps were then manually started. There was no indication of any waterhammer shock either on instrumentation readout or by reports from observers stationed inside and outside containment. Level data and feedwater pipe temperature data for Steam Generators 21 and 22 are included for comparison to the curves transmitted in Report No. 2 dated March 12, 1974 (see Figures 3, 4, 5 and 6).

7% Trip
S.G. 21
level NR
3-22-74

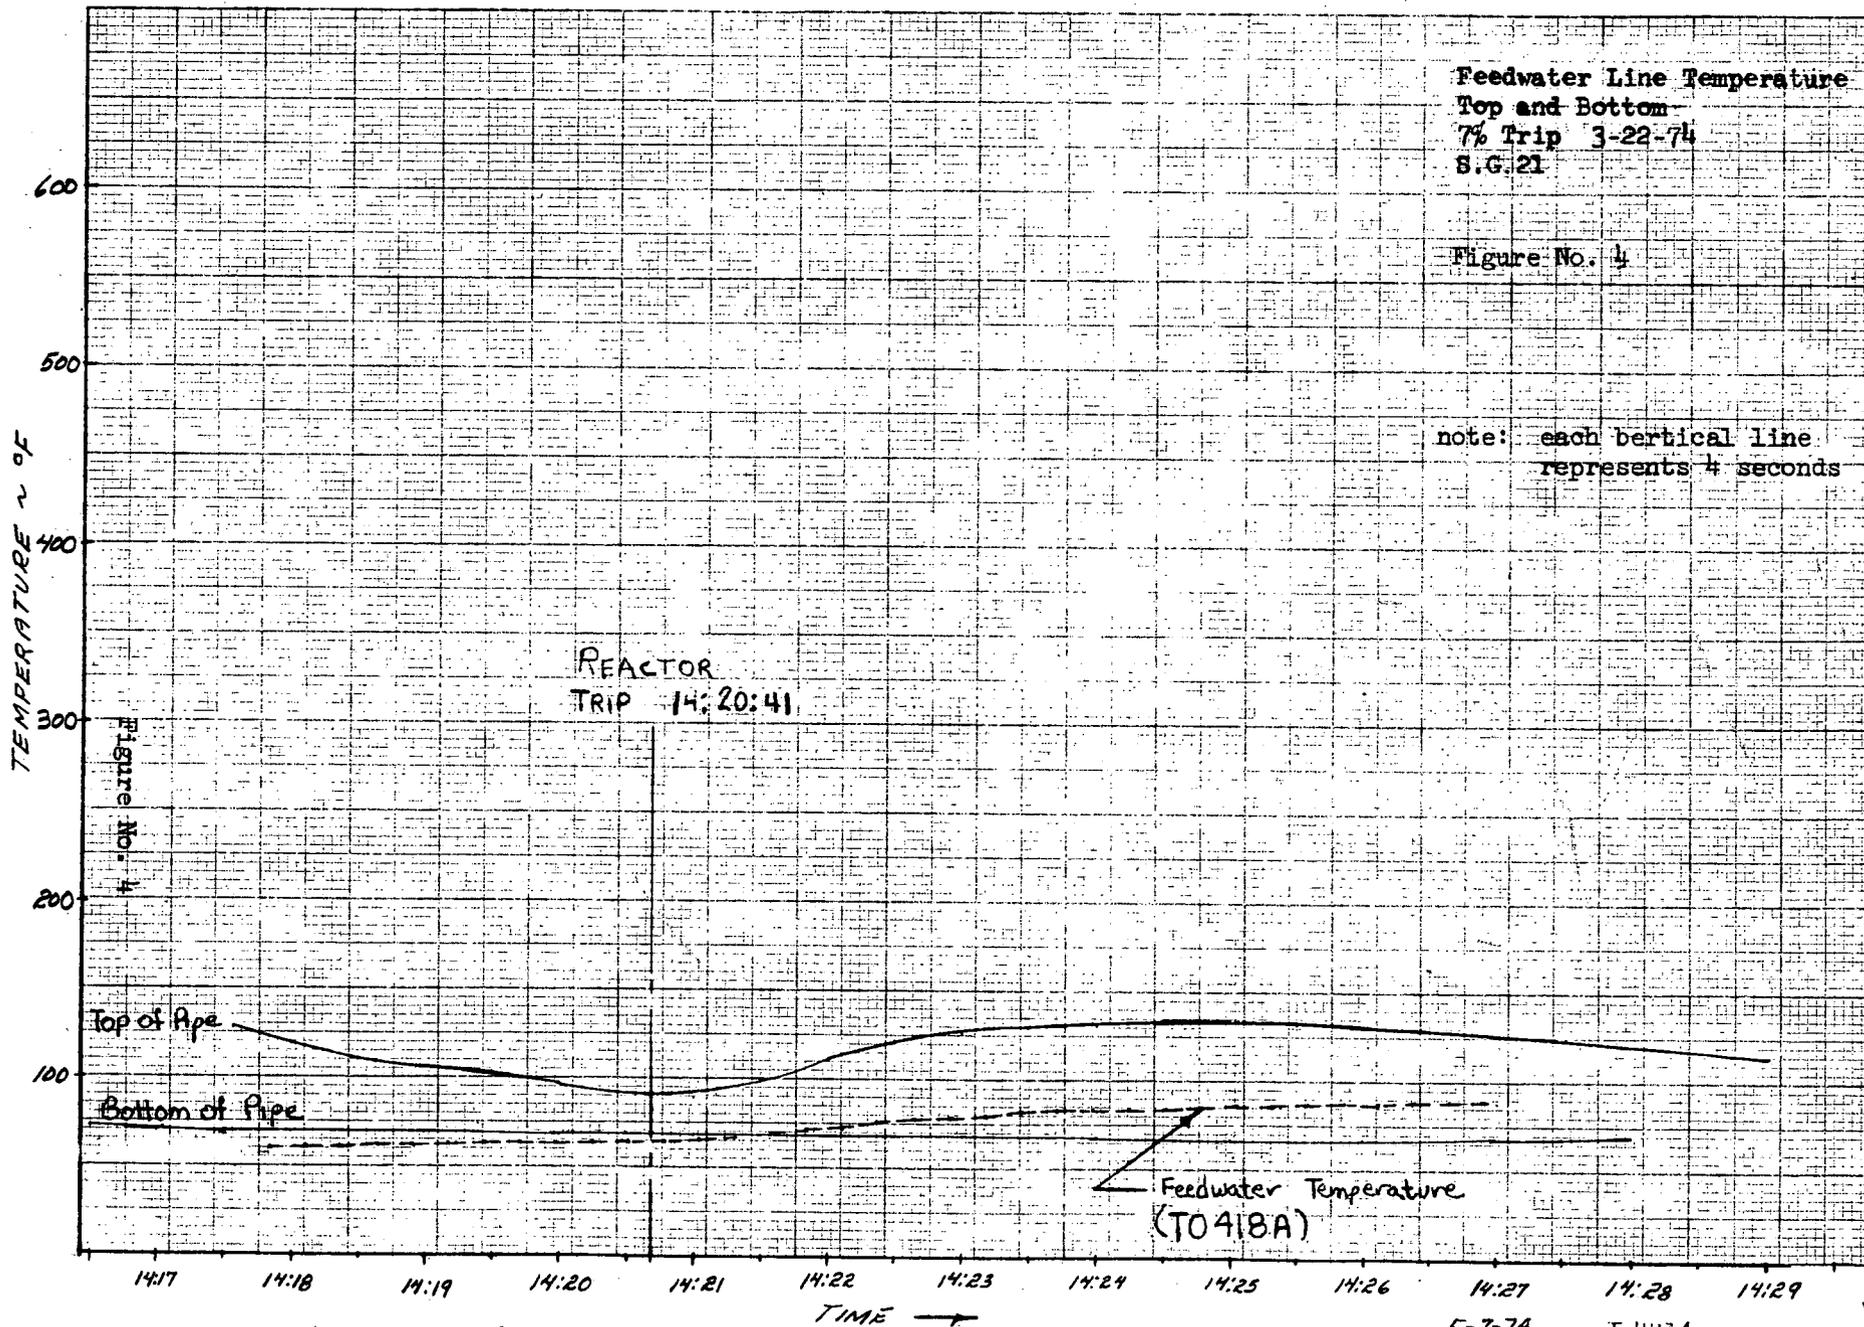
Figure No. 4

Feedwater Line Temperature
Top and Bottom
7% Trip 3-22-74
S.G. 21

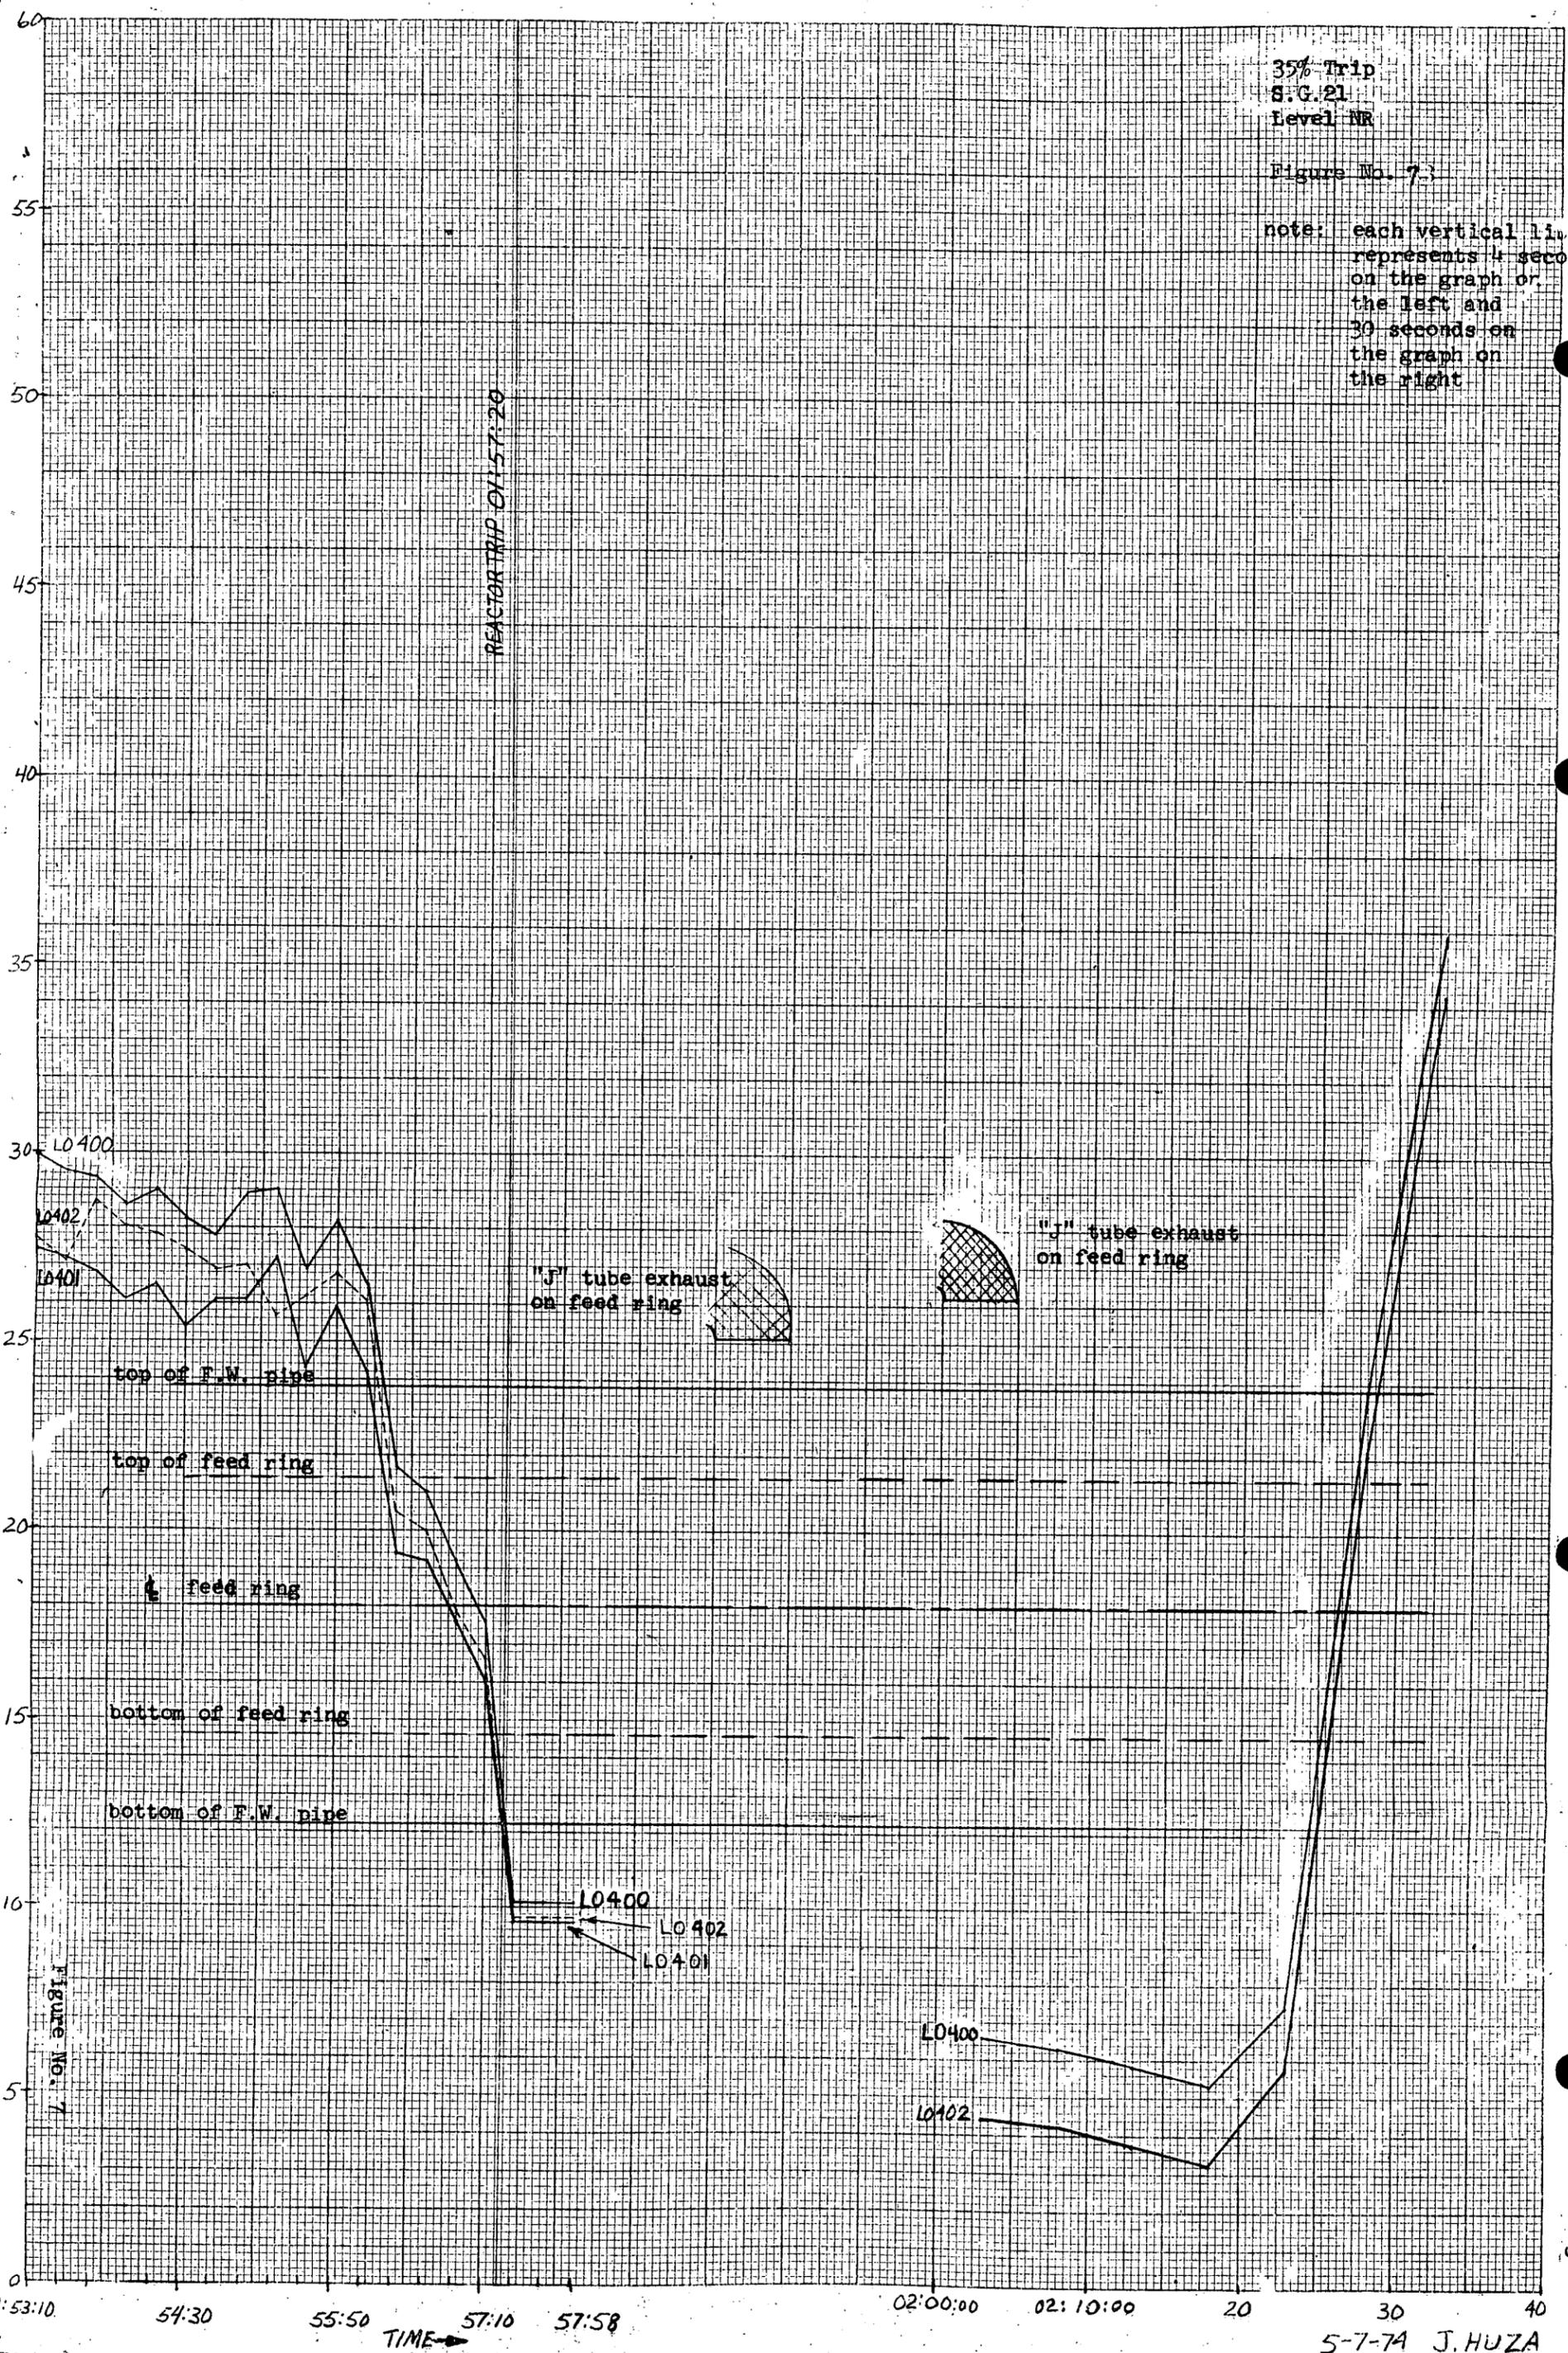
Figure No. 7

On March 22, 1974, Unit No. 2 was brought to 35% reactor power, with the feedwater system in automatic control. A plant trip was initiated again by allowing level in a steam generator to drop below its low-low point and then subsequently tripping the main boiler feed pumps and starting the auxiliary boiler feed pumps. This simulated the plant trip which occurred on January 29, 1974 when a waterhammer shock was experienced in the feedwater piping to Steam Generator No. 21 (Reference 1 Attachment, Page 3). During the March 22, 1974 test, no waterhammer shock was observed on instrumentation or by observers outside of containment. Steam Generator 21 and 22 data for this trip are plotted in Figures 7 & 8 and Figures 9 & 10, respectively.

35% Trip
S.G. 21
Level NR

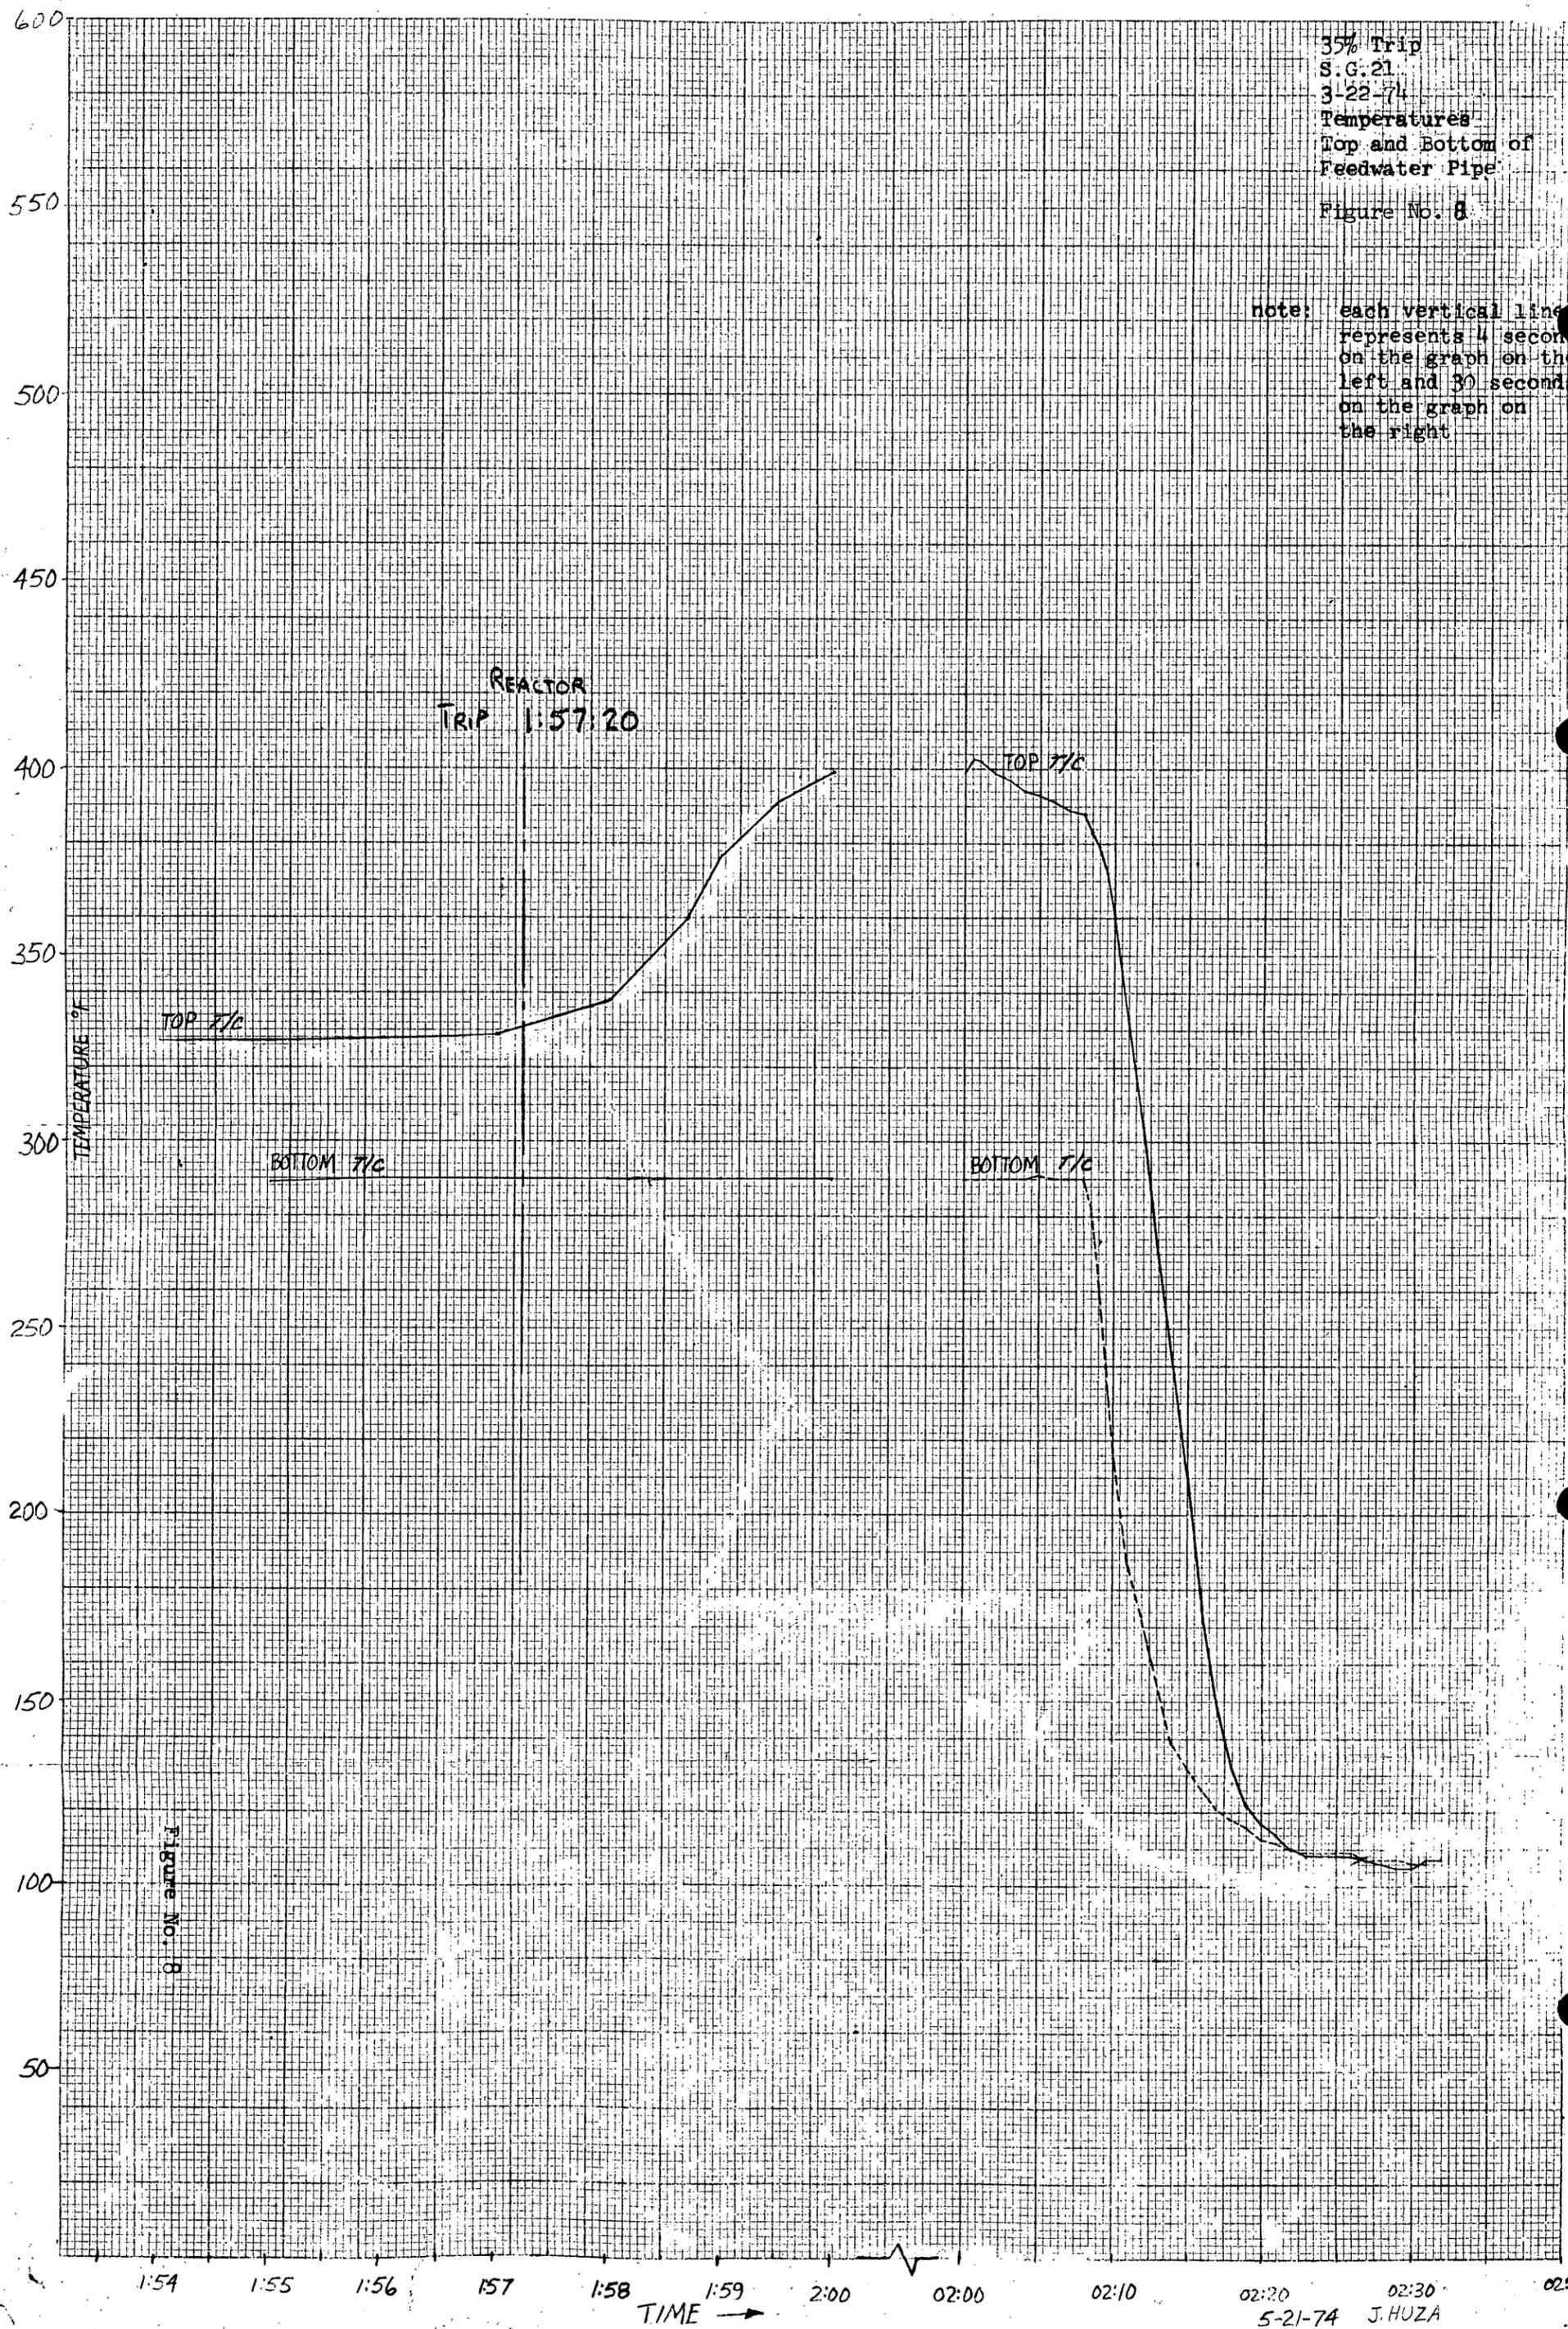
35% Trip
S.G. 21
3-22-74
Temperatures
Top and Bottom of
Feedwater Pipe
Figure No. 8

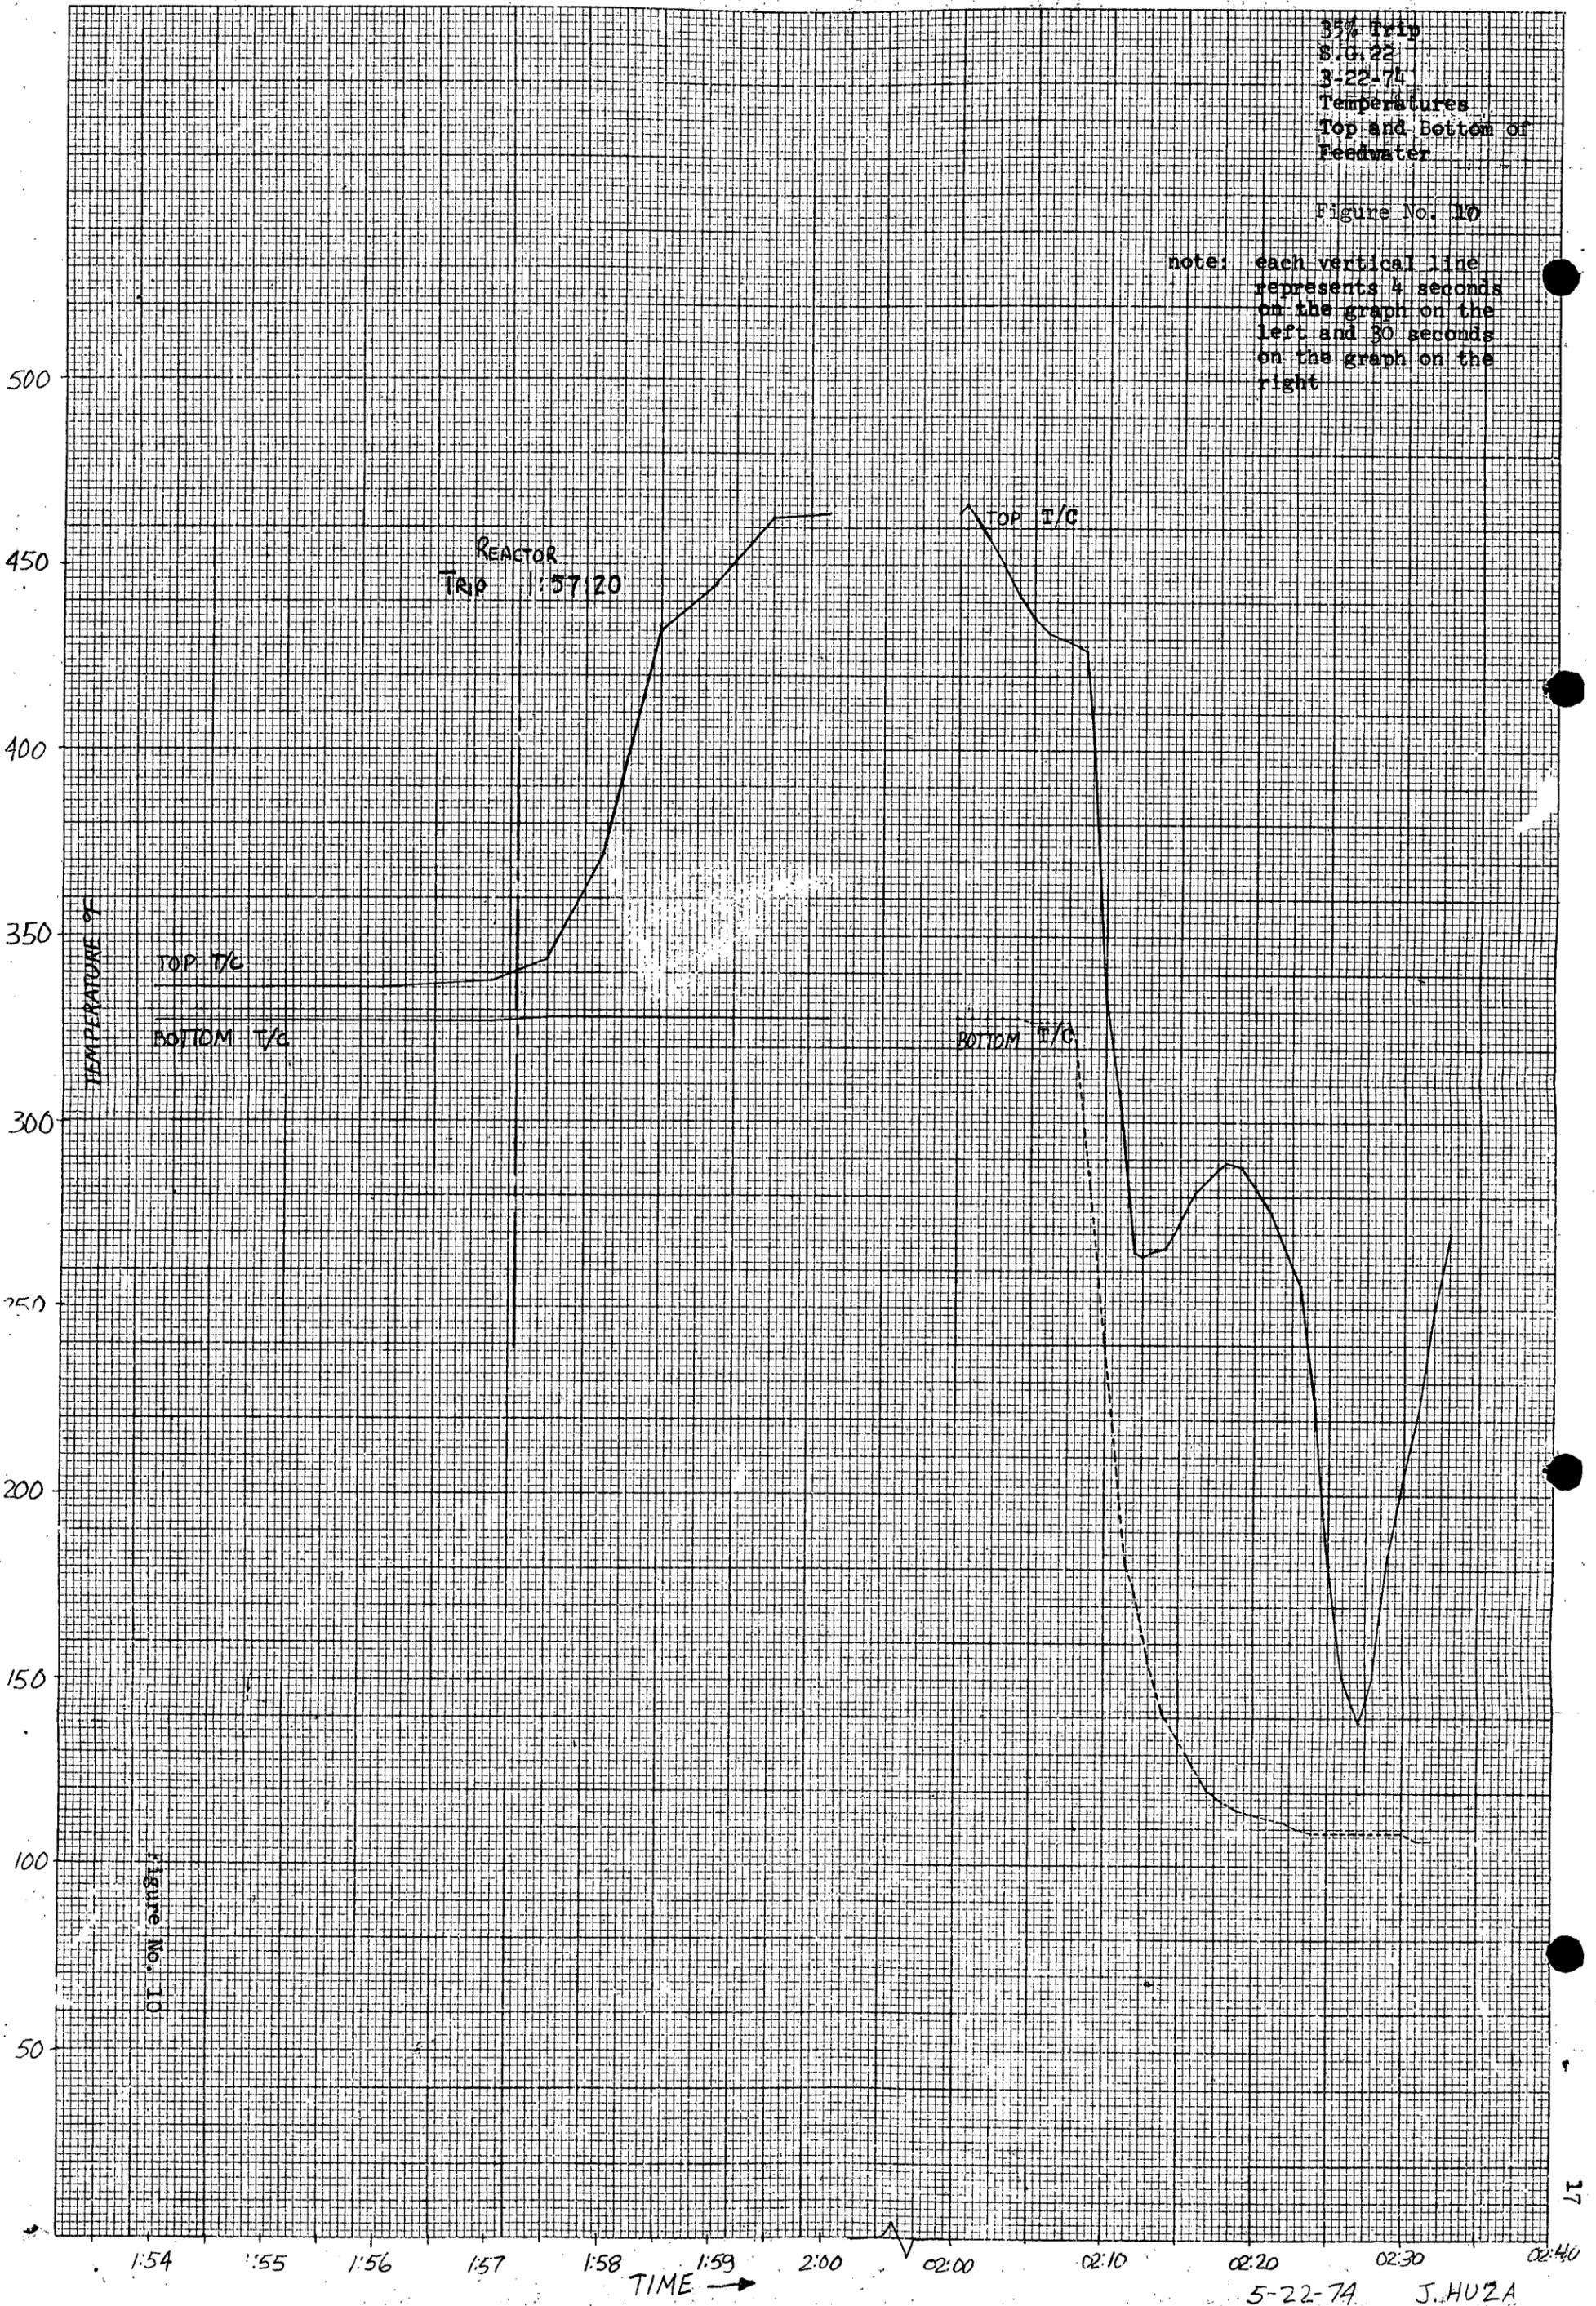
Figure No. 10

35% Trip
S.G. 22
3-22-74
Temperatures
Top and Bottom of
Feedwater
